## MATERIALS & RESEARCH

### RESEARCH UPDATE

U 2000-4

## RECLAIMED BASE COURSE STABILIZED WITH CALCIUM CHLORIDE BRANDON-GOSHEN, VT ROUTE 73

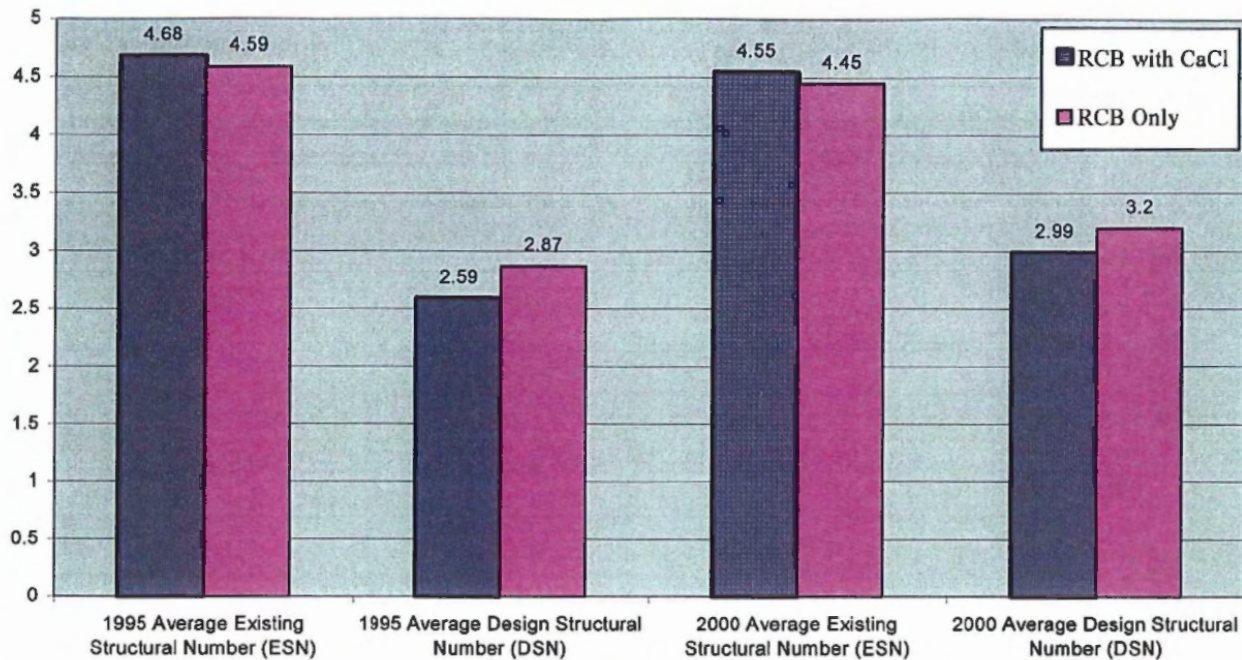
### Falling Weight Deflectometer (FWD)

The Pavement Management Division conducted falling weight deflectometer (FWD) testing in June and July 1995, and again in August 2000. The process entailed testing one location at each test site in the eastbound lane and then repeating the procedure for the westbound lane. All of the structural numbers obtained during this testing were well above the original design structural number in both 1995 and 2000. There was no significant difference noted between the existing (present) structural numbers taken in 1995 and in 2000, between the sections stabilized with CaCl and those without a stabilization agent.

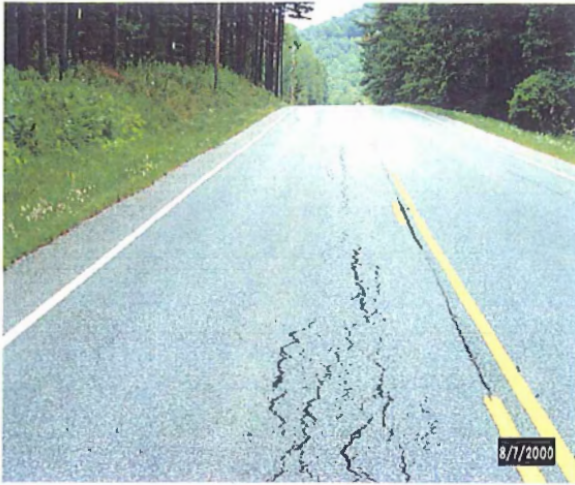
**Figure 1.** Distress in westbound lane treated with CaCl at MM 1.65.

After six years of service, the westbound lane is exhibiting more stress, both in cracking and rutting, than the eastbound lane (Figure 1). This is the case in both the treated and untreated sections. Since the test sites were set up with three treated and three untreated sections in each travel lane, it may be assumed that the stresses are not related to the treatment or lack thereof, but rather factors such as traffic loading and road terrain.

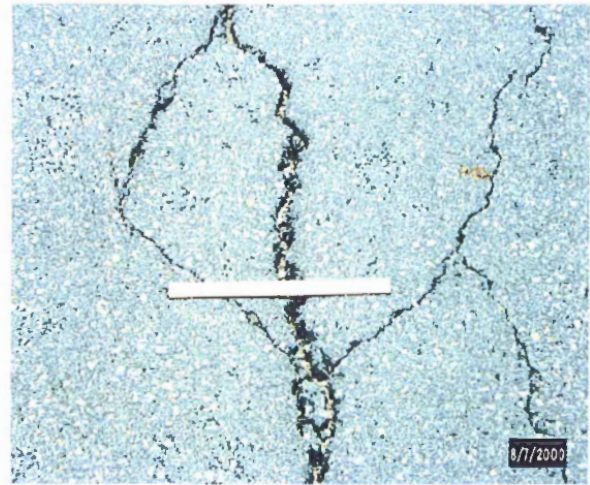
**Figure 2.** Formation of polygon cracks from existing longitudinal crack in westbound lane (RCB) at MM 2.33.

The dominant type of cracking on the project is longitudinal. Large polygons, generating from the primary cracks, are beginning to take form (Figure 2). This cracking is developing both within and outside the wheel paths. This type of cracking, typically associated with a weakened subbase, may be caused by the intrusion of water through existing cracks. This cracking may also be load related, especially in the wheel path areas.

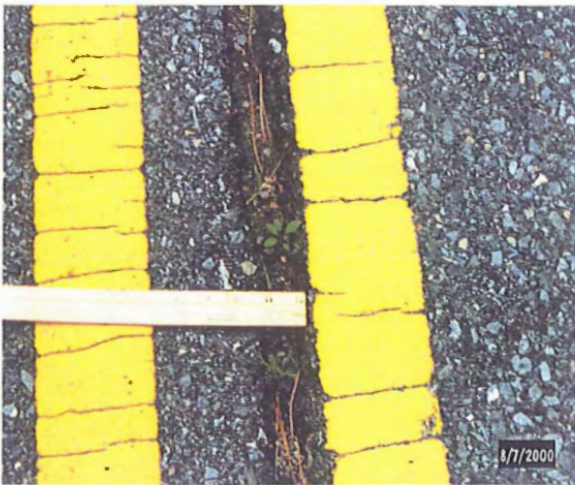
**Figure 3.** 25 mm centerline crack at MM 1.72.

Longitudinal cracking is also occurring along the centerline. Two sites have significant centerline cracks up to 25mm wide (Figure 3). Faint centerline cracking is beginning to appear at a third test site. This type of crack is likely due to construction practices and pavement joint construction.

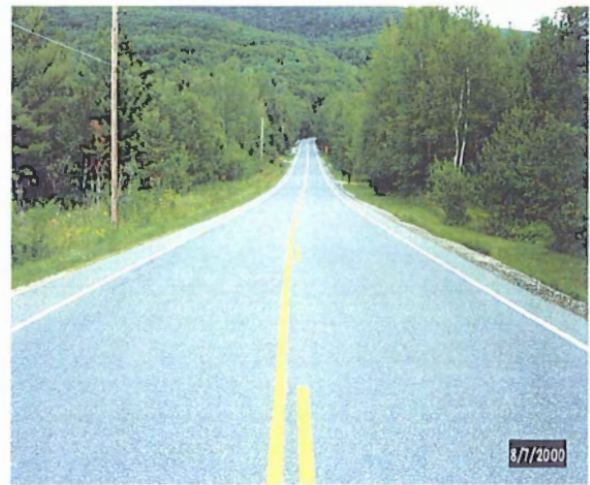
**Figure 4.** Vermont Route 73, looking east at MM 2.24.

Cracking has developed at all the test site areas without the CaCl treatment. Only three test site areas, all with the CaCl treatment, remain free of cracks (Figure 4). These test sites are located at the most easterly end of the project (Test Section 2) and experience an estimated 35% less traffic volume than the untreated section in the same travel lane; hence possibly contributing to its performance.
