## MATERIALS & RESEARCH

### RESEARCH UPDATE

U 2002-1

## ALL SIGN<sup>®</sup> POLYCARBONATE SIGN (Final Report)

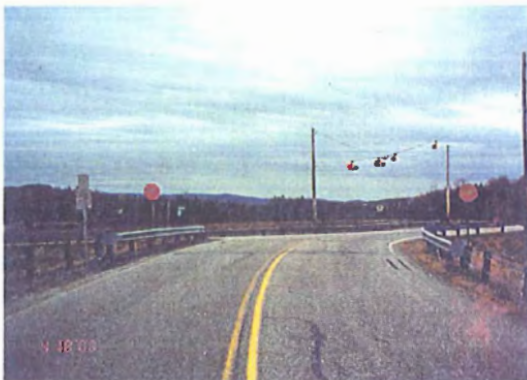
**Figure 1.** Barre – Miller Road at junction with VT Route 63 (left sign).

Four ALL SIGN<sup>®</sup> stop signs were installed by Vermont Agency of Transportation, Maintenance District 6, in April 2000. The signs, designed with a reinforced mounting area on the backside, are attached with two, 5/16-inch stainless steel nuts. The design of the signs allows for mounting from the back, with no fasteners visible on the sign face.

The signs were placed in the following locations (Figures 1-4):

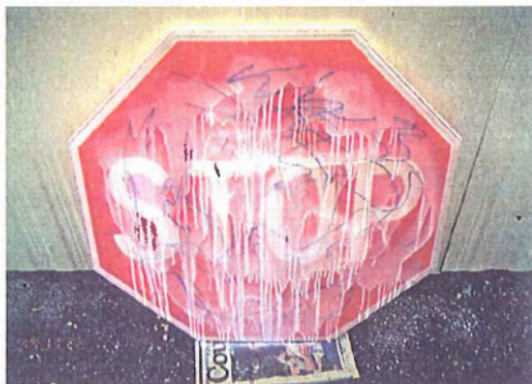
**Figure 5.** Graffiti Testing – Before.

To test the protective coating, Tedlar, manufactured by DuPont, a sign was graffiti tested in the laboratory. The sign was marked with permanent marker and painted with traffic marking paint (Figure 5). After setting for 24 hours, the sign was completely cleaned using acetone (Figure 6).

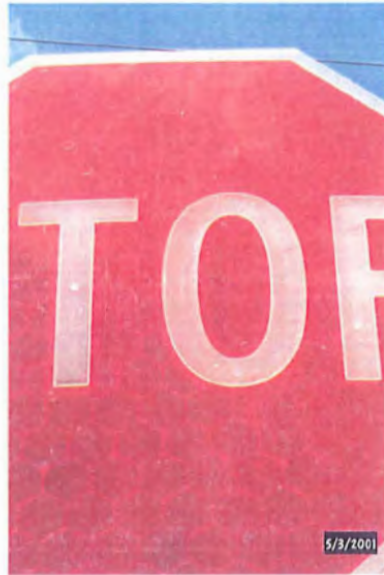
**Figure 7.** Marshfield – Scratches on sign face.

In addition, during its placement in the field, the sign located in Marshfield had been faced with paint. The Maintenance District removed the sign and cleaned it. Although no significant damage resulted, minor scratches had occurred on the sign face (Figure 7).

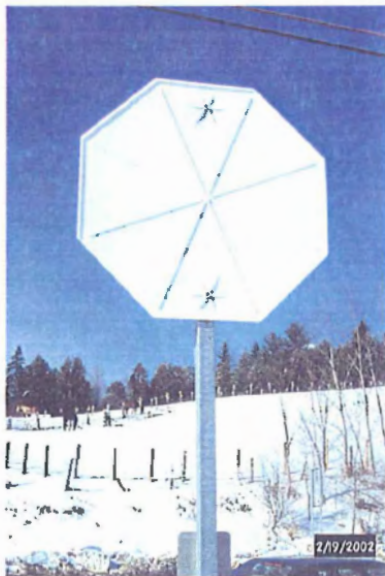
**Figure 8.** Marshfield – After 22 months of service.

After nearly two years of service, the ALL SIGN<sup>®</sup> stop sign has remained intact at two of the four test sites. The sign at the Barre site was removed and replaced with a standard Type III sign in February 2001. The removal of this sign was not by agency forces and its whereabouts is unknown. The sign at the Marshfield site was discovered in February 2002, to have had the front "STOP" portion of the sign gone. An inspection of the back of the sign remaining showed no indication of prying or tampering. No pieces were found during a visual observation of the post. The sign face may be buried in snow pack adjacent. Further investigation planned for the Spring 2002 may reveal the failure mechanism.
