## MATERIALS & RESEARCH

### RESEARCH UPDATE

U 2003-2

## FIELD EVALUATION OF DROP-ON-LINE® THERMOPLASTIC PAVEMENT MARKING MATERIAL (Final Report)

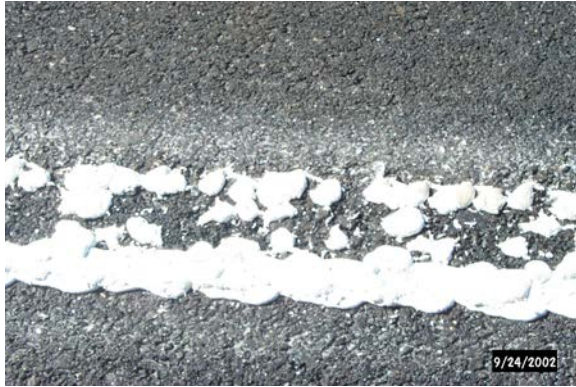
During the installation there was an immediate problem with the application of the material. As the pavement marking vehicle moved along, at an approximate speed of 5-7 miles per hour, the configuration of the line was inconsistent, producing a product with irregularities ranging from a thick, solid line to a line with an irregular patterning of the drop-on elements (Figures 1 & 2). As a result of the poor quality line produced, operations were halted after the first 0.10-mile in order to inspect the material and equipment for deficiencies (Figure 3).

**Figure 1.** Initial installation – poor quality.

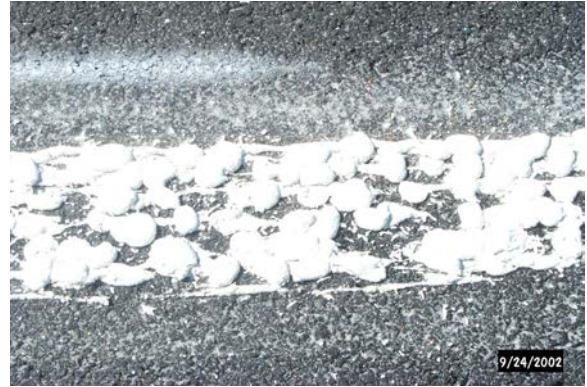
**Figure 2.** Initial installation – poor quality.

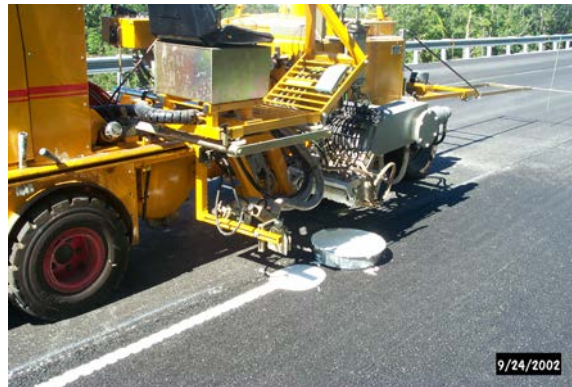
It appeared as if the material was clogging the applicator so the shoe was cleaned and the equipment checked to ensure it was adjusted and set properly. The application was resumed but inconsistencies in the line's appearance continued. The equipment was again stopped, checked over, and the melting box was checked for temperature – with an infrared gun – as well as any signs of a material problem. The temperature was within the specified range for thermoplastic pavement markings and no obvious problems were present. Again, the application resumed, this time the line produced resembled what it was designed to look like, a series of "oval drops" about 2cm by 4cm in diameter.

**Figure 3.** Equipment problems – operations halted.

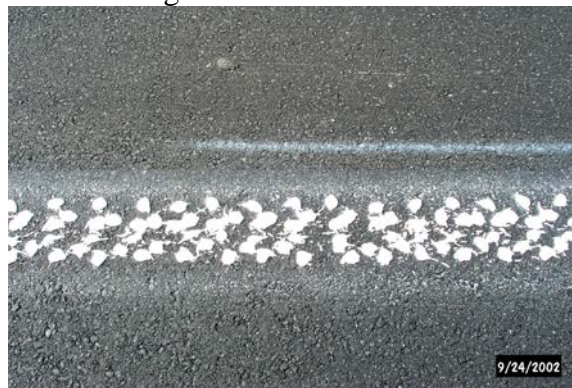
As the application continued, the equipment was stopped again due to the redevelopment of irregularities in the line configuration after approximately 0.45-miles of material was placed. Because of the complications encountered and the quality of the line, the operation was halted. It was agreed upon that only 0.10-miles of the line would be retained for evaluation purposes and the remaining material would be ground out and replaced with standard thermoplastic at no additional cost to the Agency. The area retained for monitoring was between MM 112.35 and MM 112.45 (Figure 4).

**Figure 4.** Detail of pavement marking material retained for evaluation.

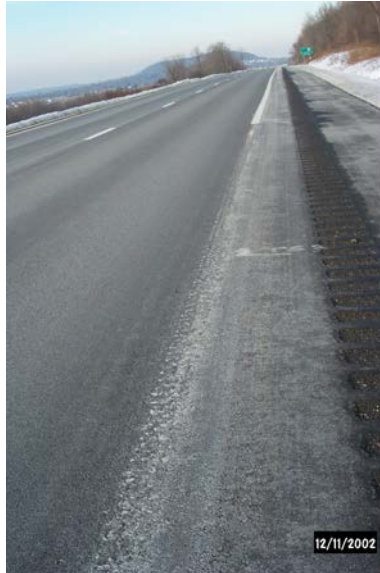
A field inspection revealed that after 2 ½ months of service, the entire test section of the Drop-On-Line<sup>®</sup> product was gone. The northbound white edge line between MM 112.35 and MM 112.45 was completely delaminated while the standard (control) thermoplastic material remained well intact (Figure 5). The loss of the marking material was likely the effect of standard maintenance snowplow operations and was associated to the material’s poor bond strength with the bituminous concrete pavement. It is inconclusive if the profile and geometry of the line was a contributing factor. As noted by the manufacturer’s technical representative, the deficiency in the binder would most likely compromise the entire material formula and the overall product’s performance.

**Figure 5. Drop-On-Line<sup>®</sup> pavement marking system (foreground) after 2 ½ months of service vs. standard thermoplastic (background).**

The experimental application of the Drop-On-Line<sup>®</sup> system on Interstate I-89 in the towns of Fairfield and St. Albans, Vermont exhibited a very short life span. The premature failure of this product was likely due to a deficiency in the material’s composition that caused a poor bond between the marking material and the pavement structure. This theory is supported by material tests done by Brite-Line Technologies’ laboratory, on the product that was supplied to Vermont. As a result, the loss of the material was accelerated by snowplow abrasion from normal maintenance routines. Additionally, the retroreflectivity results on the product were lower than anticipated, based on data provided in the manufacturer’s literature.

Based on the performance of the material in this experimental application it is not considered a suitable product for Vermont highways. A future evaluation on the product may be warranted based on data collected from other states, such as Massachusetts, that experience similar climatic events, after additional winter seasons. Additionally, it is recommended that certification and test results of the material be provided confirming the product being supplied is in conformance with the manufacturer's specifications.
