### RESEARCH UPDATE

U 2004-2

## 3M® STAMARK WET REFLECTIVE TAPE SERIES 820

Work Plan No. 2002-R-7

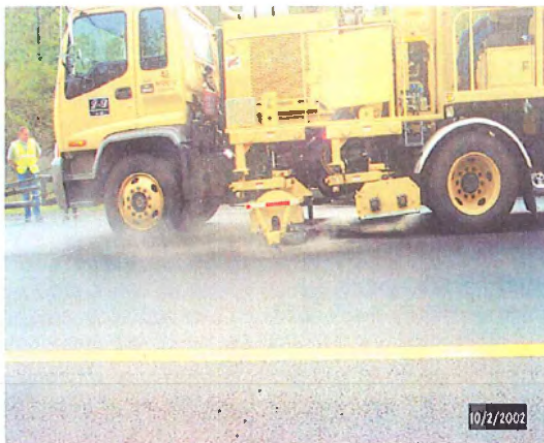
Grinding of Pavement

For the first hour to hour and fifteen minutes the grinding was adjusted and worked on in an effort to limit problems which might occur. The grooving process began at approximately 9:00 am, with a truck creating a groove 6 ½" by 11 ft by 90 mils deep. As a comparison the 820 tape averaged anywhere from 40 to 76 mils thick (based on its profile). In practice the grooves were 100 to 125 mils, which the manufacturer indicated would not be a problem. After the grinding operation was completed the grooves were cleaned and prepared for the lines.

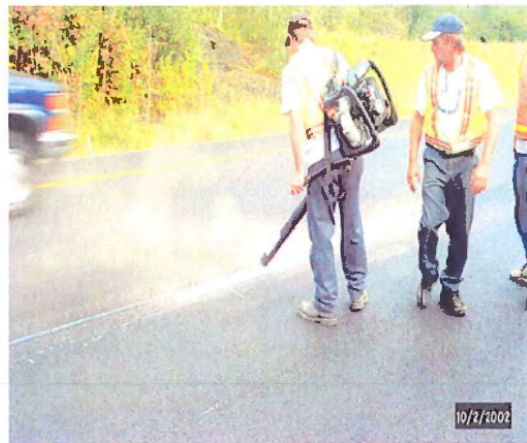
Installation of Lines

A companion product, Stamark P-50 surface prep adhesive (Lot # 2264DZ), was then sprayed on the groove. The tape was then placed with a long leading edge and using a standard tape handcart applicator and rolled with a 230 lb hand roller and tamping device. The average temperature during the time of application was approximately 65°F. The manufacturer's recommended minimum temperature requirement is 50°F. The pavement temperature was 61°F

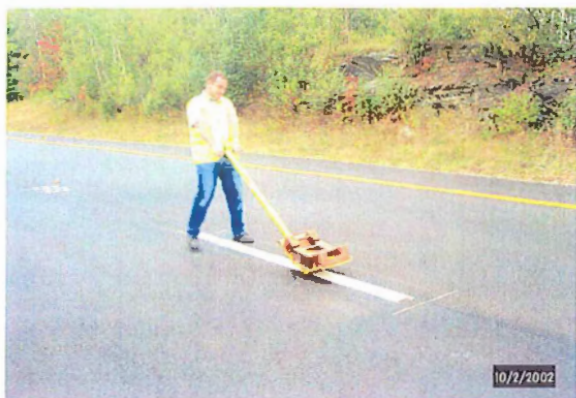
Tamping the Line

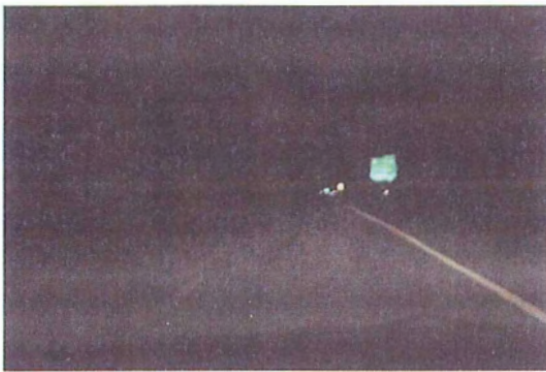
What tape did remain had diminished retroreflectivity necessitating the repainting of all skip lines in the test area as the data obtained fell below 100 mcdl. Visual observation compared favorably with the retroreflectivity results and can be seen in the following photographs:

820 Tape on skip lines (Aug. 3, 2004)

Final retroreflective readings taken in May 2004 resulted in no readings greater than 50 mcdl. Because of this data and the poor condition of the markings, it was determined that the markings were in need of rehabilitation and were repainted in the summer of 2004.

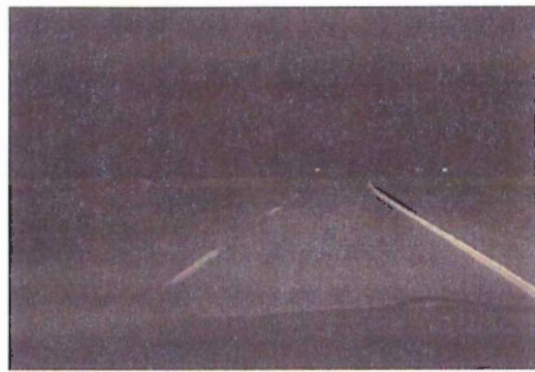
Thermoplastic on skip lines (Aug. 3, 2004)
