MATERIALS & RESEARCH

RESEARCH UPDATE

U 2004-3

SNOWPLOWABLE RAISED PAVEMENT MARKERS (Initial Report)

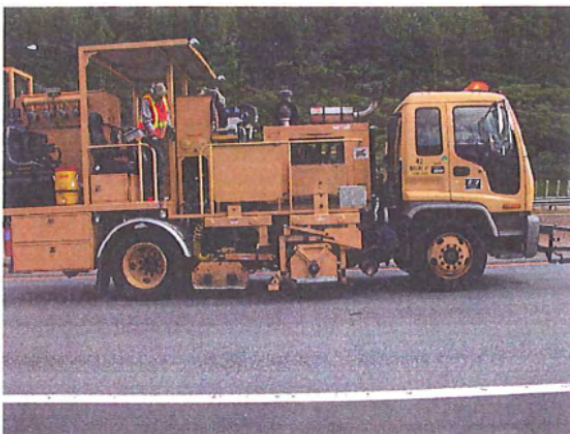
Figure 1 – Grooving

Grooving to create the recess for the markers began at 8:40AM. The truck traveled at 5 MPH and stopped every 80 feet to install a groove for the markers. This process took only about a minute each with the grooving being completed at noon. The concrete saw is designed with a stack of 18" diameter concrete saw blades bordered by 20" diameter saw blades on each side. With a single plunge, the groove created is in the same configuration as the marker, allowing for a close match for the inset. (This blade pattern will vary depending on marker size and shape).

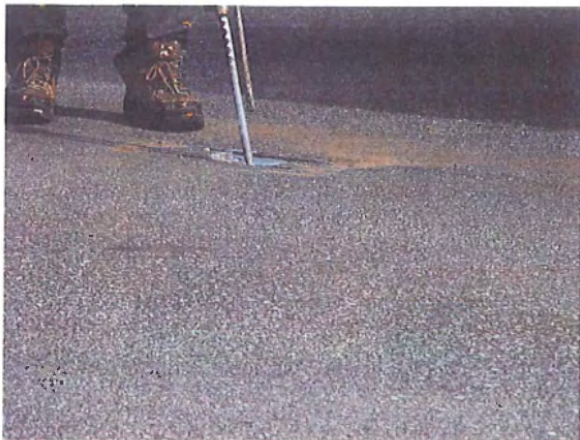
Figure 3 – Applying epoxy

Behind the grooving truck two employees used a pneumatic hose to clean out the groove with compressed air. Immediately after this process, epoxy sealant was poured into the grooves. Without delay, the markers were positioned and tamped into place. This part of the installation process took considerably more time to accomplish than the grooving because of the number of

steps which took about one minute at each groove for the installation process. This had to be repeated every 80 feet for a distance of 4.47 miles, the length of the experimental site. This part of the installation began at 8:50 AM and was completed close to 7 hours later, at 3:45 PM. The epoxy adhesive system used consisted of two independent pressurized tanks that feed through two independent lines to a disposable plastic application tip. The two components, discernible by color, met at the nozzle and mixed within the spiraled chamber of the application tip producing a gray adhesive material. There were no difficulties or setbacks during the installation.
