MATERIALS & RESEARCH

INITIAL REPORT

U 2005-2

EVALUATION OF CROWN TECHNOLOGY'S TUFFLINE HYDROCARBON THERMOPLASTIC

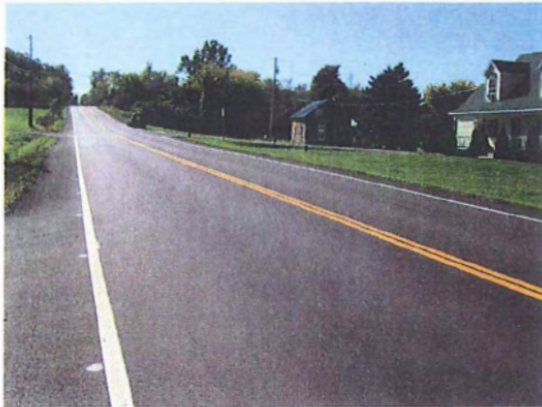
Figure 1 Test site 3 –Oct. 7, 2004

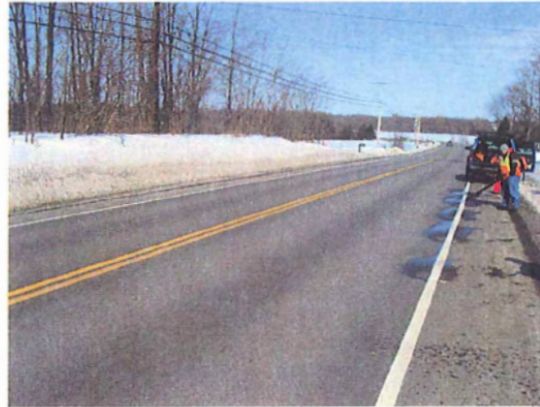
Figure 2 Test site 2 – March 14, 2005
(Cleaning of lines evident)

After five months of service, a second set of readings were taken on March 14, 2005. Winter cleaning protocol (see Appendix C) was carried out to insure that the lines were clear of salt and dirt from snow removal and salting operations. This can be seen in Figure 2 above. The readings collected at this time on the white edge lines averaged 127 mcdl on the Tuffline markings and 135 mcdl for the SG 70 markings. All data sampled can be seen in Appendix A. The yellow lines were not sampled at this time.

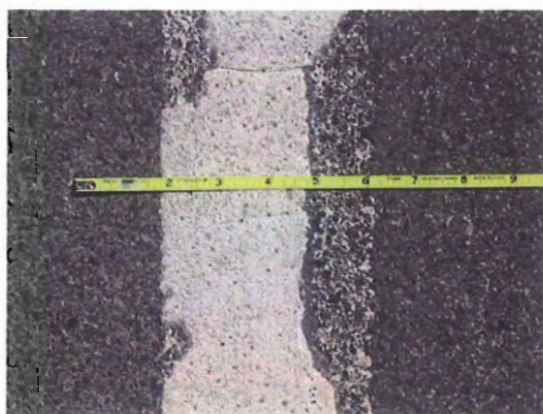
The white edge line readings sampled in May were similar to those taken in March. The average readings collected at this time were 115 mcdl for the Tuffline markings and 160 mcdl for the SG 70 markings. The average readings collected on the yellow center lines were 81 mcdl for Tuffline and 77 mcdl for SG 70. Durability ratings for both March and May were 7 which are in the “good” range. (See Appendix A & B). In Figure 3 below, some damage can be seen on part of the white line. This pattern of damage seems to indicate chipping due to snowplow contact rather than abrasion due to wear.

Figure 3 Test site 3 – May 12, 2005

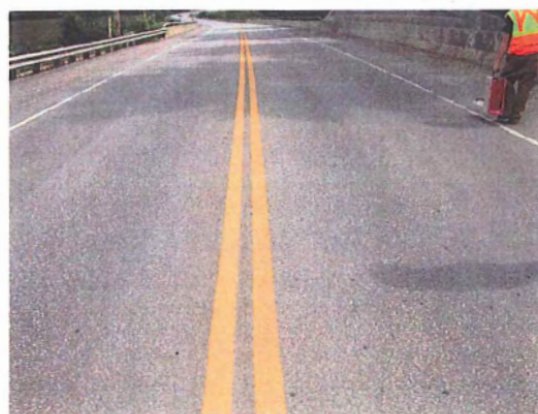
The most recent set of readings was taken on August 23, 2005. These readings were slightly higher than the May 12, 2005 readings with average white edge line readings of 150 mcdl for Tuffline and 168 mcdl for SG 70. Yellow readings averaged 108 mcdl for Tuffline and 95 mcdl

Figure 4 Test site 1 – August 23, 2005
