MATERIALS & RESEARCH

RESEARCH UPDATE

U 2006-2

SNOWPLOWABLE RAISED PAVEMENT MARKINGS

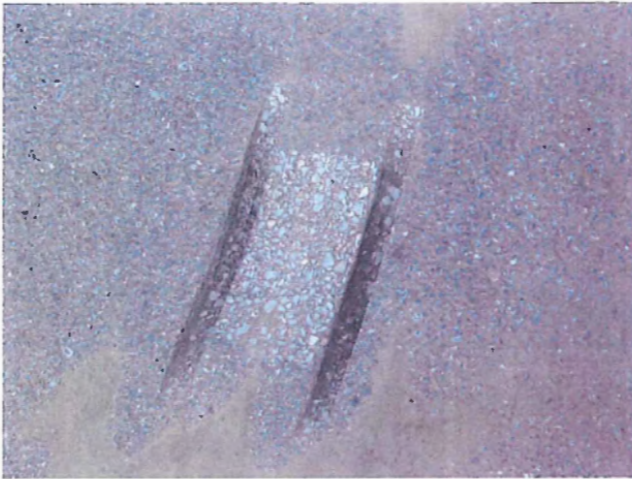
Figure 1 – Marker Groove

To further evaluate these types of markers, this section of I-89 was remarked in July 2004 with four different SPRM products. During the application of the markers the weather was clear and the temperature ranged from 65°F to 72°F. A detailed account of the installation is provided in Report U2004-3. The four types of markers installed in this test were the 101LPCR manufactured by Avery Denison, Incorporated, Hallen Incorporated's model H100 and two products by Ray-O-Lite Incorporated, the SnowLite 150 and SnowLite 200. Figures 1 & 2 show typical examples of the preparation and installation of these markers. All of the markers were installed in the same manner using epoxy manufactured by Avery Dennison.

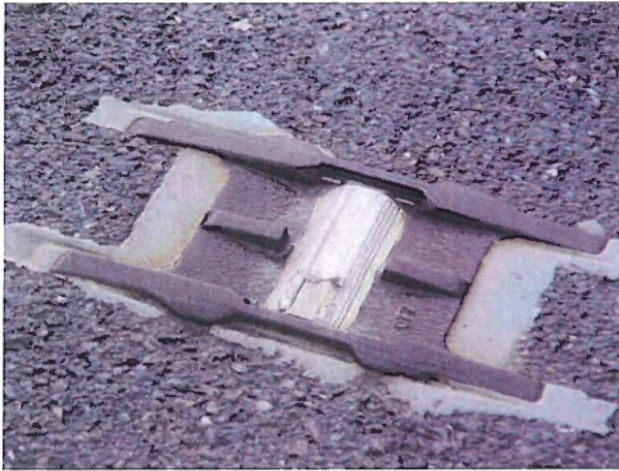
Figure 3 – Avery Dennison 101LPCR

The markers have been monitored continuously since their installation. On November 29, 2005, seventeen months following installation, a visual inspection of each of the markers was performed, with the results of the examination reported in Table 1. Figures 3, 4, 5 & 6 are examples of the conditions of the four types of markers during this inspection.

Further inspection revealed that 101 LPCR only had two damaged or cracked lenses, while the H100 (6) and SnowLite 150 (8) exhibited a similar number of damaged lenses. The SnowLite 200 had the most significant damage with one third of the lenses (17) affected, however it had only one lens completely missing from the

marker. This compared to the H100 markers which had seven lenses absent from their housings. Both the 101LPCR and the Snowlite 150 had no lenses missing from their housings at the time of inspection.

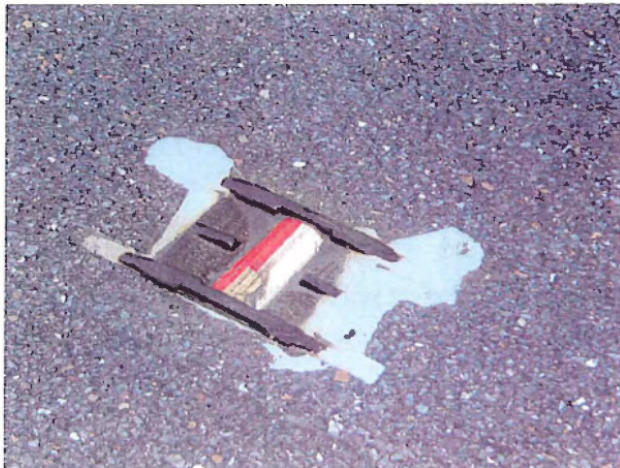
Figure 5 - Ray-O-Lite SnowLite 150

It was noted that one of the markers (in the Ray-O-Lite 150 area) appeared to be completely missing from the test site. However, upon closer inspection of that particular site, it became apparent that while the epoxy had been applied, no marker had been placed in the groove at the time of installation. All other housings appear to be in good condition with no significant distress at the time of this inspection.
