### INITIAL REPORT

U 2006-3

## Smart Stud In-Pavement Crosswalk Lighting System

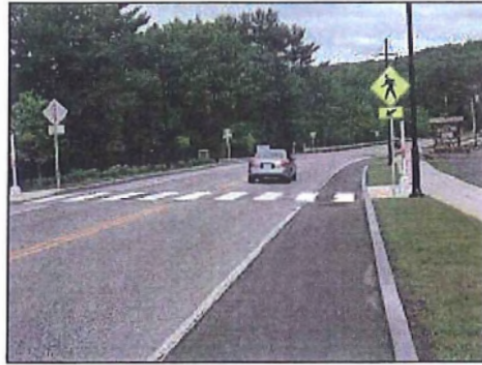
Figure 1 – Overall View

consisting of local residents and tourists. The AADT, or Average Annual Daily Traffic, on this two lane roadway, is 12,500, a moderately high AADT for the State of Vermont. Although the posted speed limit along this roadway is 30 mph, visual observations indicate that many motorists travel above this speed. The setting for the reduced speed limit is similar to approaches posted at 50 mph from either direction. It is suspected that the observed rates of speed may be caused by unfamiliarity with the area as much of the demographic is composed of tourists. Figure 1, provided below, displays the crosswalk location in reference to US 4.

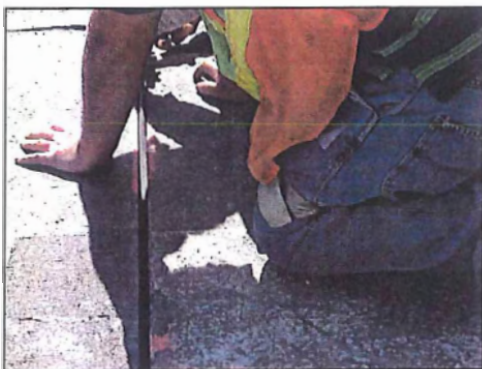
Figure 2 – Saw cutting

Installation by a private contractor began at approximately 9:00 A.M. on Wednesday, September 21, 2005, by marking out the layout of the cable installation with temporary paint. Once the site layout was properly marked, the pavement was saw cut to a minimum depth between 3.5" and 4" along the temporary paint markings. Please note that this procedure was carried out in two series as only one lane of traffic was left open to facilitate the flow of traffic coming from either direction. The surface of the pavement was then milled to generate a trench on either side of the future bi-directional SmartStud markers to provide for optimum visibility when operational. Please note that markers should never be installed within a wheel path. According to the manufacturer, the length and slope of the trench is directly correlated to the viewing distance of the lights as a longer trench will allow for a longer site distance. In this case, each trench was 24" in length on either side of the future lights creating a viewing distance of approximately 350 ft. Figure 2 and 3 demonstrate the saw cutting and milling efforts, respectively.

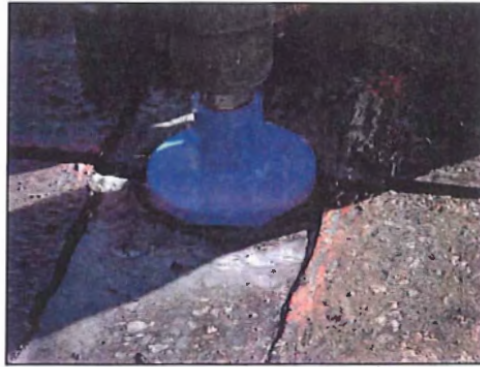
Figure 4 – Coring

Once the pavement was properly milled, a core drill with 5" bit was utilized to core the underlying pavement to a depth between 5/16" to 3/8" below the surface. This provided a clean and level surface for adhesion and a recessed area for the SmartStuds minimizing inherent damage from winter maintenance practices. Finally, to ensure proper installation, each marker was placed within the cored location to verify that the LEDs would not be obstructed from high spots in the adjacent pavement. Figure 4 displays the coring procedure.

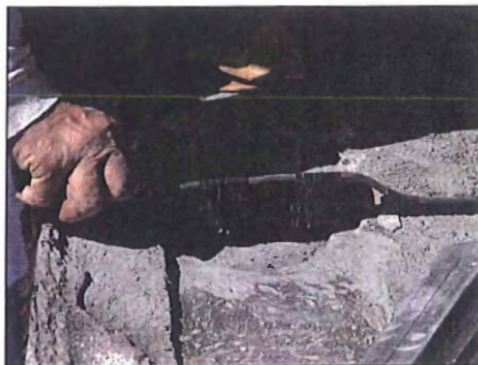
Figure 5 – Inserting Node and Cable

A pressure washer was used to remove any dust or debris from within the saw cut, or slot, and coring locations. In order for the sealant and adhesive to adhere, an air compressor was used to remove any excess water residing in the slot. Once sufficiently dry, the cable was inserted into the slot. At each cored area, the cable was cut using a utility knife. A node was then placed into the split section of the cable and inserted into the slot. Figure 5 shows the insertion of the cable and node. Upon verification that the cable and nodes were securely in place, a sealant applied into the slot, on top of the cable. Care was taken to ensure that the sealant did not overflow into the cored areas or trenches. When the cable sealant had cured, all of the SmartStuds were installed. This was performed by applying a special adhesive to each core location and inserting each SmartStud. Any excess adhesive was removed. Finally, the loose end of the cable was inserted into the SmartCabinet providing power supply and activating the system. The operation was completed by 6 PM. Please see Appendix B for a diagram of the SmartStud with cable and node.

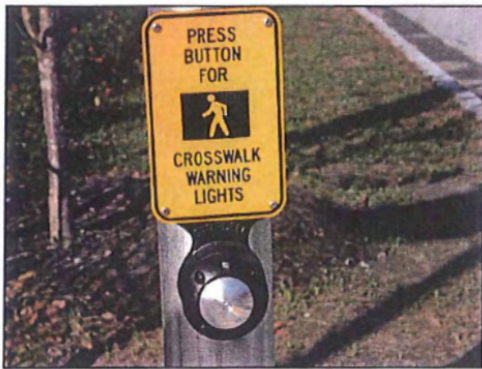
Figure 6 – SmartButton

Materials and Research personnel returned to examine the experimental feature on Friday, September 30, 2005, nine days following installation, to examine the ease of operation of the system. As stated previously, both a SmartButton and SmartPED was installed on either side of the crosswalk activating the system either by pressing the button or pressure produced by standing on the SmartPED. Each activation element was examined and found to be in good working order. In addition, each SmartStud with LED lighting was assessed and appeared to be installed correctly with the bottom of each lens below grade. Figure 6 and 7 display the SmartButton and SmartPED, respectively.

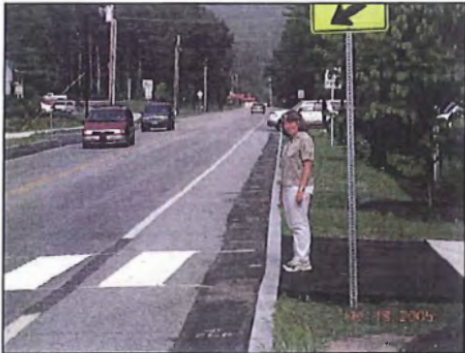
Figure 9 – Looking

In order to assess and document any changes in driver behavior, an observational study, known as a before and after study, was conducted in association with the in-pavement lighting system. For this examination, two scenarios were carried out prior to and following installation. The first situation involved an Agency member dressed in typical pedestrian clothing providing an impression that they were about to step into the crosswalk by looking in both directions. The second situation involved the same Agency member looking in both directions and then stepping into the crosswalk. Oncoming traffic was visually monitored during these events in order to assess driver behavior. Figure 9 and 10 below depict the two scenarios.
