## MATERIALS AND RESEARCH

INITIAL REPORT

U 2006-4

### Brifen Wire Rope Safety Fence

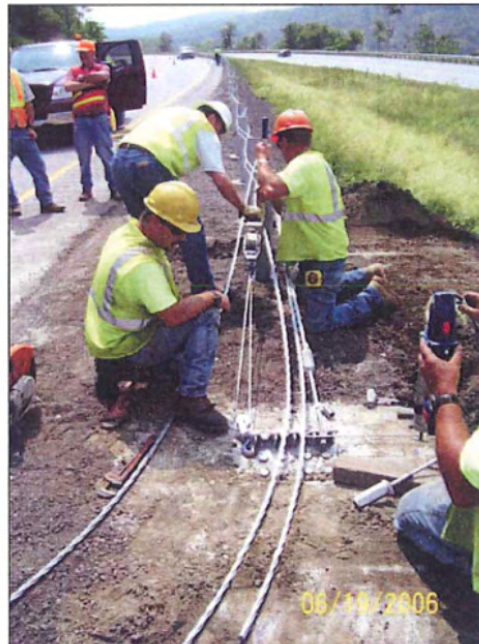
Figure 1 – Brifen Wire Rope Installation

Construction of the Brifen Wire Rope Safety Fence began the week of May 30, 2006. In accordance with the associated Category II Work Plan, WP 2005-R-11, the experimental test section of safety fence was installed on the shoulder of the north bound passing lane of I-89 from MM 56.545 to MM 56.860. Pre installation activities included the removal of underlying substrate for all post hole locations and the application of concrete into round paperboard forms known as "sonotubes". The sonotubes contained rebar cages in order to support the line of posts required for the fence system. The sonotubes were spaced 10.5 feet apart on average. The spacing decreases to 6.5' at each end terminal. On June 19<sup>th</sup> the wire and posts were set for erection. (See figure 1) Following the arrival of the representative from Brifen, assembly began on the test site.

6/19/06 - Topsoiled, fertilized, limed, seeded and mulched areas around end anchors. Tamped and dressed up areas around posts with aggregate shoulder material. Brifen rep Lyndal Wiseman then instructed the onlookers (Doug Newton D6, Tom Anderson D6, Michael Wilder D6, Carl Fielder Const. and Ken Atkins representing Const.) how to tension the Brifen rail using the equipment supplied thru Brifen. Tensioned to 3600 lbs.

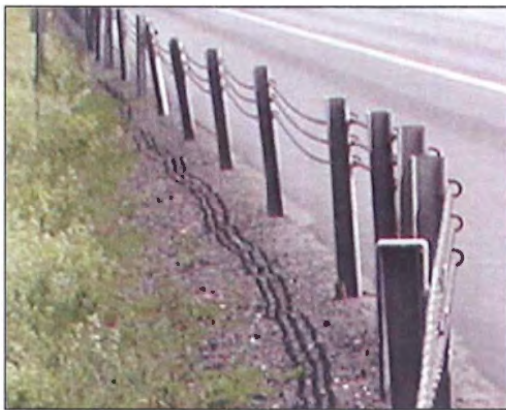
Figure 2 - Three Rope Fence

During the initial post installation site visit conducted on June 21<sup>st</sup>, the fence appeared to be very highly tensioned and visibly stronger than the standard three rope safety fence which seemed to sag in the middle between posts (See Figures 2 and 3). The referenced three cable barrier is located on the shoulder of the break down lane of I-89 northbound diagonally across from the brifen test site and end at MM 56.53. It was also observed that all four wire ropes were secured at the end terminals. While the three cable wire fence is hung on the front face of the post, the Brifen system weaves two wires around both sides of the posts as shown in Figures 2 and 3.
