# GUARDRAIL APPROACH SECTION, 3 RAIL BOX BEAM, CURBLESS

STANDARD  
S-364D

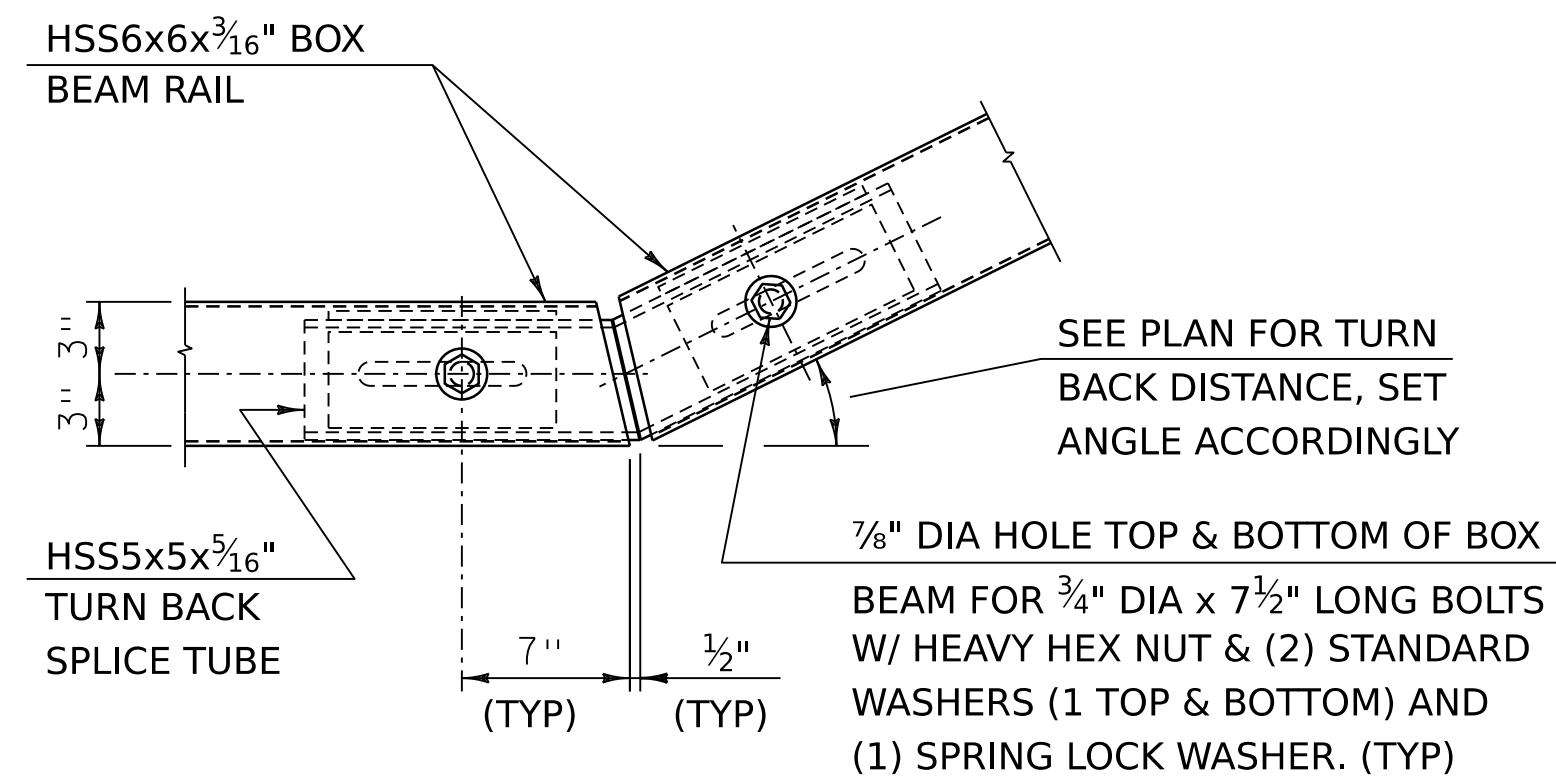
## TURN BACK SPLICE TUBE ASSEMBLY

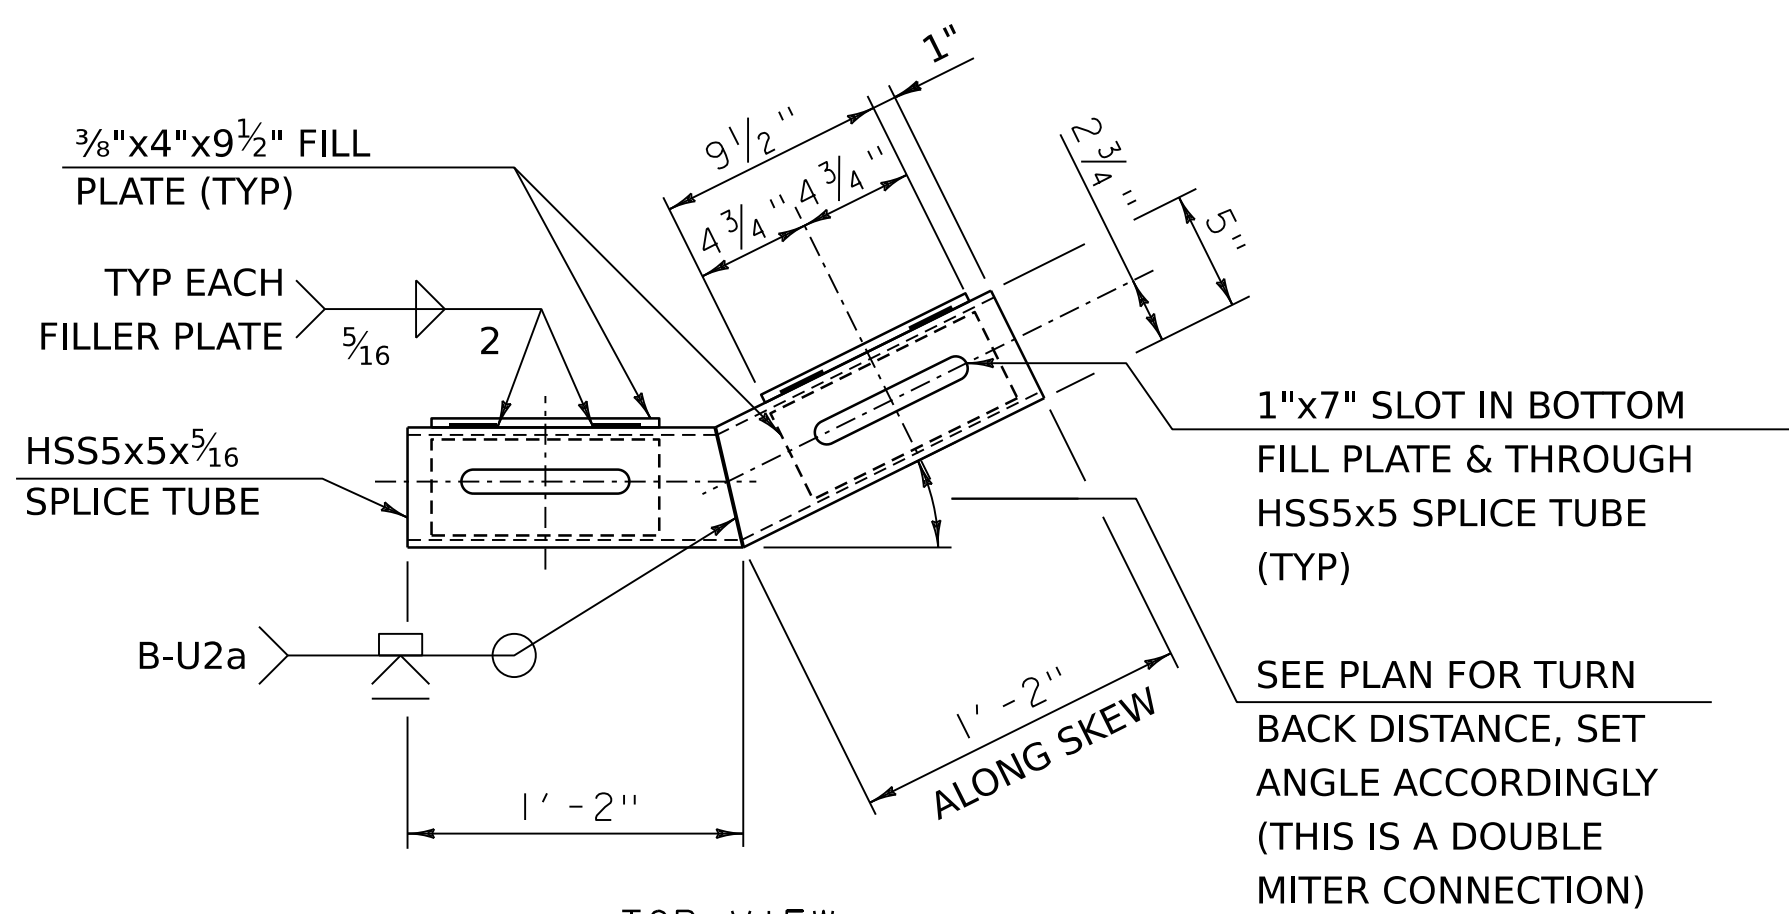
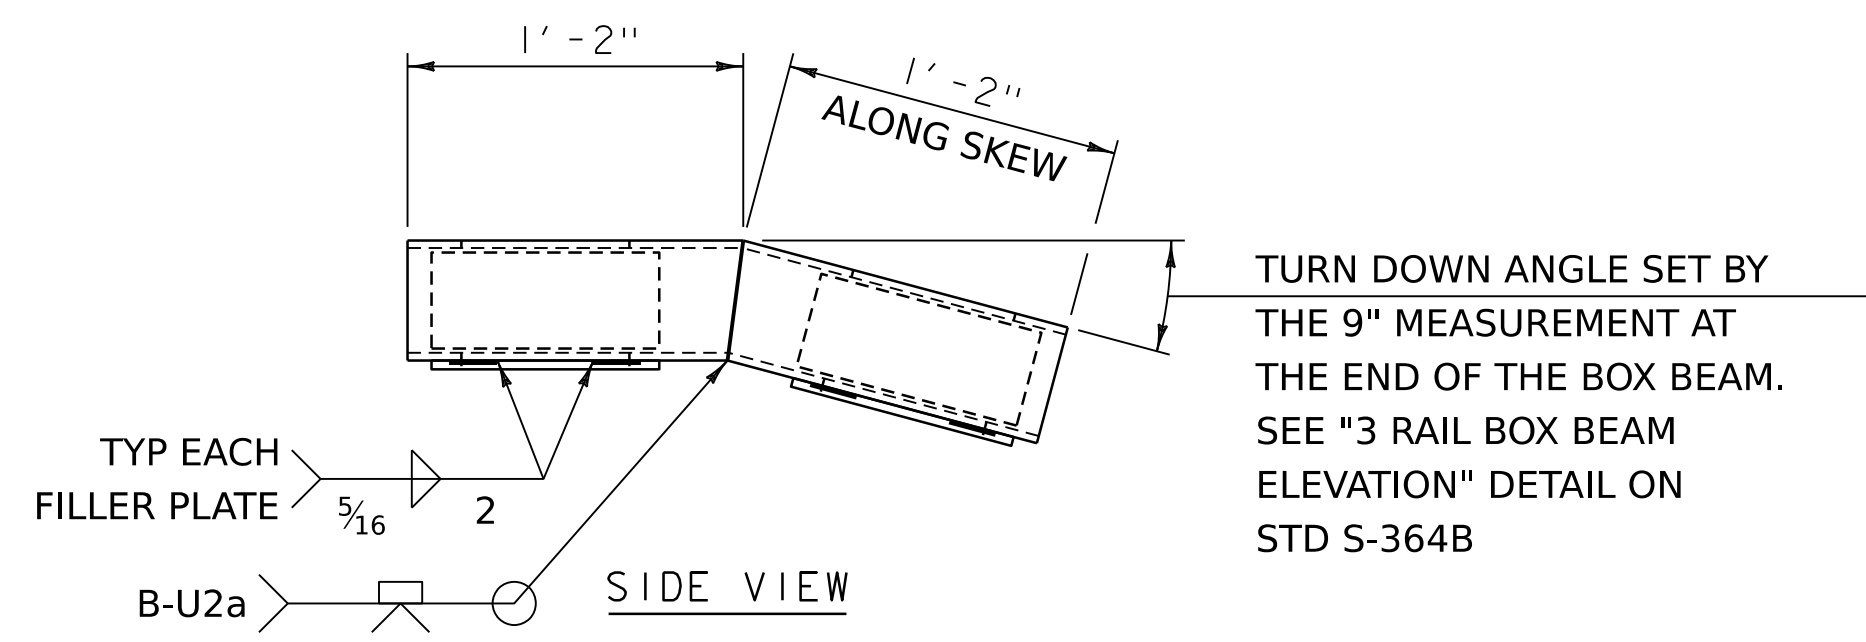
## TURN BACK SPLICE TUBE DETAIL TURN BACK & TURN DOWN TUBE JOINT

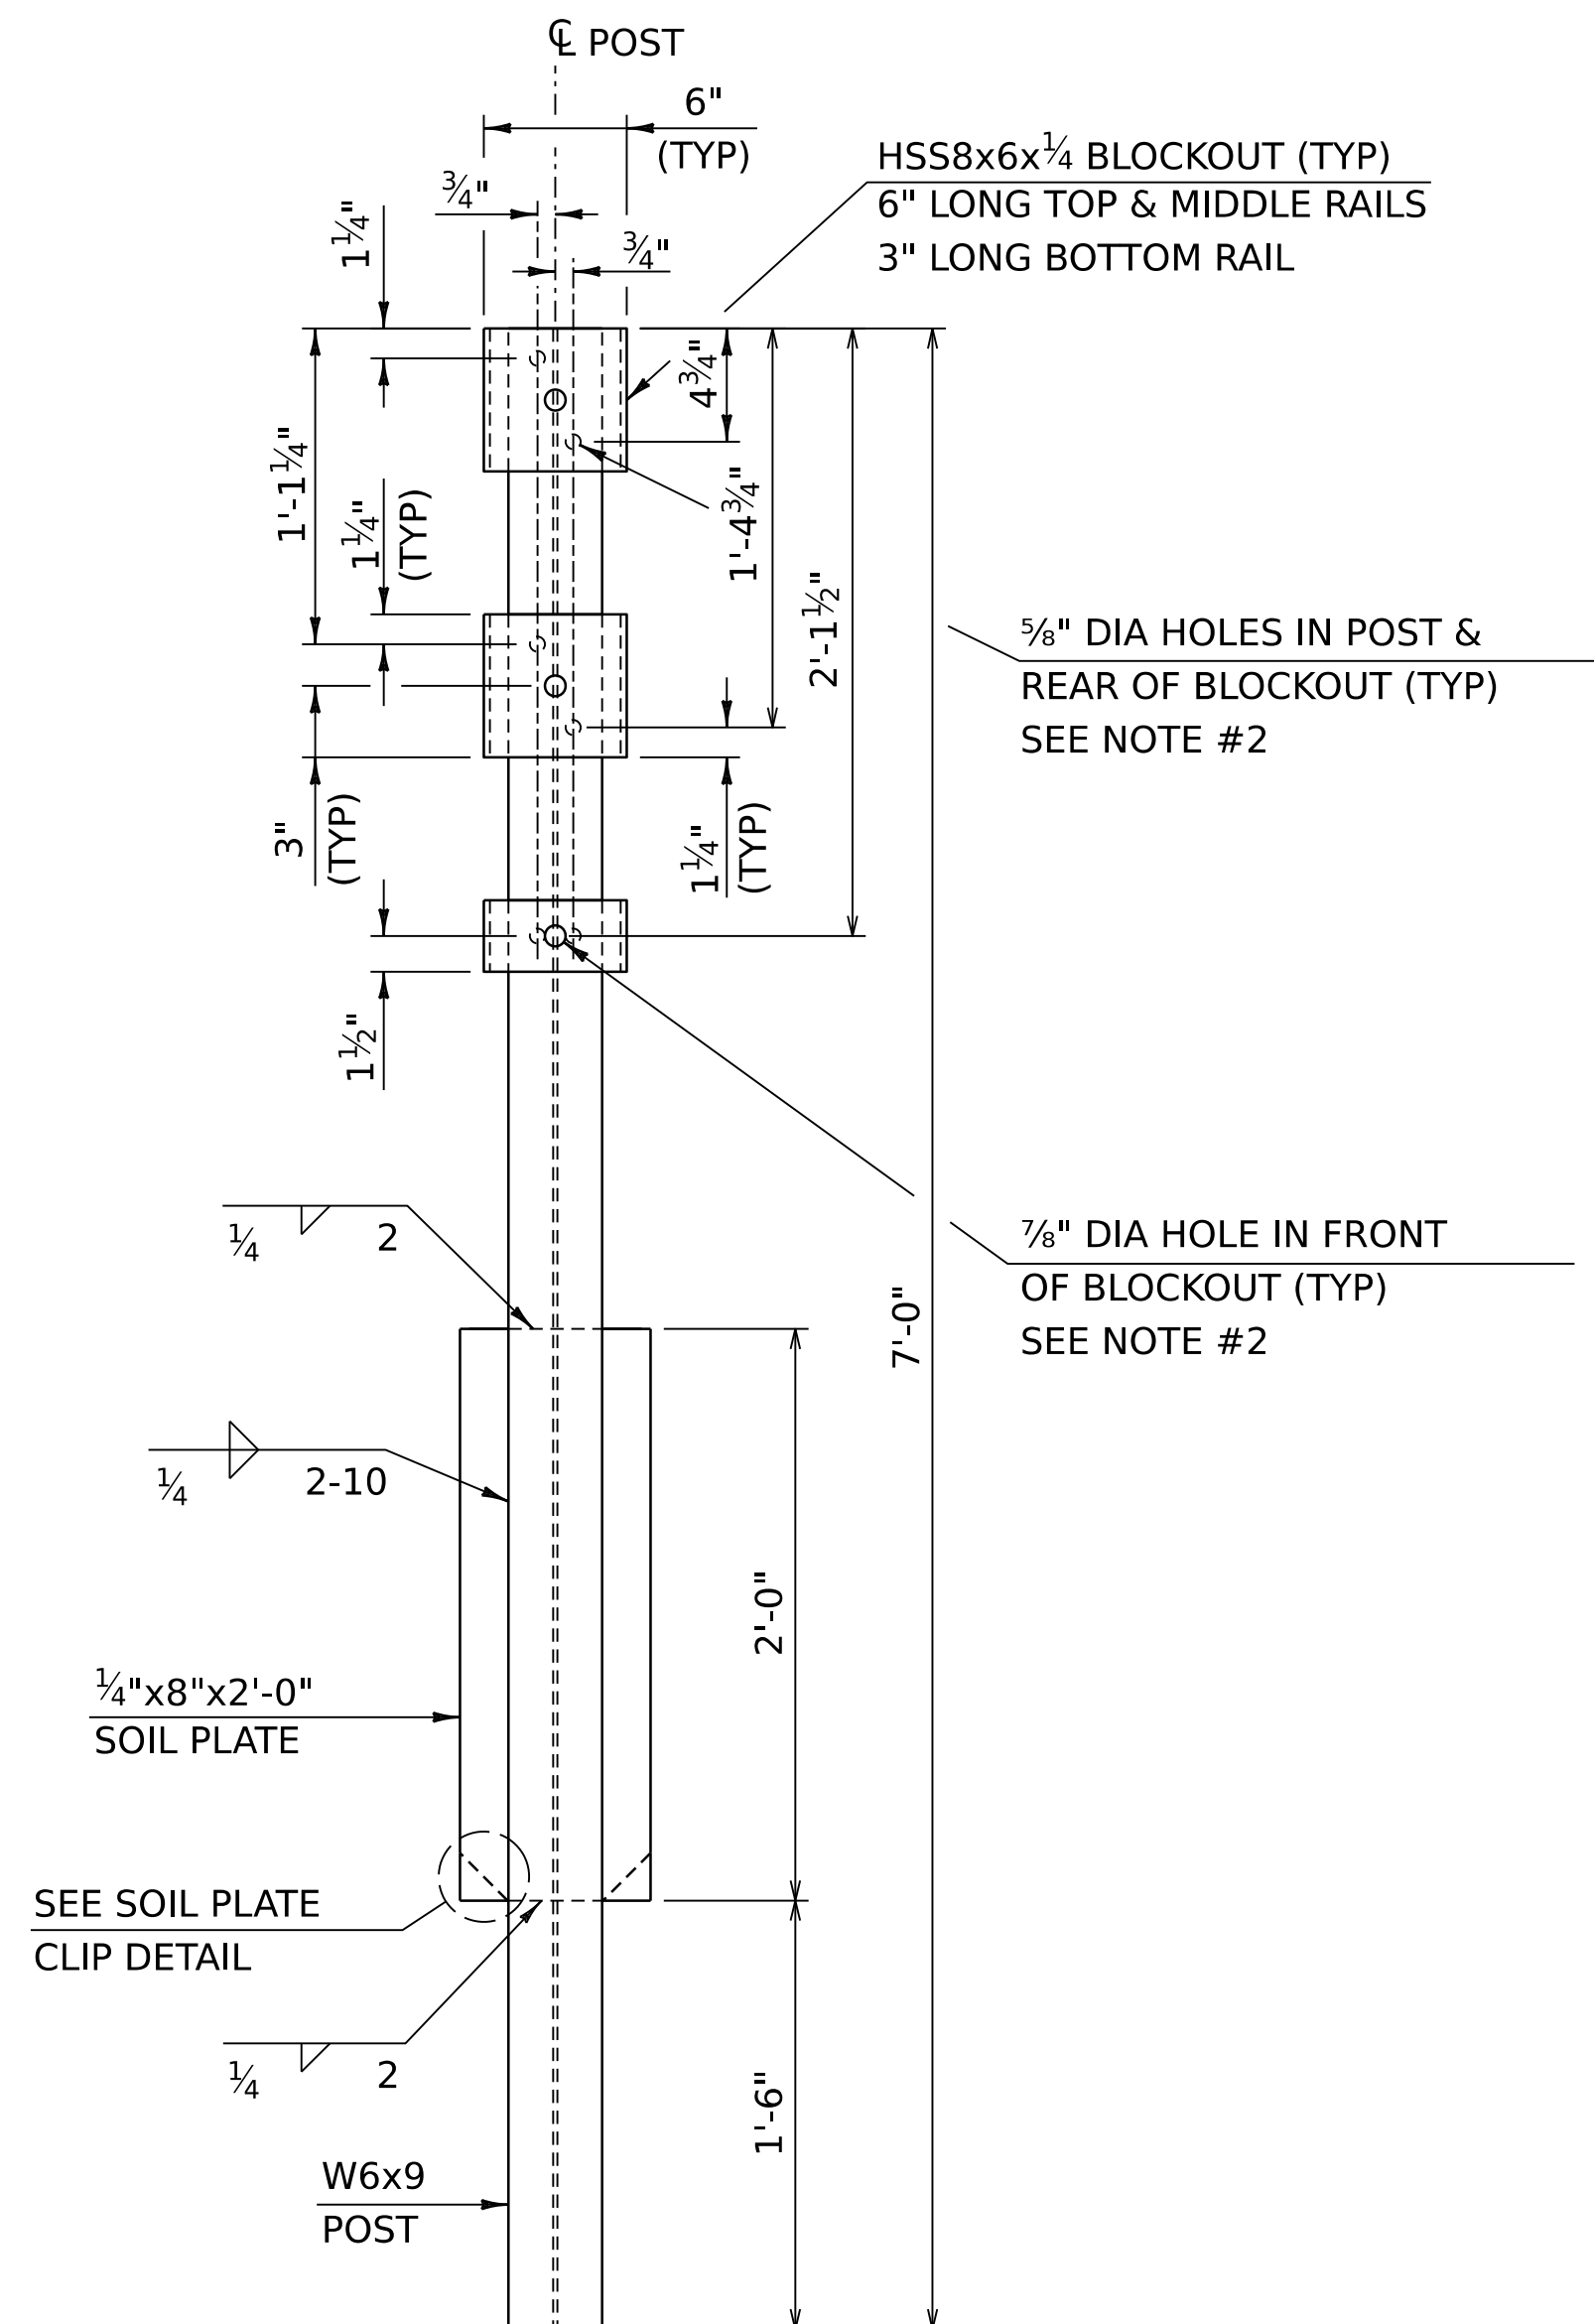
## HEAVY POST DETAIL

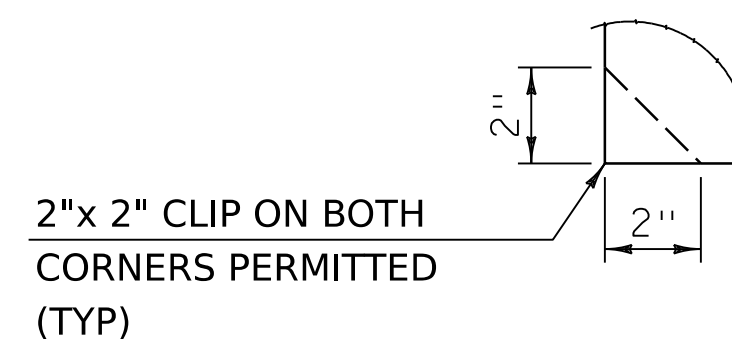
## SOIL PLATE CLIP DETAIL

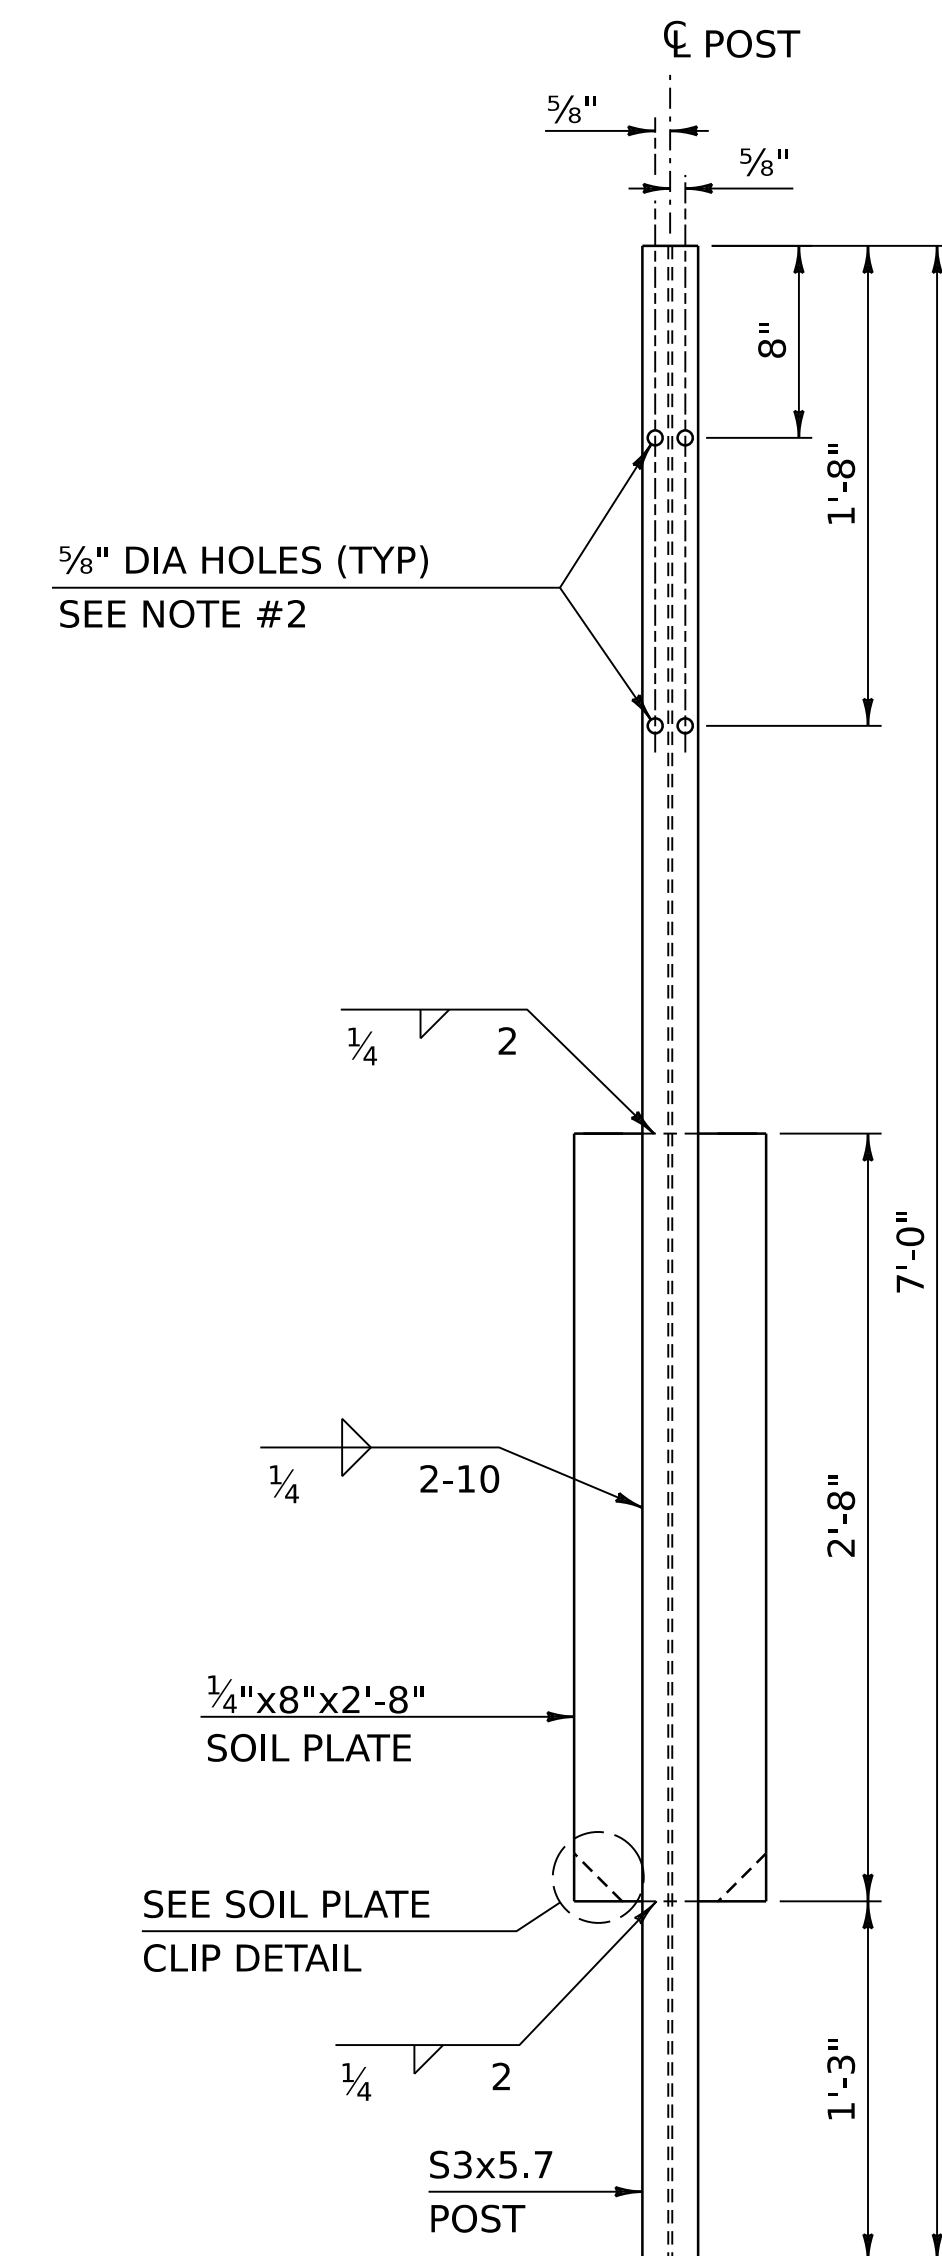
## TRANSITION POST DETAIL
