MANHOLE DATA SHEET

MH No. R2-4

226 WESTCHESTER AVENUE  
WHITE PLAINS, N.Y. 10604JOB NO. R2.2SUBJECT CITY OF RUTLAND SUBSYSTEM R5INFILTRATION / INFLOW STUDY KEY MH —MH INSPECTION DATE - 4/18/74MANHOLE NO 6PERSONNEL - DWS, GWSSTREET LOCATION - RIVER ST AT PUMP STA.

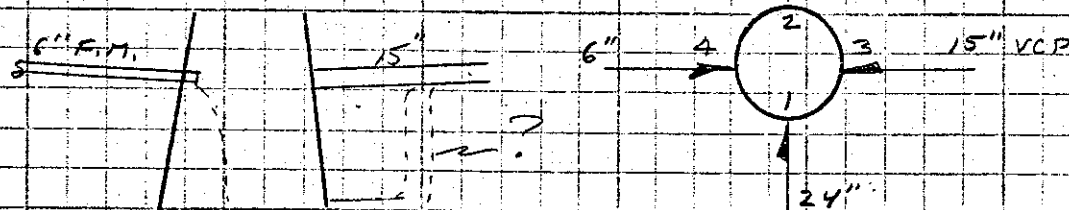
SPECIAL CONDITIONS - EDGE MAIN DISCHARGE (cannot descend MH because of F.M. discharge)PIPE INSPECTION STRAIGHT JOINTS — SEDIMENT — ROOTS —MH INVERT BENCHES YES FLAT — PIPES DROP YES F.M.MH RISER MAT'L BRICK JOINTS GOODMH STEPS TYPE RUNG CONDITION GOODMH SHIMS MAT'L CONDITION —MH FRAME TYPE LEVEL —MH COVER DIA THICK — HOLES —PAVING OVER COVER — INCHES —
