Evaluation and Comparison of Snowplowable Raised Pavement Markings (SRPM) Waterbury/Bolton IM089-2(33) Final Report

July 2007

Report 2007 - 8
Reporting on Work Plan 2003-R-5

State of Vermont
Agency of Transportation
Materials and Research Section

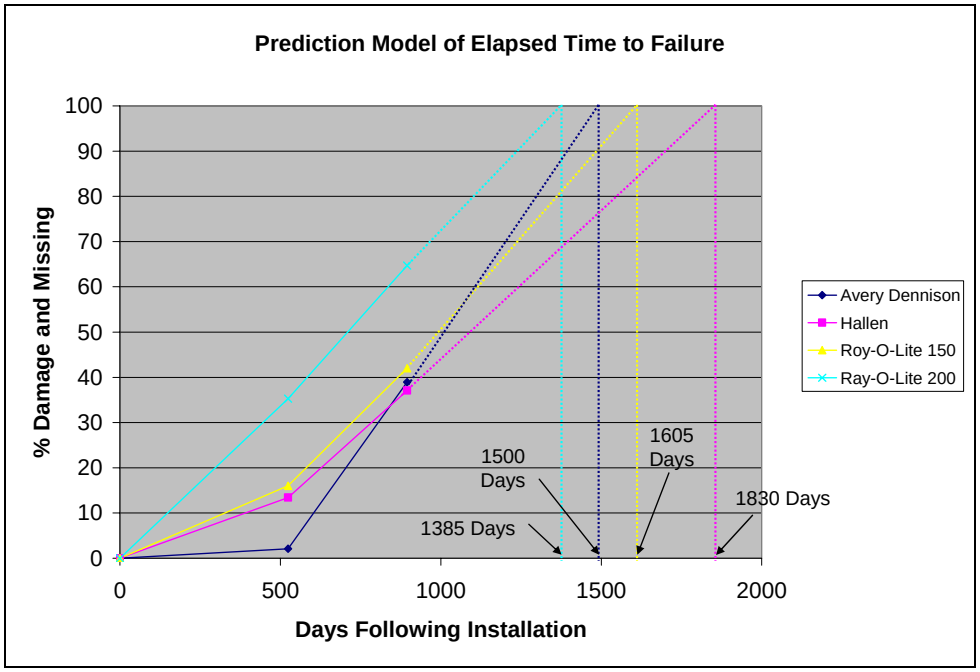
Figure 14 – Service Life Estimate

Service life estimates for each white line pavement marking were not determined from Table 3 and 4 due to the large extent of time between data collection events. Therefore, a scatter plot of the data was generated in order to establish the approximate amount of elapsed time before all of the lenses were missing or damaged as shown in Figure 14. Please note that some of the Avery Dennison markers were damaged in association with a 2006 construction project.

- Ray-O-Lite 200 – 1385 days
- Avery Dennison – 1500 days
- Ray-O-Lite 150 – 1605 days
- Hallen – 1830 days

Please note that a non-linear trend in the performance is shown within the graph above. By utilizing a linear performance model from 2005 to 2006, a highly liberal estimate of service life is shown within Figure 14. The actual life span will likely be shorter in duration. Also, given the additional damage of the Avery-Dennison markers due to construction practices, an increased slope between 2005 and 2006 has likely resulted in a more conservative life estimate as compared to the other markers.

As shown in the Table 8 above, it appears that the Hallen and Ray-O-Lite 150 markers are the most cost effective and provide the longest performance. It is interesting to note that the Ray-O-Lite 200 markers have the highest initial cost the shortest service life. In addition, while the Avery Dennison markers appear to be slightly more expensive than the Hallen and Ray-O-Lite 150 markers, this estimate may not accurately depict the actual cost per month as some markers were damaged from an adjacent project. Therefore, the installation of each marker is recommended with the exception of the Ray-O-Lite 200 markers.
