EXPERIMENTAL BRIDGE DECK MEMBRANE

APPLICATIONS IN VERMONT

REPORT 74-4

Initial Report

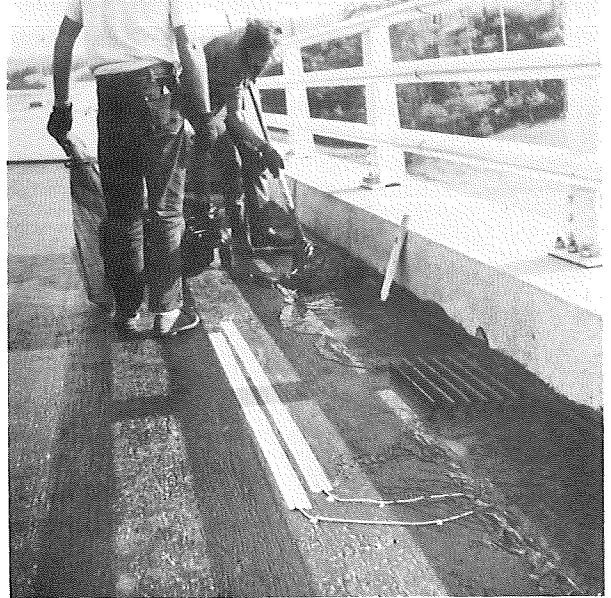
Placing glass fabric in the first coat of asphalt along the curb. Note moisture sensing copper foil strips placed beneath the membrane to detect the passage of moisture.

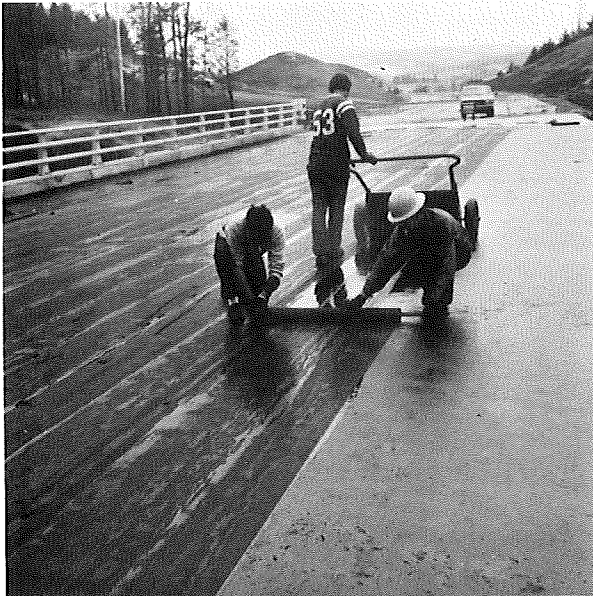
Placing glass fabric in first coat of hot asphalt.

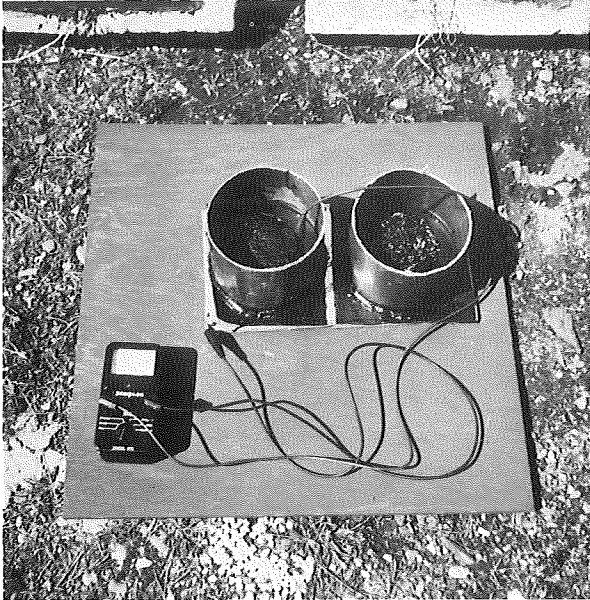
Checking the puncture resistance of preformed sheet membranes subjected to applications of 275° - 325°F bituminous mixes applied at a load of 200 psi.

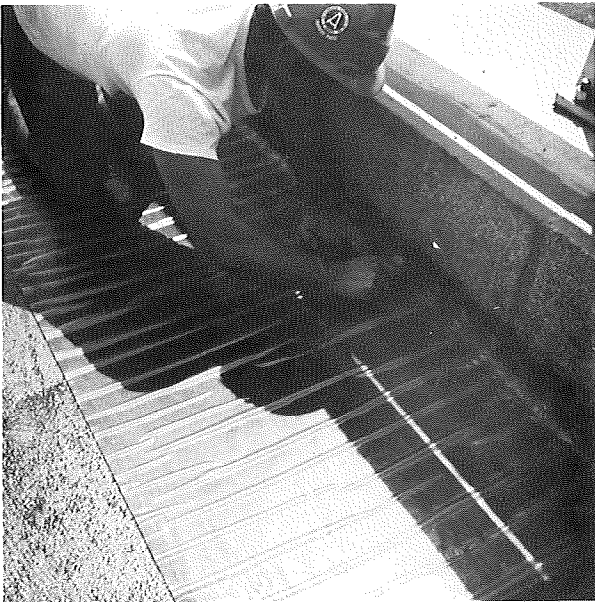
Pressing the membrane into the mastic at the curb line with a one inch diameter wallpaper roller.

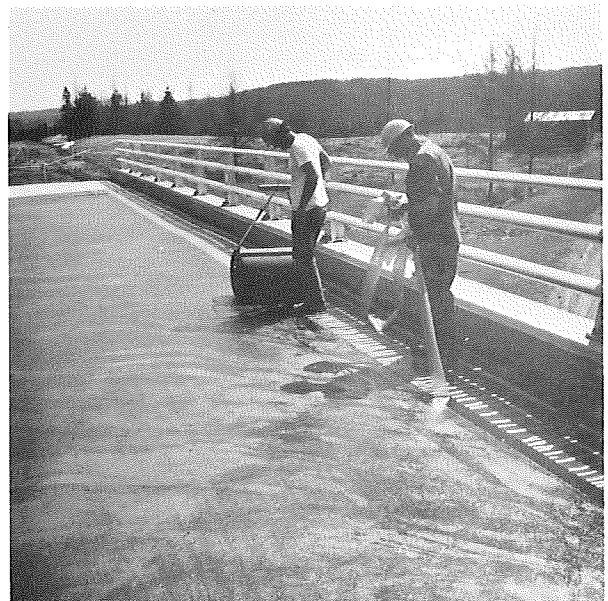
Rolling the membrane and removing the polyethylene film to expose the self sealing edge.

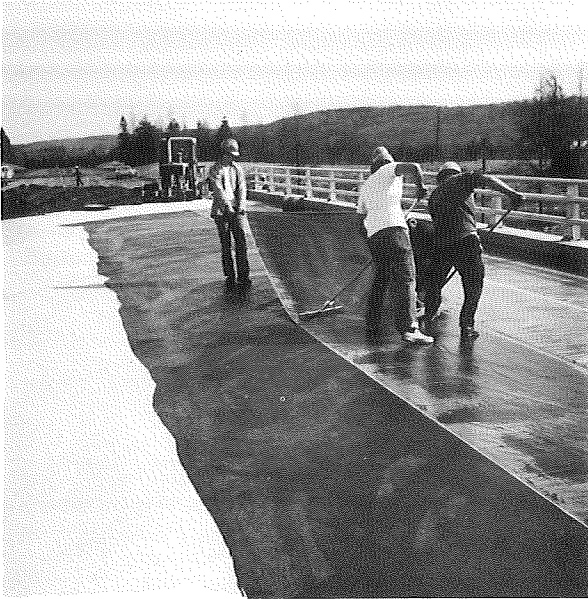
Using squeegees to prevent entrapment of air beneath the membrane during application.

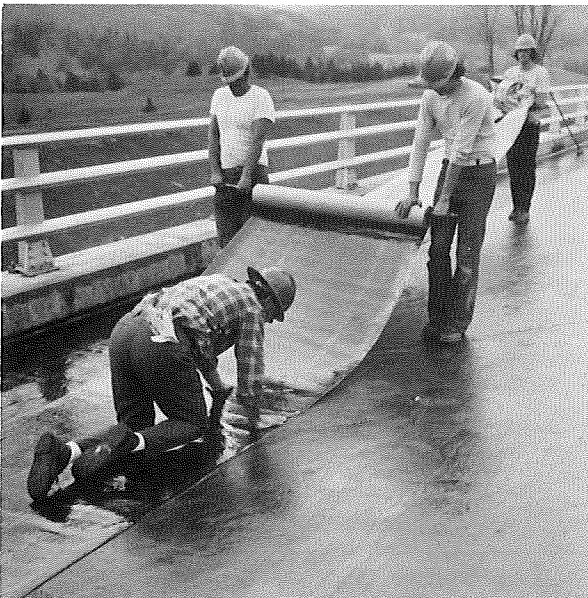
Placing 48 inch wide membrane sheet with 2-1/2 inch edge overlap. Ripples which remained in the membrane did not cause any difficulties with the pavement application.

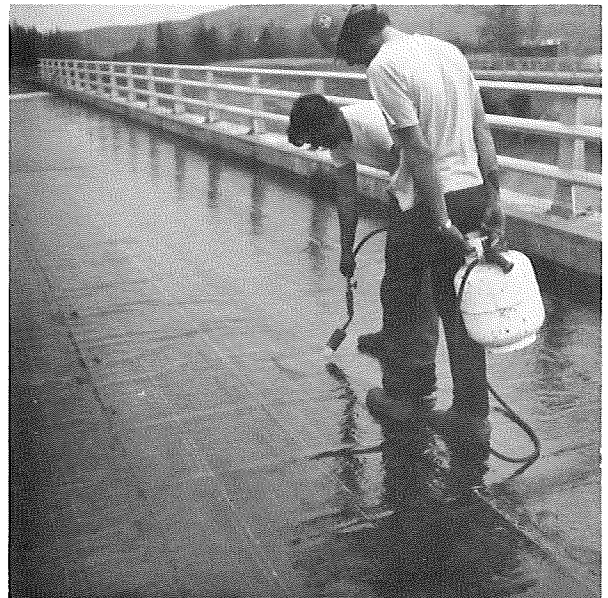
Heat sealing edges and ends of the membrane sheets with a torch. Material now under production is supplied with a self sealing edge.
