ALTERNATIVE REFLECTION CRACK TREATMENTS
PULVERIZATION AND RUBBERIZED SLURRY SRI

INITIAL REPORT 75-1

March 1975

VERMONT DEPARTMENT OF HIGHWAYS

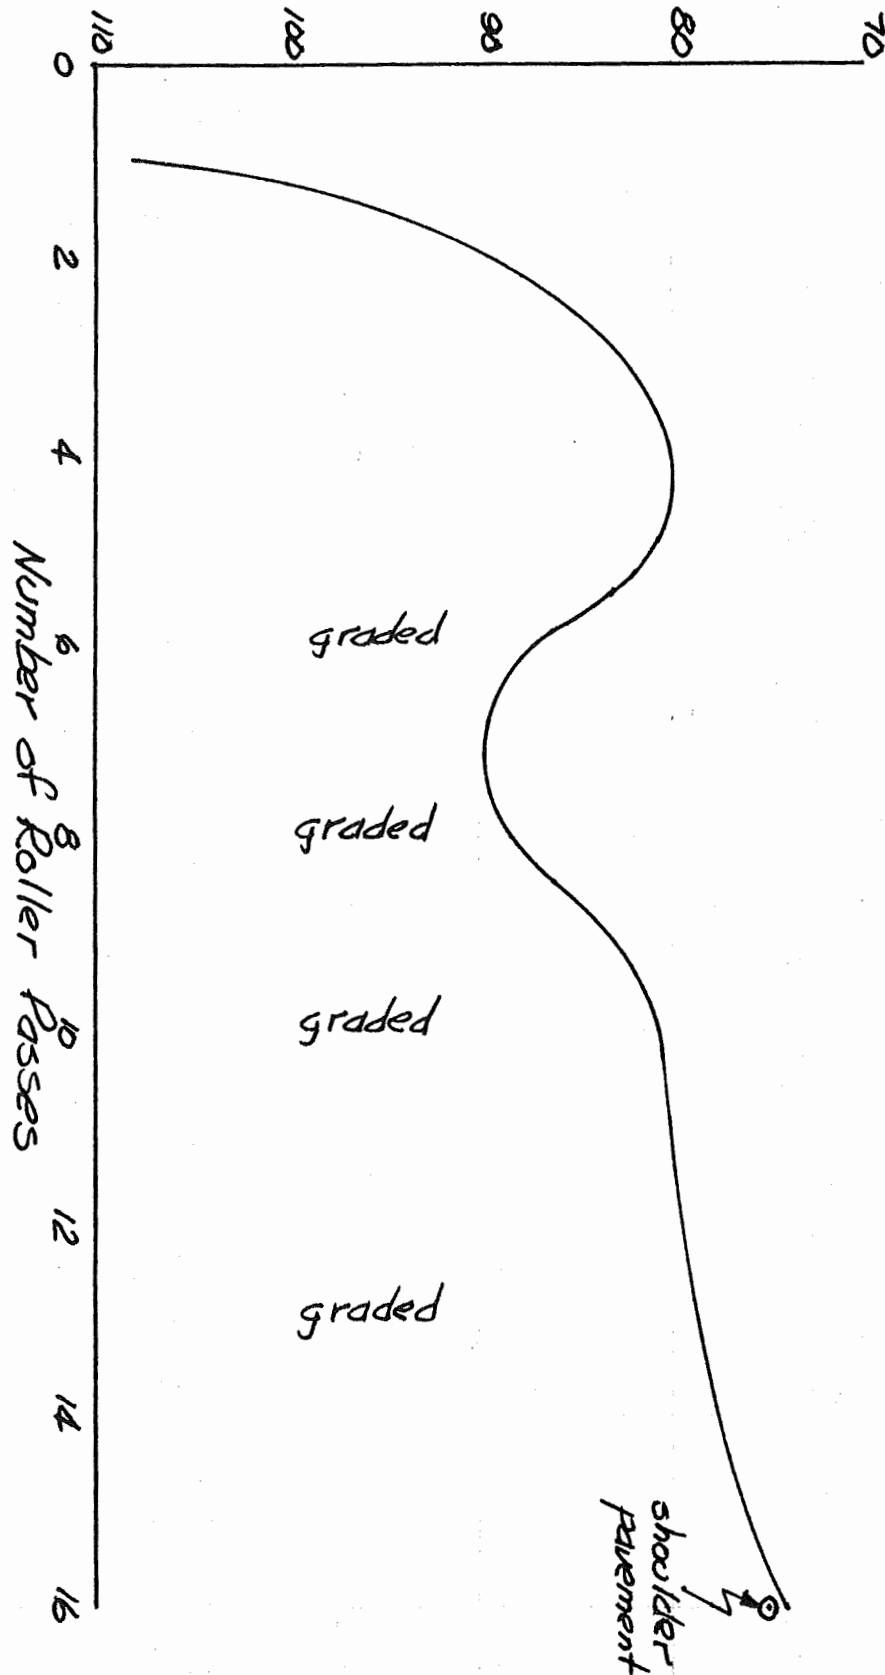
FIGURE 1

The results of Figure 1 indicate that there was a rapid increase in compaction up to 4 roller passes, then an appreciable variance in compaction from 4 to 10 roller passes as the grading process was going on. The final gain from 10 to 16 roller passes was slow, but appreciable.

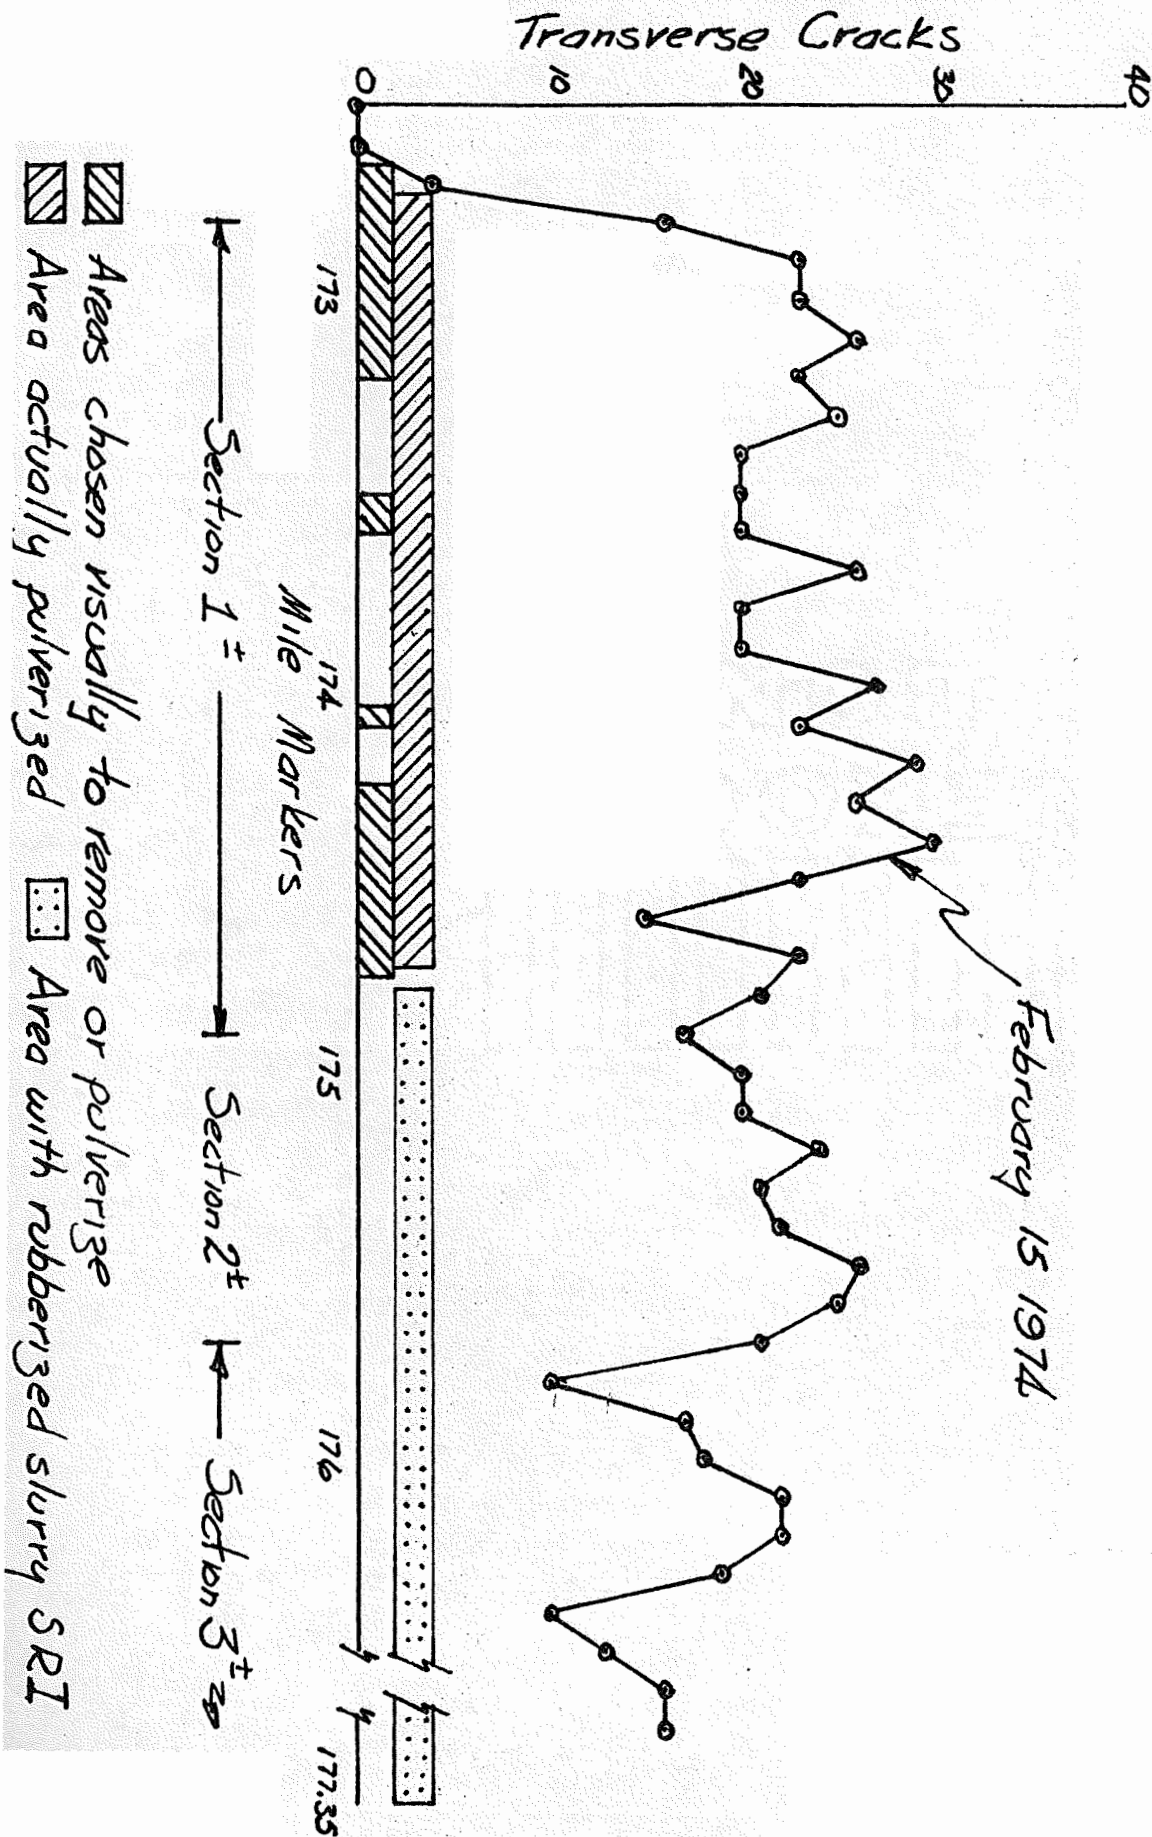
FIGURE 2

The pavement was continuously pulverized from MM 172.725 to MM 174.731 and not intermittently as shown in Figure 2. It was felt that a better job could be achieved in this manner. The time to scarify, pulverize and rough grade this nearly two mile section was 23 working days for 24 feet of width, or approximately a week to do one mile of 12' pavement width. The equipment was varied from time

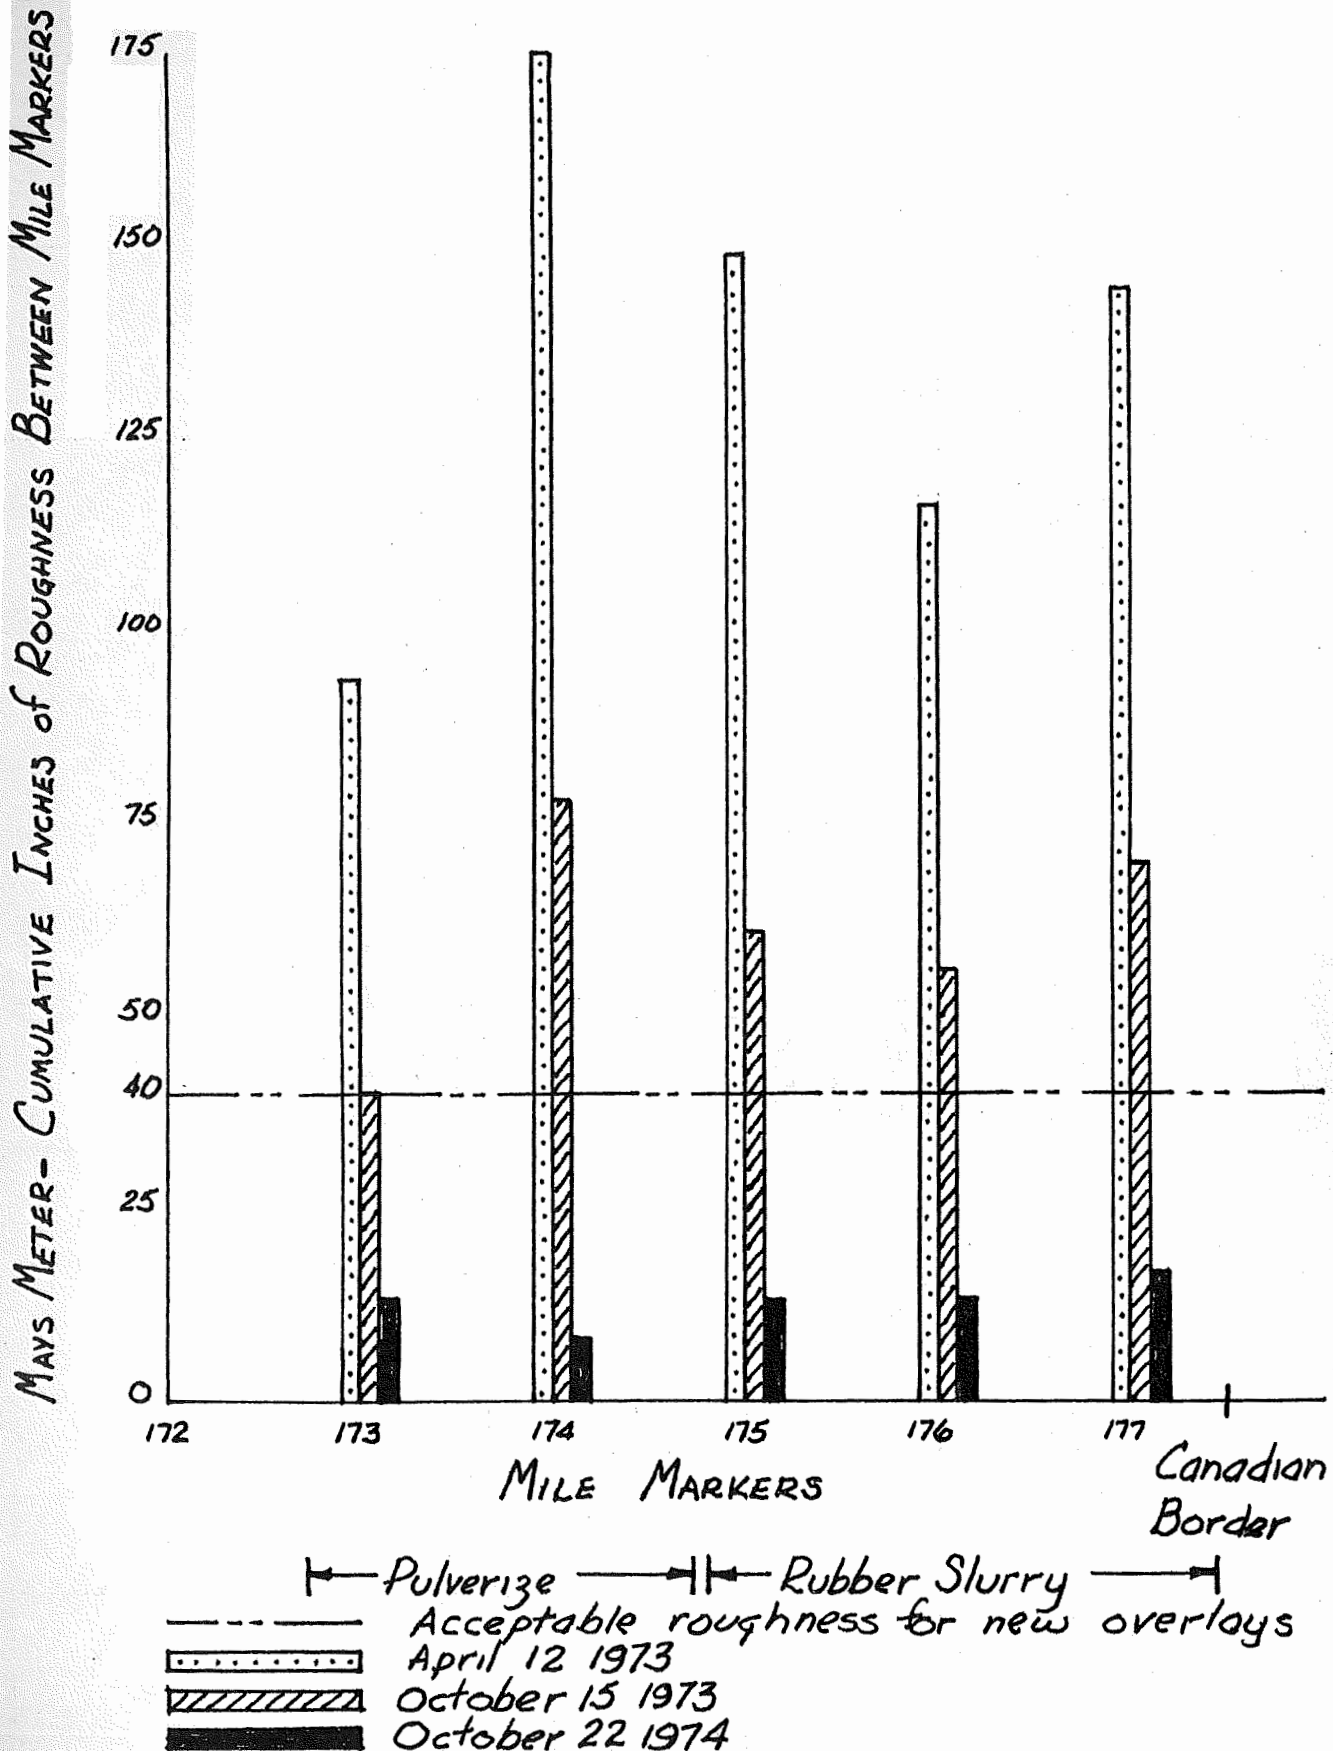
FIGURE 3

The immediate improvement in the ride is shown in Figure 3. This illustrates the cumulative inches of roughness from mile marker to mile marker, as measured by the Mays Meter, for the major portion of the project. It can plainly be seen that the ride was very rough in the spring, as compared to the fall, and prior to any work, was above acceptable limits. Further, the relativity of sections remained in the spring and fall readings, as indicated by the peaks and valleys. After the project had been completed, the Mays Meter showed the roughness well within limits, with perhaps the pulverized section looking a little better than the slurried area. For the ride then, the results have been satisfactory.
