ALTERNATIVE REFLECTION CRACK TREATMENTS
PULVERIZATION AND RUBBERIZED SLURRY SRI

FINAL REPORT 77-4

August 1977

VERMONT AGENCY OF TRANSPORTATION

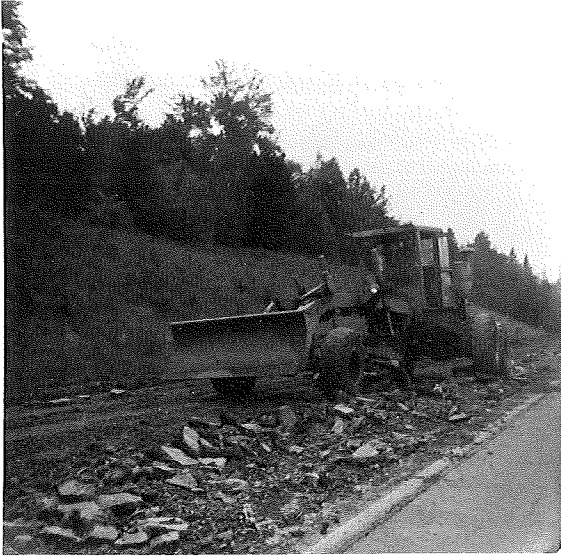
Windrowing pavement between shoulders during pulverization process.

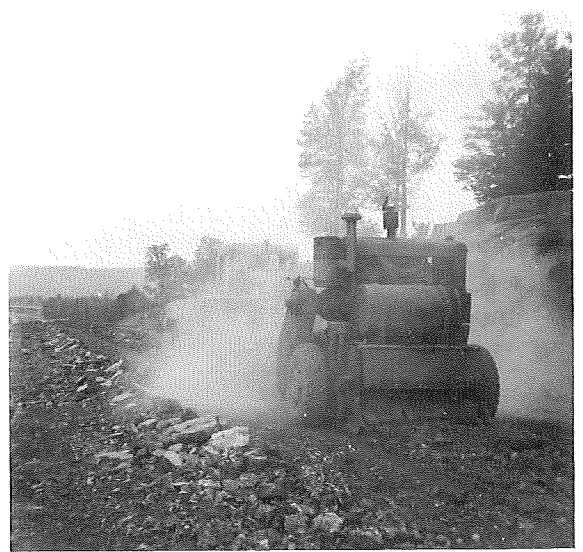
Motorized pulverizer drawn by front-end loader.

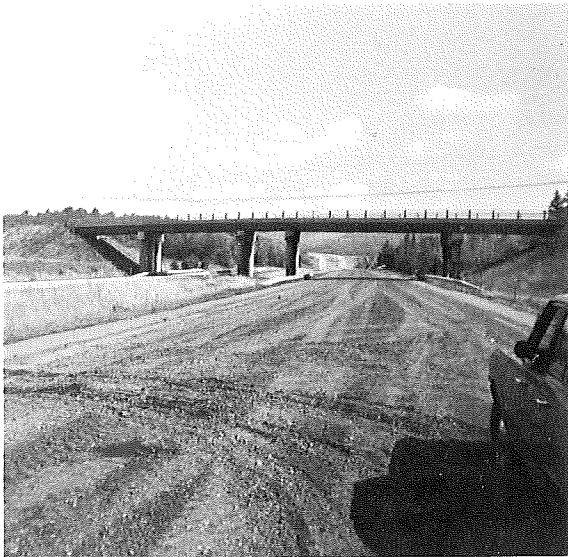
View of pulverized area after grading prior to addition of emulsion and rolling.

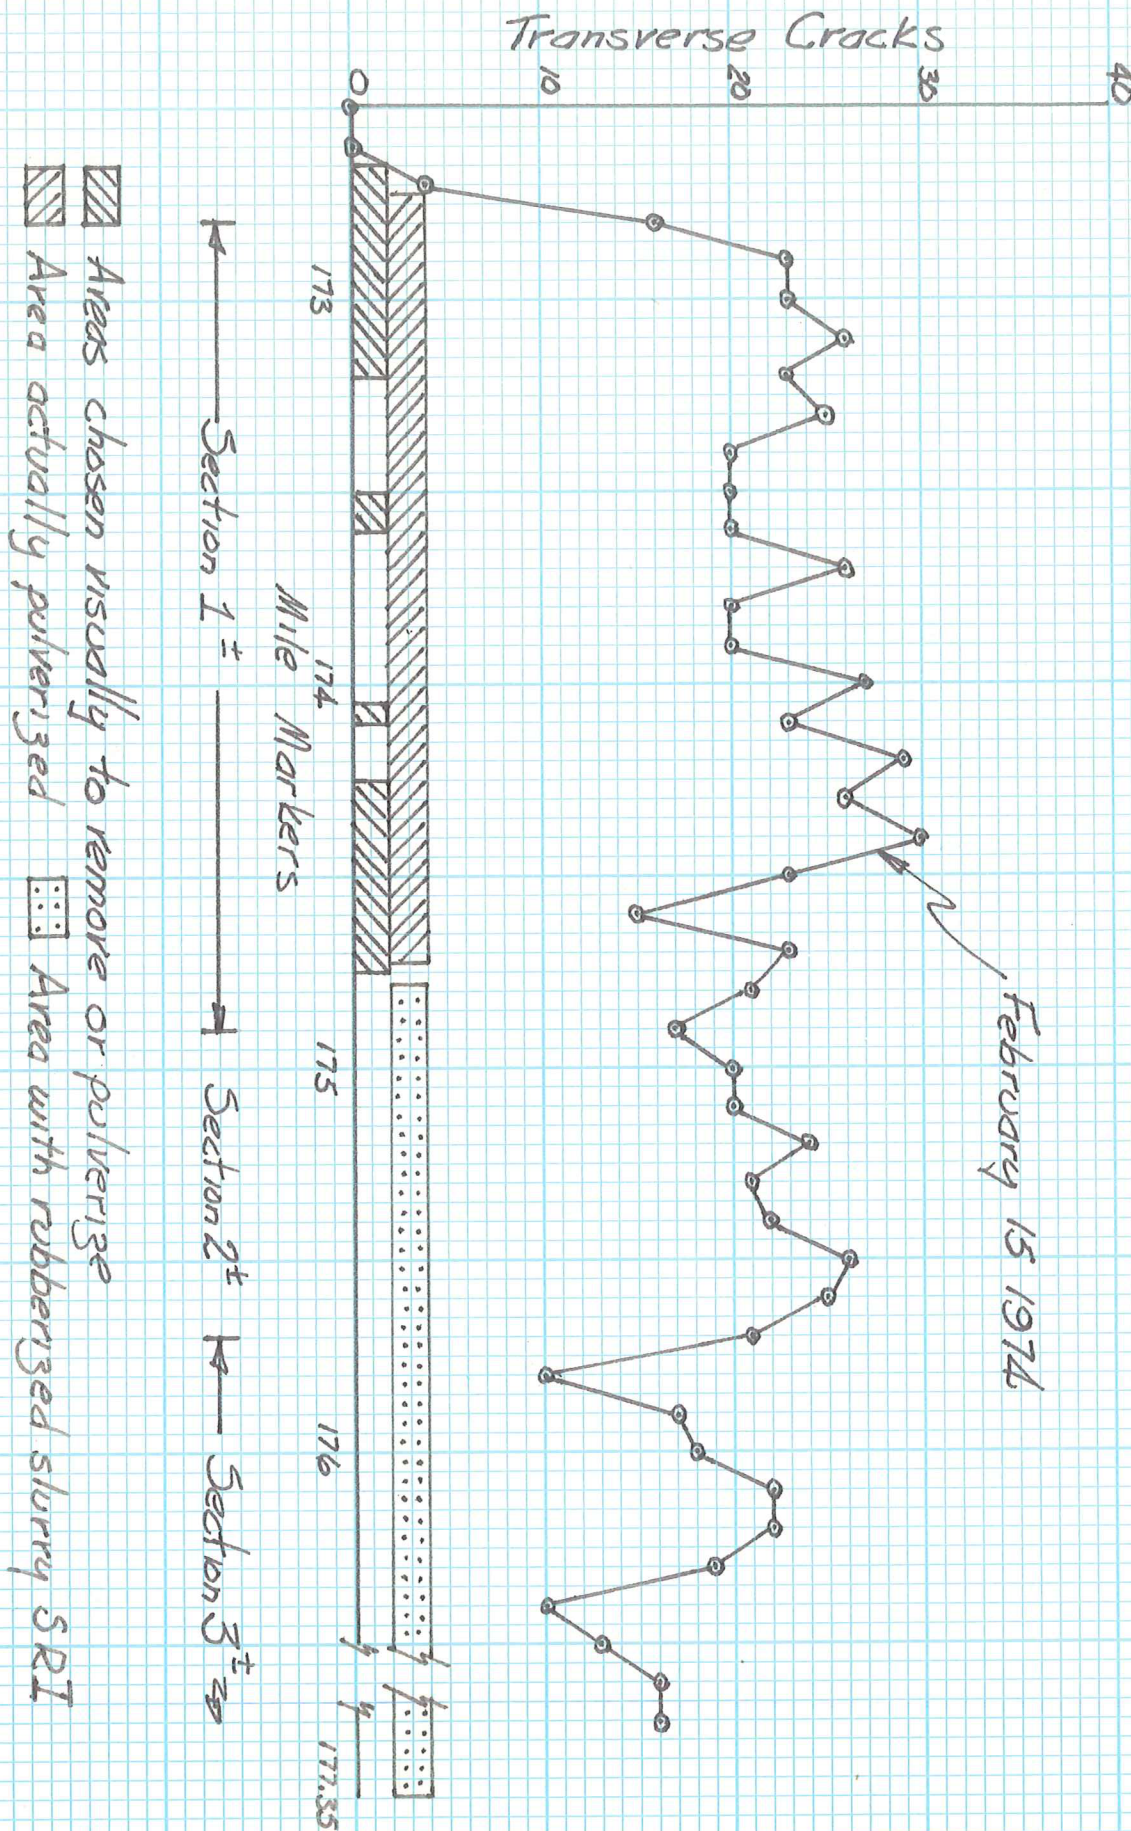
FIGURE 2

The pavement was continuously pulverized from MM 172.725 to MM 174.731 and not intermittently as shown in Figure 2. It was felt that a better job could be achieved in this manner. The time to scarify, pulverize and rough grade this nearly two mile section was 23 working days for 24 feet of width, or approximately a week to do one mile of 12' pavement width. The equipment was varied from time

TRANSVERSE CRACKS vs 0.1 MILE MARKERS

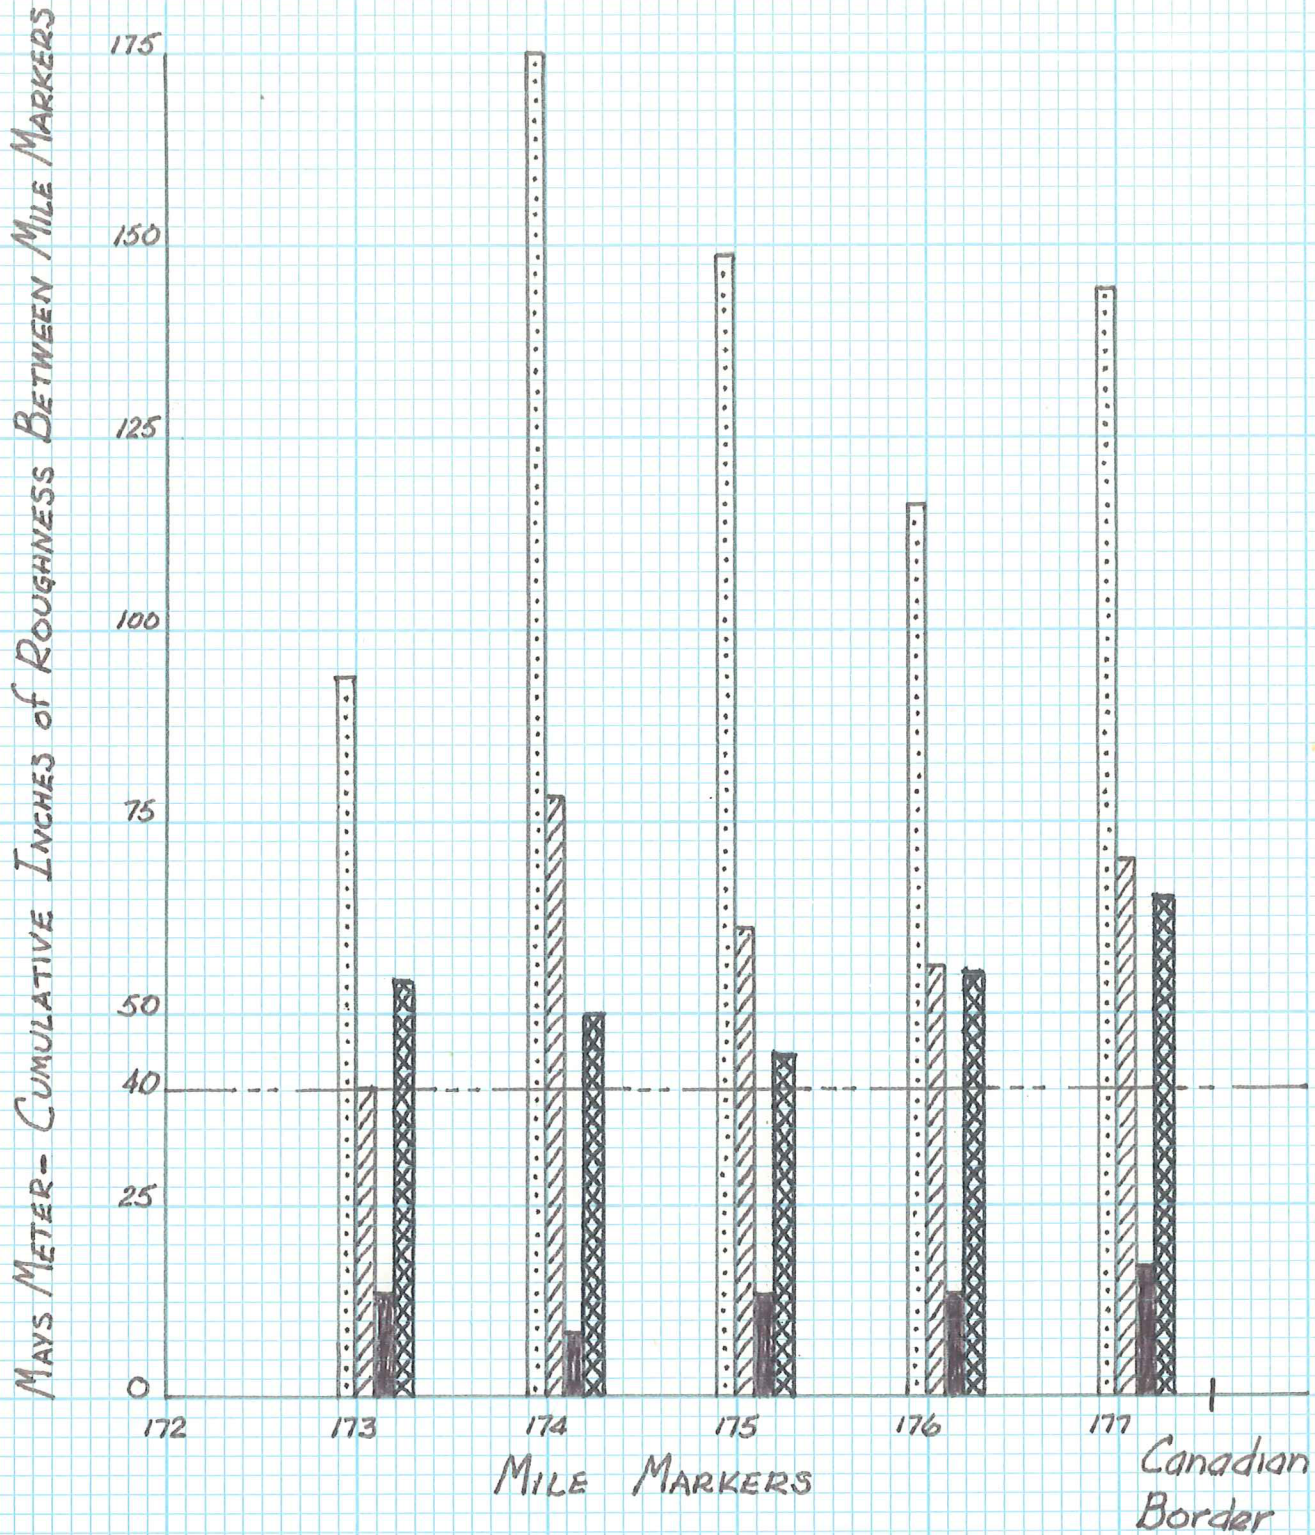
FIGURE 3

The immediate and long term improvement in the roughness is shown in Figure 3. This illustrates the cumulative inches of roughness from mile marker to mile marker, as measured by the Mays Meter, for the major portion of the project. It can plainly be seen that the ride was very rough in the spring as compared to the fall. Further, the relativity of sections remained in the spring and fall readings, as indicated by the peaks and valleys. After the project had been completed, the Mays Meter showed the roughness well below the acceptable roughness for new overlays, with perhaps the pulverized section looking a little better than the slurried area. After three years the roughness has increased, but the ride is still satisfactory. The pulverized area appears to have reduced roughness during the summer somewhat more effectively than the slurried area.

CUMULATIVE INCHES of ROUGHNESS vs MILE MARKERS

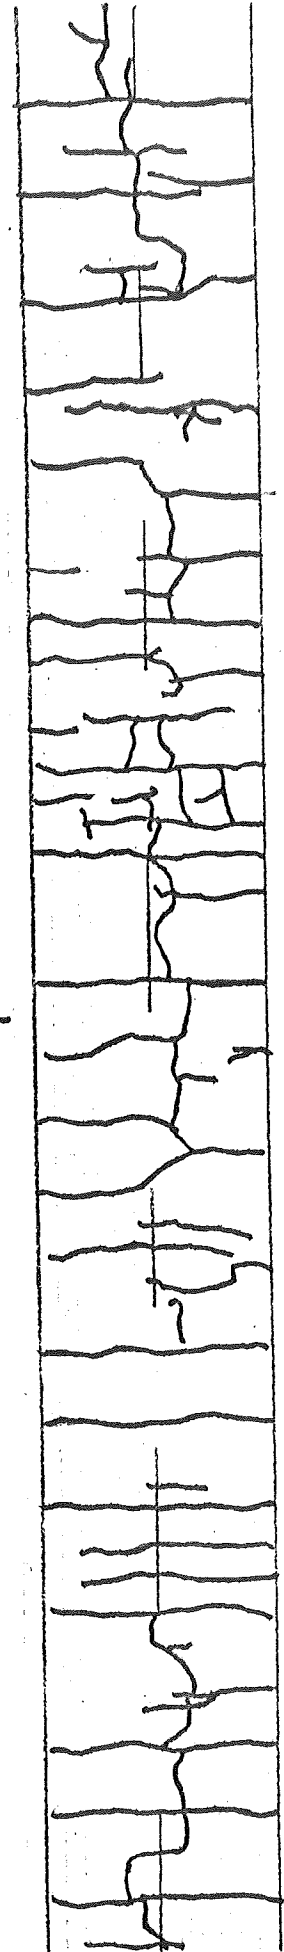
Start Section #1.
Mile Marker 172.725
Pulverize and Emulsify for 1.91 miles.
Original cracks shown from 1974 survey,
no reflection shown from 1977 survey.

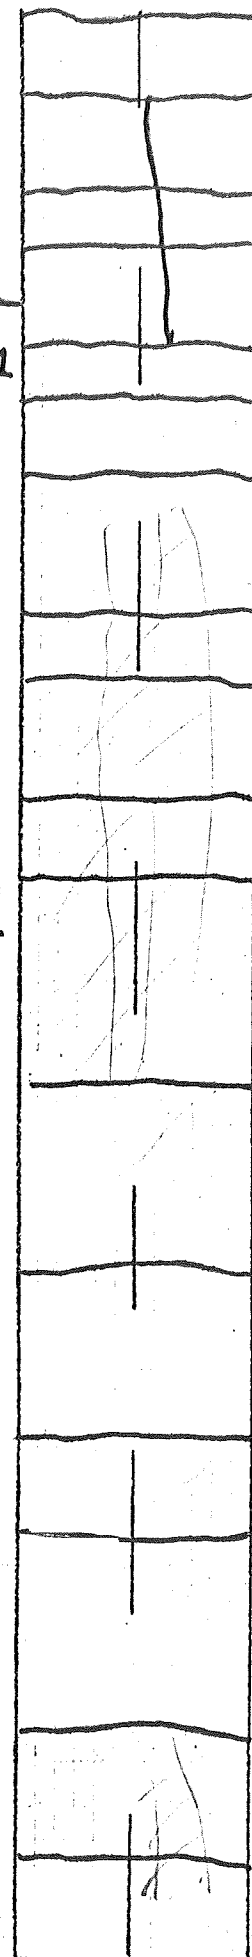
End Section #1
 Begin Section #2
 Mile Marker 174.6375
 Pulverize only for 0.09 miles.
 Original cracks shown from 1974 survey,
 no reflection shown from 1977 survey.
