EXPERIMENTAL USE OF REINFORCED CRACK  
SEALING SYSTEM ON ROUTE 14,  
SOUTH BARRE, VERMONT

INITIAL REPORT 85-2  
January, 1985

REPORTING ON WORK PLAN 83-R-32

STATE OF VERMONT  
AGENCY OF TRANSPORTATION  
MATERIALS & RESEARCH DIVISION

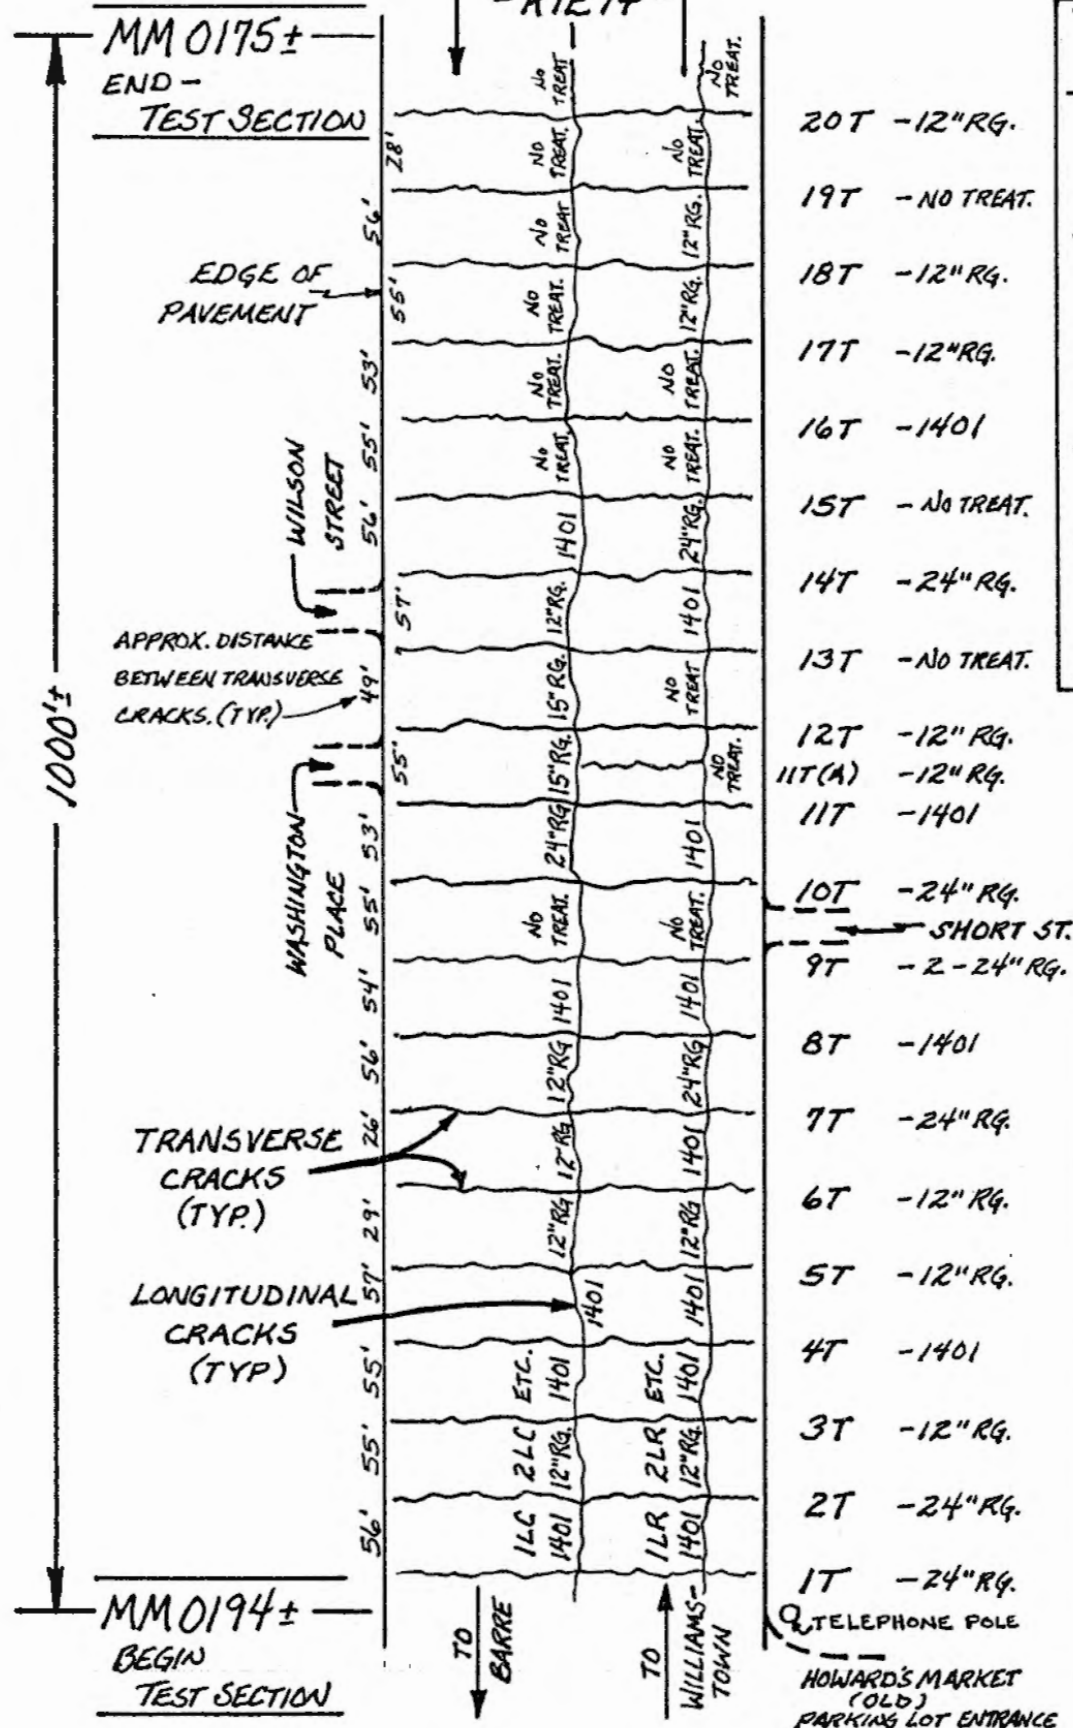
LOCATION OF TREATMENTS  
- PLAN VIEW -  
- SKETCH -  
NOT TO SCALE

- EXPERIMENT: OWENS CORNING  
ROADGLAS SPOT REPAIR  
SYSTEM AS COMPARED  
TO STANDARD TREATMENT  
AND NO TREATMENT.

ALL ROADGLAS TREATMENT OF TRANSVERSE CRACKS IS IN SOUTH-BOUND LANE ONLY.
