EXPERIMENTAL USE OF
CORRUGATED POLYETHYLENE PIPE
CULVERTS AND STORM DRAINS ON ROUTE 12
MONTPELIER, VERMONT

Initial Report 85-5

Reporting on Work Plan 83-R-1

STATE OF VERMONT
AGENCY OF TRANSPORTATION
MATERIALS & RESEARCH DIVISION

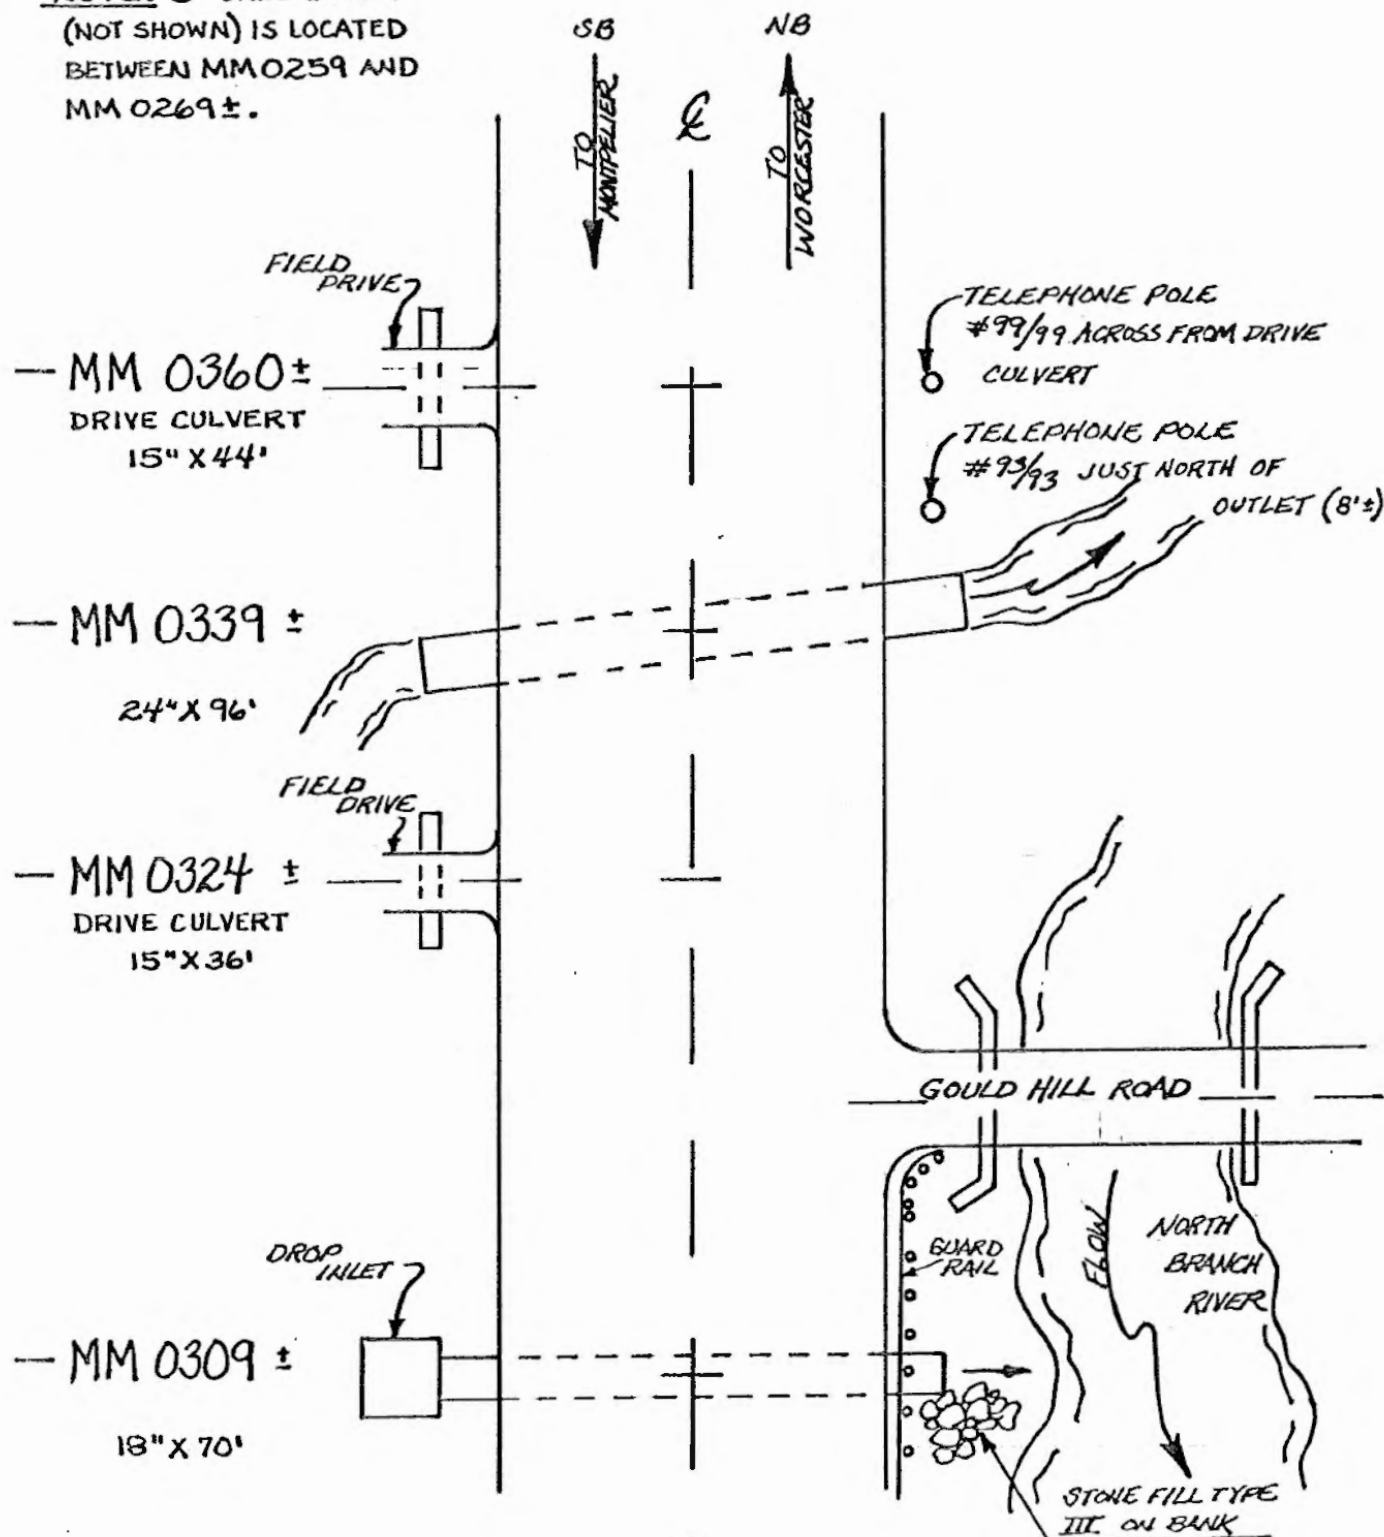
A.D.S.
PLASTIC PIPES
LOCATION SKETCH
-NOT TO SCALE-

NOTE: 6" UNDERDRAIN
(NOT SHOWN) IS LOCATED
BETWEEN MM 0259 AND
MM 0269±.
