**Westfall Fiberglass Bridge Drain Pipe System
South Burlington, Vermont
Initial Report**

June 2007

**Report 2007 - 7
Reporting on Work Plan 2000-R-2**

State of Vermont
Agency of Transportation
Materials and Research Section

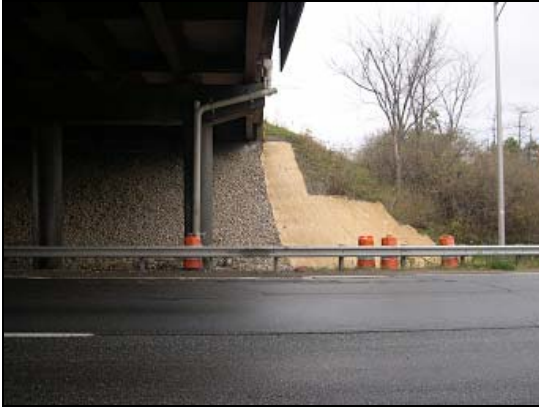
Figure 8 – After Installation

The intent of this investigation was to assess the durability of a material that is reportedly inert to oil, gas and deicing salts known as fiberglass. Installed in 2003, the six fiberglass drainage systems were found to be performing well four years following installation. Minor fisher cracking typically caused by fatigue, movement and expansion stressing was observed inside a few catch basins located at the outlet of the trough. Iron-oxide staining was also visible inside the catch basin most likely resulting from runoff containing rust. Although there were concerns raised regarding flaking of the resin adhesive found at joint connections, the Westfall Company assured that this is common when adhered to the glaze finish of the fiberglass. The bolts connecting the supporting system for the drainage pipe to the pier column were deformed as a result of wind and vibratory forces. This along with apparent section loss will most likely result in some type of shear or stem failure in the future. As a final aside, inadequate drainage was noted below the fiberglass drainage system indicating that the stone fill basin has failed generating a ponding effect around the adjacent concrete piers. This will cause premature concrete spalling and corrosion of reinforcing steel if left unaddressed. Maintenance is recommended at this time. This could be accomplished by cleaning the stone fill or by extending the discharge drainage pipe away from the column. With regards to cost, fiberglass is certainly cost effective when compared to other typically utilized materials. Overall, preliminary results are favorable. Figure 8 and 9 display the drainage system immediately following installation and three years following installation.
