**WESTFALL FIBERGLASS BRIDGE DRAIN SYSTEM**

Report 2013 – 03

March 12, 2013

Follow Up to Initial Report 2007 – 07

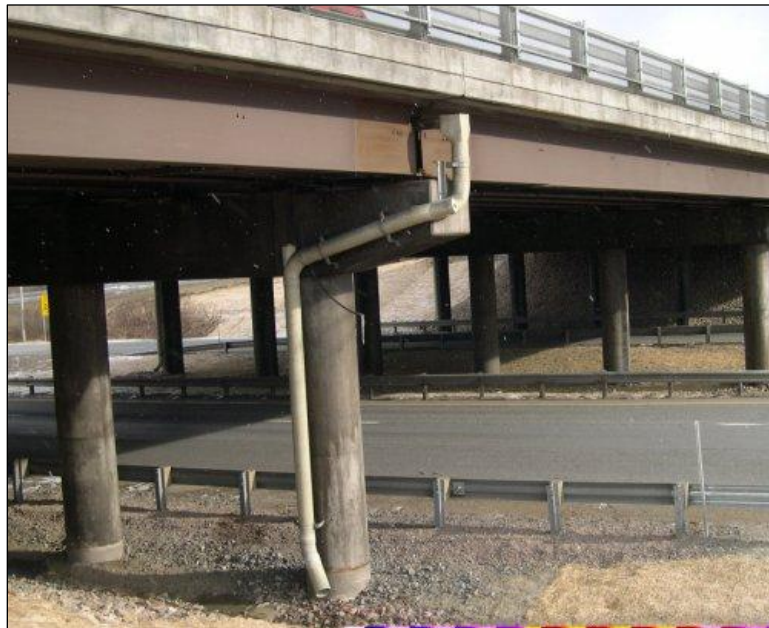
The group also examined the pipefittings. While found to be in good condition, external flaking of the resin adhesive, used to bond and seal the elbow pieces to the straight pipe section, was observed as shown in Figure 1. This raised concerns regarding the potential for water infiltration between the connections potentially resulting in freeze thaw damage during winter months. Immediately following the site inspection, the Westfall Company was contacted to discuss this phenomenon. The company explained that the resin adhesive would not adhere to the glazed finish on the exterior of the pipe. The company further stated, the bond between fittings is the only place requiring the resin and that it is not required beyond the joint.
