**ASSESSMENT OF JAHN PERMEABLE MORTAR SYSTEM IN A
HISTORIC BRIDGE ABUTMENT APPLICATION**

Report 2015 – 10

June 2015

Reporting on Work Plan 2011-R-05

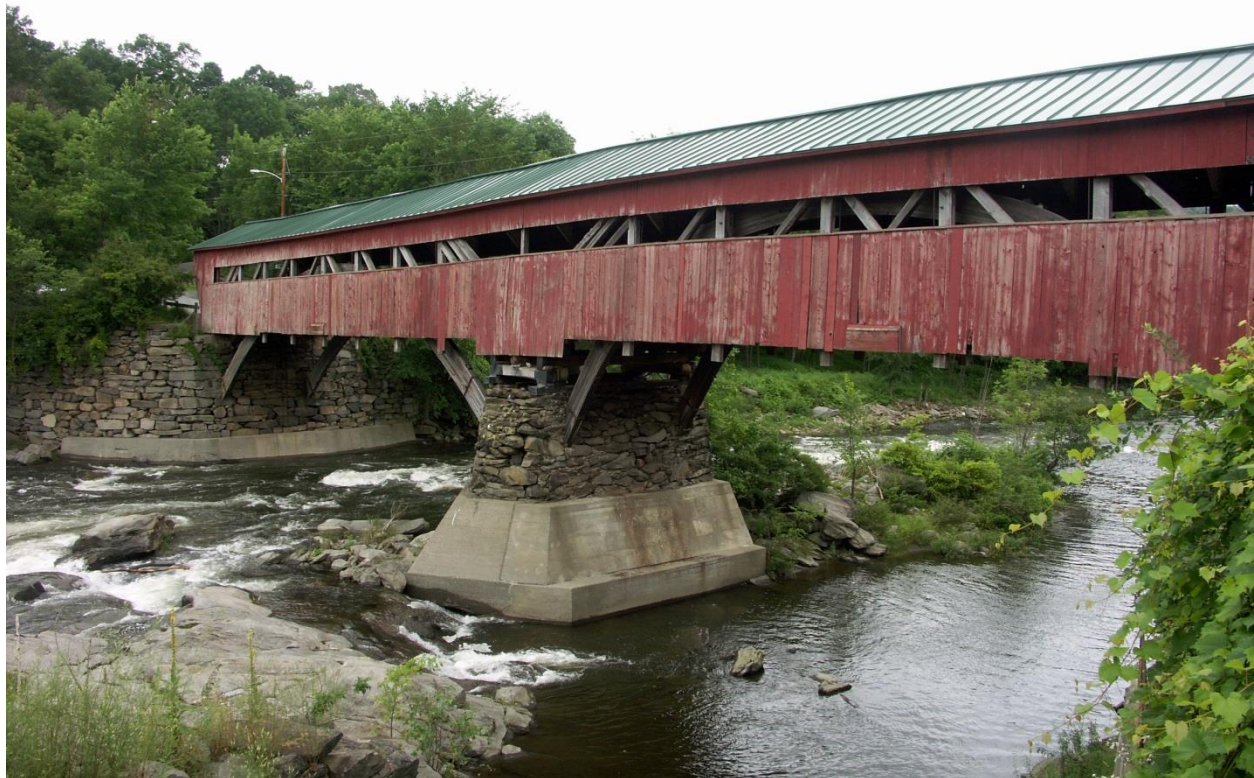
Similar structural capacity enhancements were necessary in the substructure as well. Existing stone and concrete masonry components of the substructure were intact (Figure 2) with the exception of the westerly abutment. The westerly abutment was reconstructed with stone-faced reinforced concrete. The two surviving substructure components were identified for preservation. Typically, this type of preservation is accomplished by removing and replacing the deteriorated mortar with new pointing mortars and grouts to fill in the gaps and void spaces between stones in the wall. During design and construction, it is vital to account for lateral forces that build up behind the wall from rain events, frost penetration and groundwater. In the case of piers and abutments, consideration must also include vertical forces applied by the superstructure's weight and applied live loads. Preservation considerations were centered on maintaining the visual appearance of the surviving pier and abutment. All structural enhancements were hidden from the sight for that reason.

Figure 2 The Taftsville Covered Bridge in 2006 showing the Pier and Abutment that were preserved ([cmh2315fl](#))

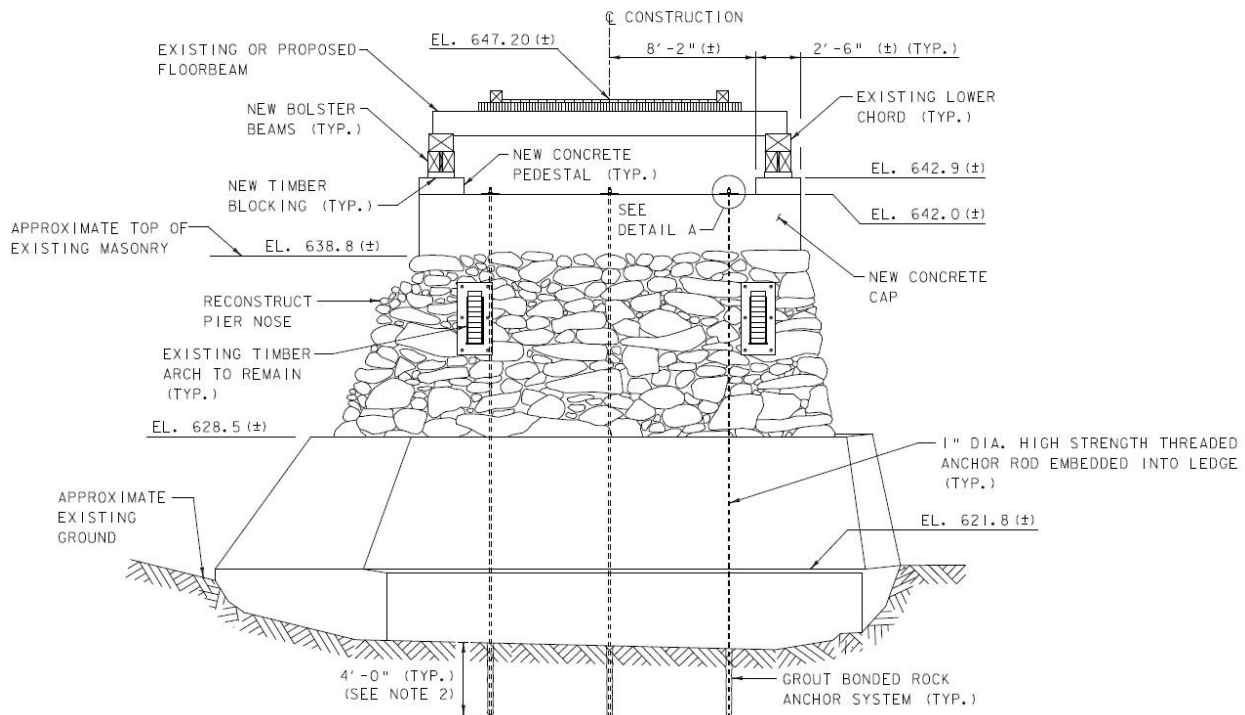
Alpine constructed an enclosure around the pier (Figure 13) and on February 5, 2013, the stonemasons began initial application of the Jahn Pointing Mortar on the westerly face of the pier. (Chase, 2013) The purpose of this initial activity was for testing and training on how to prepare the dry-laid stone for the mortar, mix the mortar to the right consistency and apply to it. Cathedral Stone Products was onsite to oversee the testing and to train the stonemasons. The contractor provided heat in the enclosure to bring the atmospheric and stone temperatures up to the specified level for stone pointing and grouting. Initial observations indicated that the mortar mix had to be adjusted initially to obtain the consistency required for pointing stones.

Figure 13 Details of the Bridge Pier (VTrans 2012)

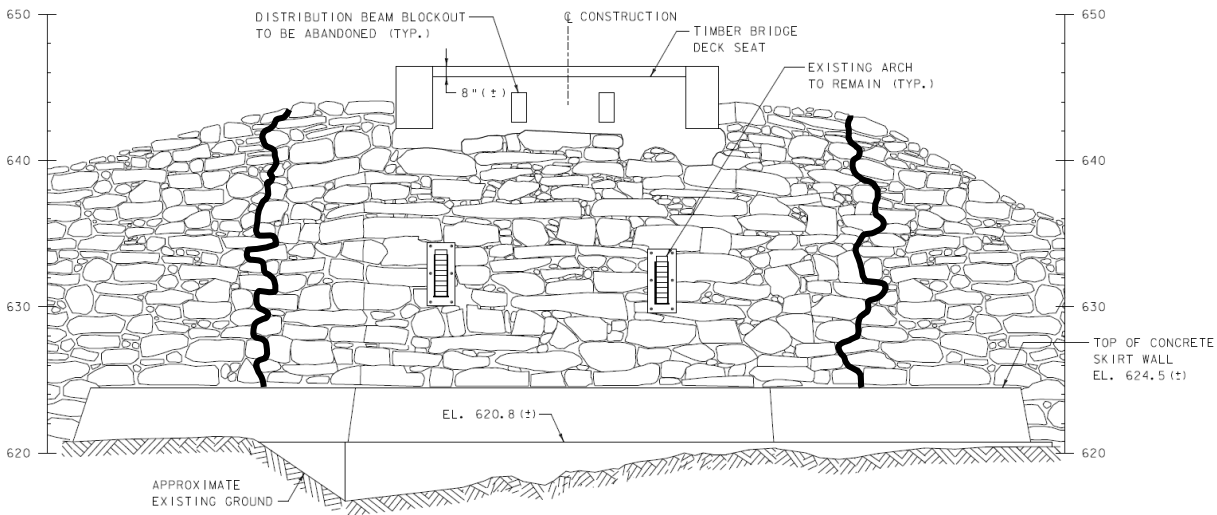
Figure 16 Details of the Easterly Abutment (dark lines shows approximate extent of pointing – VTrans 2012.)

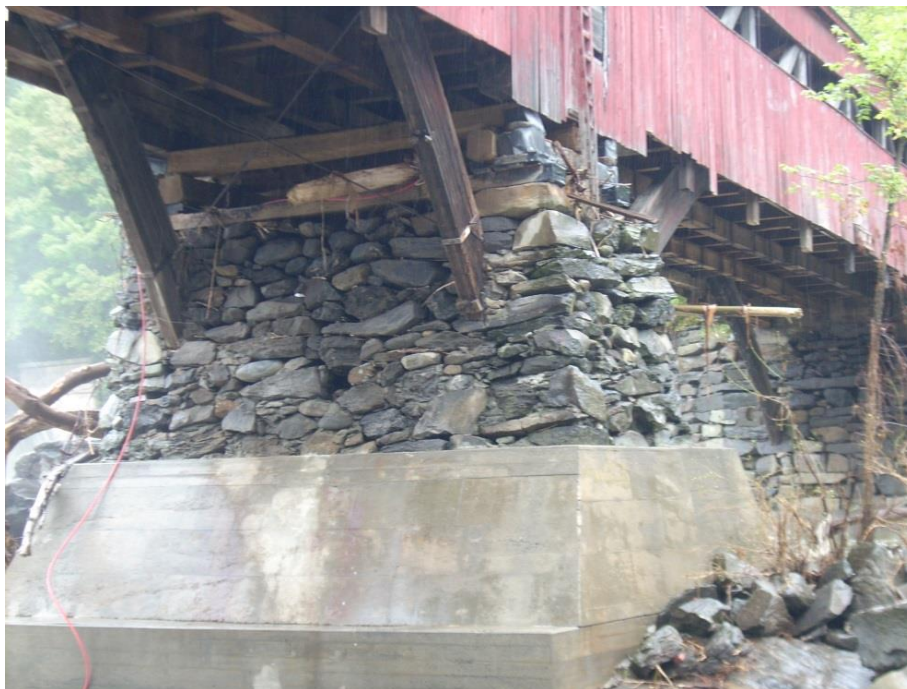
Figure 19 Pier before Tropical Storm Irene in 2011

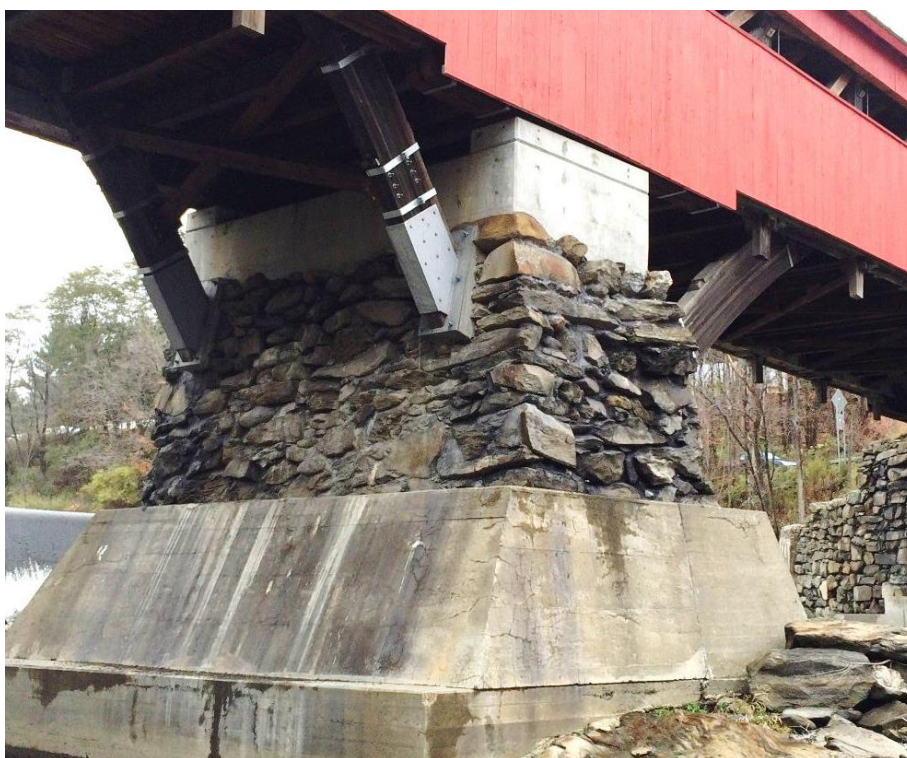
Another purpose of using the Jahn products was to strengthen the dry-laid stone pier and abutment to preserve the overall historic appearance of the bridge. Concerns were that the mortar would be obvious from a distance. Observations at various distances from the substructure units gave an appearance of dark joints between stone (Figure 19 and Figure 20). The mortar and pointed stones were virtually invisible to the eye from afar. Even up close, the dark grey color of the mortar has aged in a way that it is not obvious in most places on each substructure unit. Places where the mortar is visible are where there were large gaps in the dry-laid stone (Figure 21).

Figure 20 Pier after Construction in 2014
