### RESEARCH UPDATE

U 2003-6

## INSTALLATION OF THE ULTRALINER PVC ALLOY PIPE LINER BARTON, VERMONT

**REFERENCES:** Work Plan No. 2001-R-8

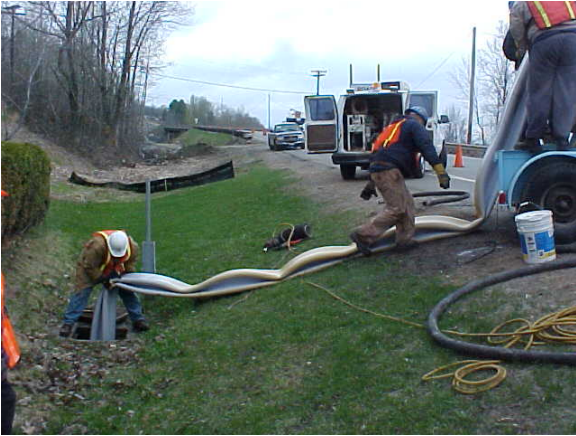
The 'steam truck' houses a 50 HP Kewanee brand boiler which, by the manufacturer's requirement, supplies low pressure steam at 10 to 15 psi for up to two hours for processing. The folded pipe liner arrived on a large wooden spool as seen in the adjacent photograph.

To prepare the product for installation, steam was applied to the liner for approximately 4 hours by covering the entire spool with tarps and injecting the steam within the tarps. The time needed to soften the liner depends on the length and diameter of the liner as well as the ambient temperature. Once the liner was sufficiently malleable it was pulled through the existing pipe with a winch.

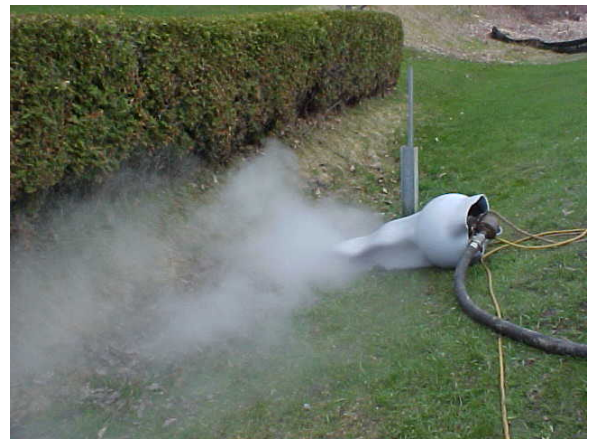
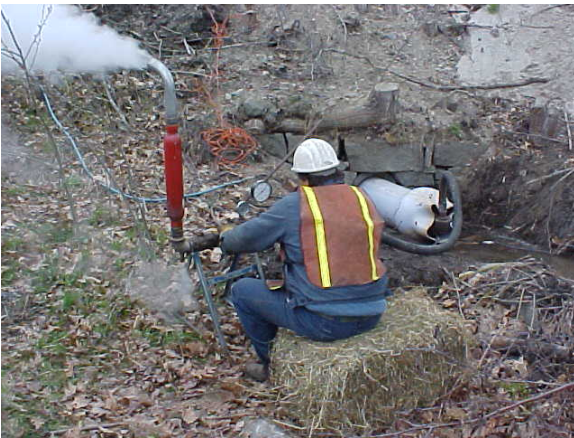
The existing pipes were in poor condition with deformations, tree root infiltrations, and extensive areas of corrosion.

During this process the temperature of the liner is lowered, therefore stiffening the liner and making it necessary to reheat. Plugs are inserted in both ends of the liner which are attached to a hose supplying steam from the boiler.

At first, steam is applied through the entire liner and then the pressure is raised in order to mold it to the existing pipe. Two ways this is done is to inject compressed air into the liner, and to restrict the flow of air using the pressure regulator attached to the outlet.

According to the manufacturer's documentation the pressure within the liner is never to exceed 12 PSI. For this installation pressure was brought to 5 PSI. Once the liner has taken the shape of the existing pipe the injection of steam is stopped and only compressed air is applied to cool the liner. The temperature of the exhaust air was brought down to 100 degrees before the pressure was released.
