Town: 30 - BRISTOL

IDENTIFICATION	
(1) State Names	50 - Vermont
(8) Structure Number	100103002001031
(5) Inventory Route	1
(2) Highway Agency District	5 - District 5
(3) County Code	1 - ADDISON

INSPECTIONS *			
(90) Inspection Date	08/01/2024		
(91) Frequency	24		
(92) Critical Feature Inspection	Done	Freq. (Mon)	Date
A: Fracture Critical Detail	No		
B: Underwater Inspection	No		
C: Other Special Inspection			
* The inspection date and frequency information in this box contains the current NBI date and frequency information. Please refer to the report header for the date this inspection was conducted.

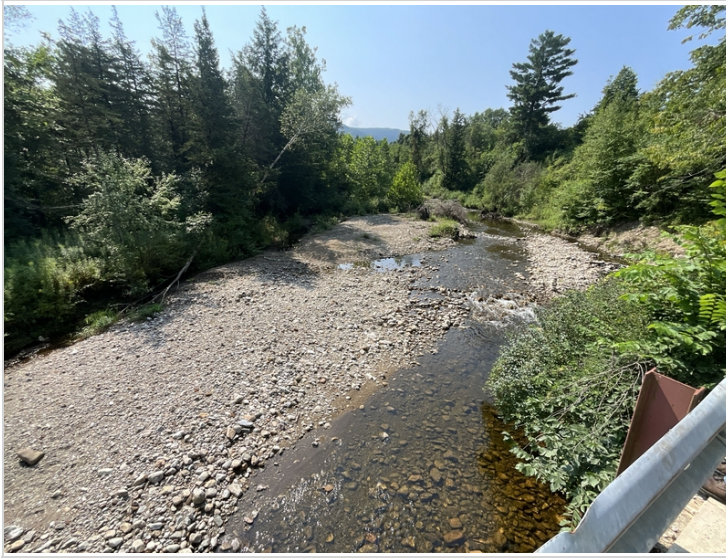
Upstream

Heavy aggradation along upstream stream bed over the years has forced the channel along the upstream abutment 2 embankment and runs into/along abutment 1. This has caused localized scour exposing the abutment 1 footing and small voids were found below the base of footing in the downstream end. Heavy erosion along same side and protection has washed away over years.
