RESEARCH UPDATE

U96-1

INSITUFORM PIPE LINING PROCESS

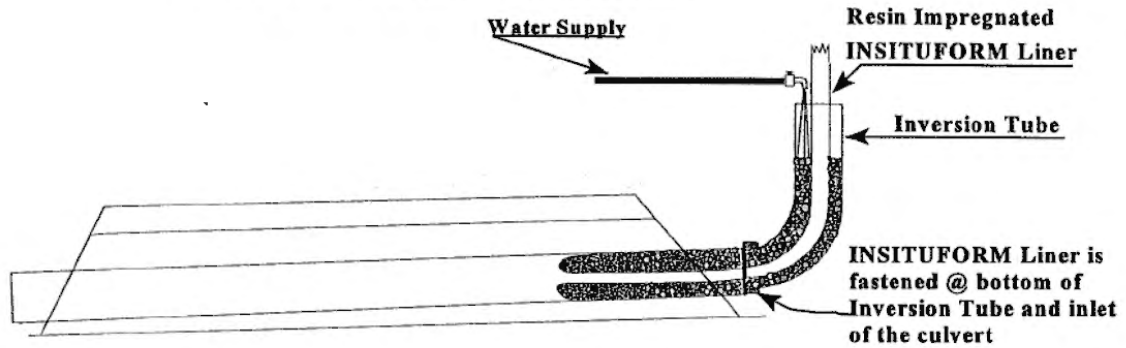
INSTALLATION SCHEMATIC

The INSITUFORM process begins with the manufacture of a fabric tube which is custom fitted to the pipe which is in need of rehabilitation. The fabric is impregnated with thermo setting resin and installed by fastening it to the lower end of an inversion tube, which is in turn fastened to the inlet of the culvert. The tube is then forced through the culvert and inverted, pressing the Insituform material against the inside of the culvert utilizing hydrostatic pressure. The water is then heated, effecting a cure of the thermosetting resin.
