Update U96-19

**MEASURING CORROSION WITH EMBEDDED PROBES**

Work Plan 88-R-7

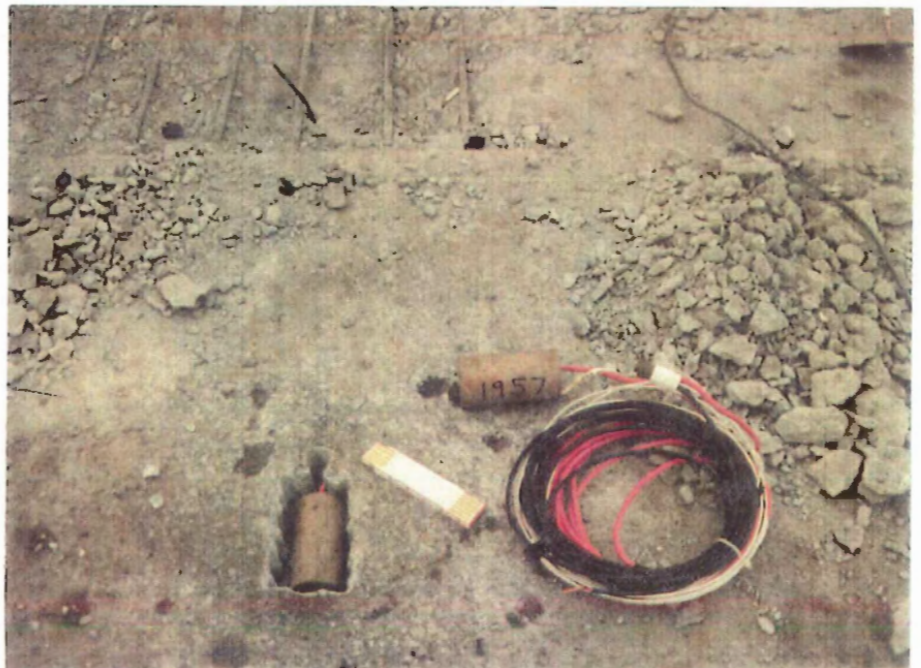
The 3LP probe system allows the application of a measured current change to a rebar adjacent to the embedded probe via a counterelectrode in the probe. If a large current is required to change the potential, this means that the corrosion rate is high. Conversely, the corrosion rate would be rated low if a small current is required. The readings are then entered into a computer program, which gives the corrosion rate in mA/sq ft.(ICORR). The readings are time dependent and can vary greatly depending on temperature, moisture, and other factors.

INSTALLATION OF PROBES IN BRIDGE DECK
