Pavement Marking Durability Statewide Final Report

March 2007

Report 2007 - 3

State of Vermont Agency of Transportation Materials and Research Section

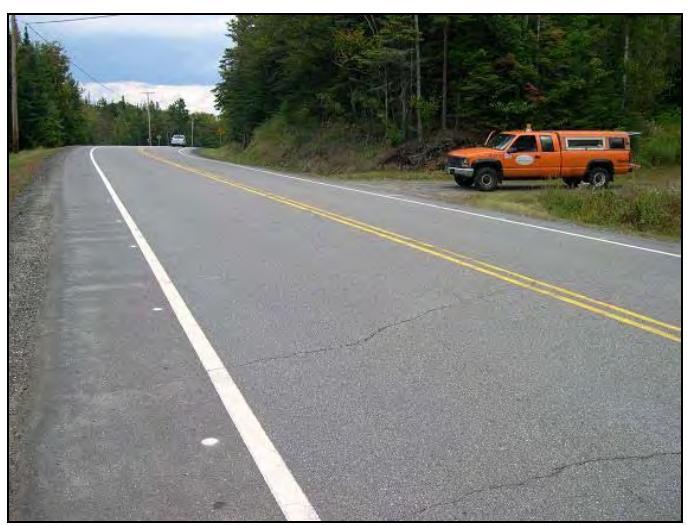
Figure 1 - Test Site on VT 114 in Norton-Cannon

All data was collected and recorded under the "Data Collection Procedures" published by the Materials and Research Section in April of 2002. In brief, a minimum of five test site locations were established throughout the length of a construction project. All test sites were selected by a random number generator and referenced by a mile marker location. Each test site consisted of a total length of 40' partitioned into 10' intervals incorporating all white and yellow edge lines as well as white skip lines and yellow centerlines. Every interval was distinguished by white marking paint along the shoulder of the driving lane and freshened as needed to mark the sampling locations. Data collection was carried out on a periodic basis at all specified locations. Efforts were made to conduct testing within 14 days of application in order to comply with ASTM D 6359-99, "Standard Specification for Minimum Retroreflectance of Newly Applied Pavement Marking Using Portable Hand-Operated Instruments" for newly applied pavement markings. Figure 1, provided below, displays a typical test site.

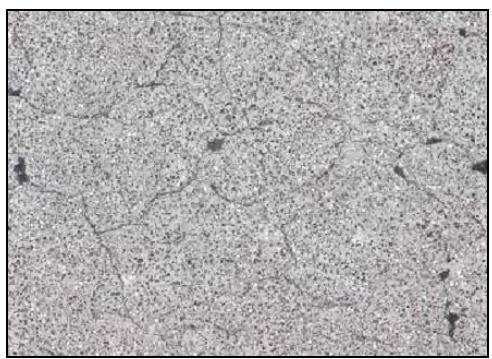
Figure 2 – 98% Intact

As stated previously, both daytime and nighttime visibility is closely correlated. Therefore, data collection efforts included both the collection of retroreflectivity readings, in order to adequately assess nighttime visibility, and a visual assessment of the amount of intact marking substrate. All retroreflectivity readings were collected with an LTL 2000 Retrometer in accordance with ASTM E 1710-97, "Standard Test Method for Measurement of Retroreflective Pavement Marking Materials with CEN-Prescribed Geometry Using a Portable Retroreflectometer." Visual assessments were conducted in accordance with ASTM D913-03, "Standard Test Method for Evaluating Degree of Resistance to Wear of Traffic Paint." This method requires a visual comparison between the representative areas of the traffic paint stripes to photographic reference standards shown within the testing protocol. Two examples of varying film thicknesses are shown in Figures 2 and 3. These photographs were collected from test site 5 within the Cavendish Wethersfield construction project one to two years following application, respectively. All retroreflectivity and durability readings were recorded onto the appropriate field forms and then entered into project specific spreadsheets. A copy of the field form is provided in Appendix D.

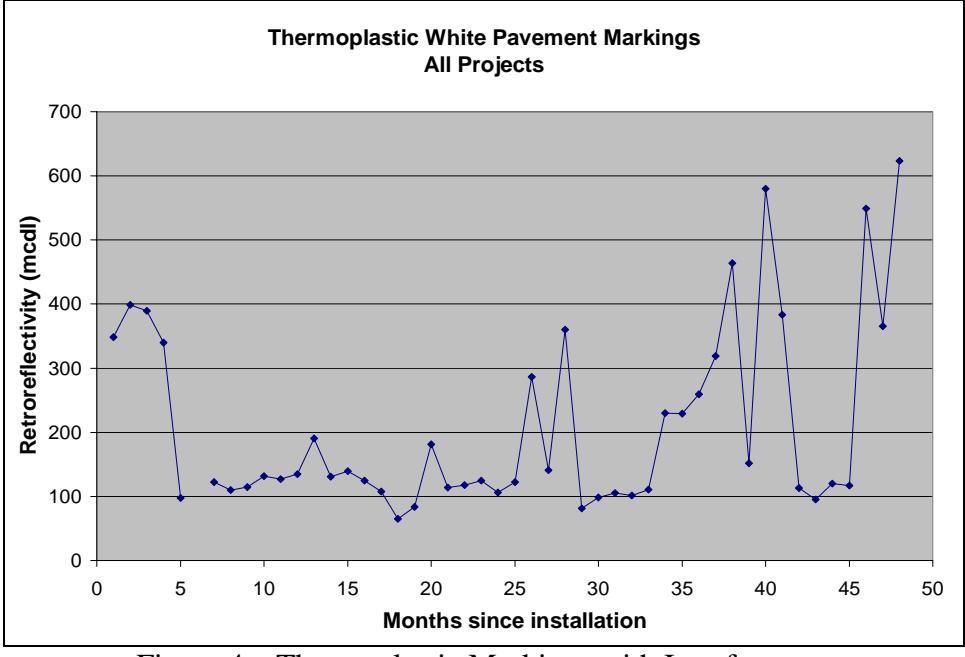
Figure 4 – Thermoplastic Markings with Interferences

Following the initial assessment of each project, all data was compiled into a master database. The database was sorted by each marking type and color. In order to provide a comparison between markings comprised of the same material, the number of days since installation was calculated. From this information, the number of months since application was determined and all results were inserted under the appropriate month. An average was calculated for each month and utilized to compose a graph of retroreflectivity readings over time for each marking type for a given color regardless of what time of year the marking was applied. The following graph displays the retroreflectivity readings over time in conjunction with all thermoplastic projects.

In examining the graph above, it was clear that interferences still remained within the data pool as retroreflectivity readings were expected to continually decrease over time. Higher luminance readings well above the initial readings within the first 6 months of application were considered implausible. This lead to one final examination of all data sets. As the study was initiated in 2002, the initial retroreflectivity readings were not collected on projects constructed in 2001 and 2000 until one to two years following application, respectively. Additionally, the Agency typically applies standard waterborne paint over durable markings two to three years in age. Therefore, it is difficult to ascertain whether readings collected from projects constructed in 2000 were from the

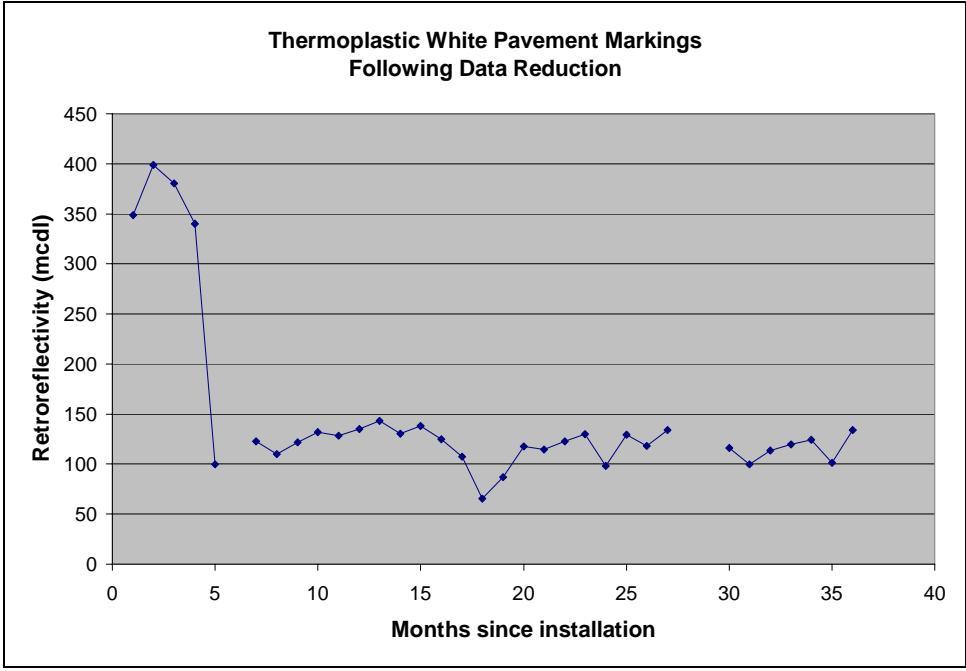
Figure 5 – Thermoplastic Markings following Data Reduction

The graph depicted above is consistent with field factors. Initially, the readings increase over the first few months as the result of tire abrasion exposing a larger portion of glass beads. The luminance readings then drop significantly during the winter months which may be attributed to shearing effects from winter maintenance practices and dirt or debris on the markings during data collection. The markings rebound during the spring and summer months climaxing in late summer and into early fall. This cyclic pattern continues over time.

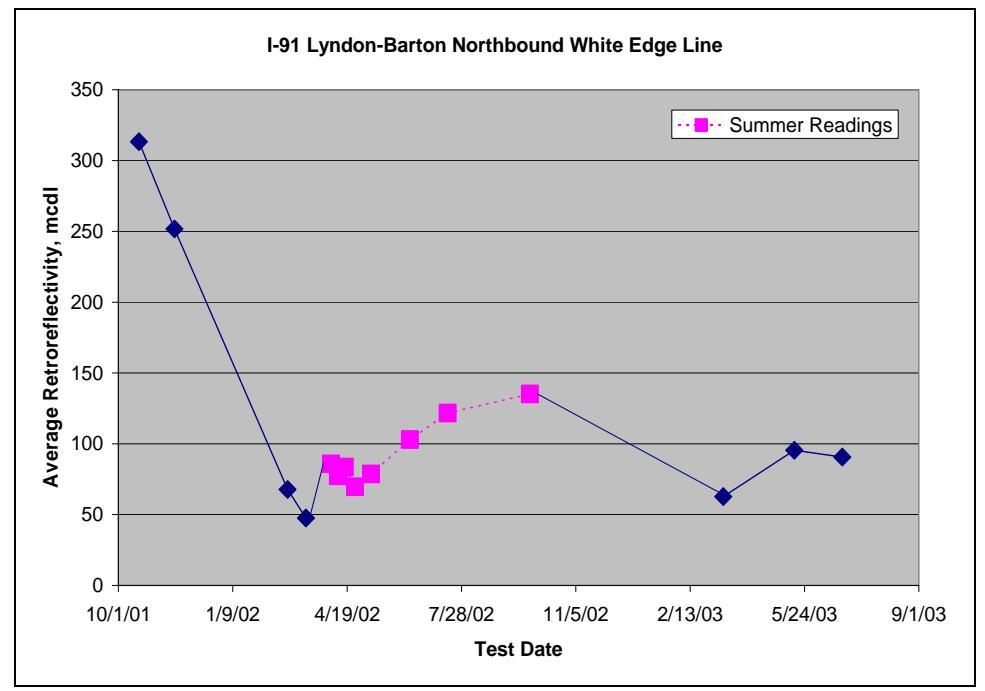
Figure 6 – White Thermoplastic Edge Line, I-91 Northbound

Figure 6 below presents the average retroreflectivity across all test sites within a newly constructed roadway section of I-91 for the entire duration of the study. The project incorporated the placement of durable thermoplastic markings in October of 2001. Readings indicated in pink were expected to display little variability during summer months where environmental conditions are relatively constant. However, the average retroreflectivity reading measured in the test section during the summer of 2002, one year subsequent to application, ranged from 70 to 135 mcdl with an average of 94 mcdl. The standard deviation of the average retroreflectivity reading was approximately 23 mcdl. This is a relatively large standard deviation displaying the significance of the variability on the data set.

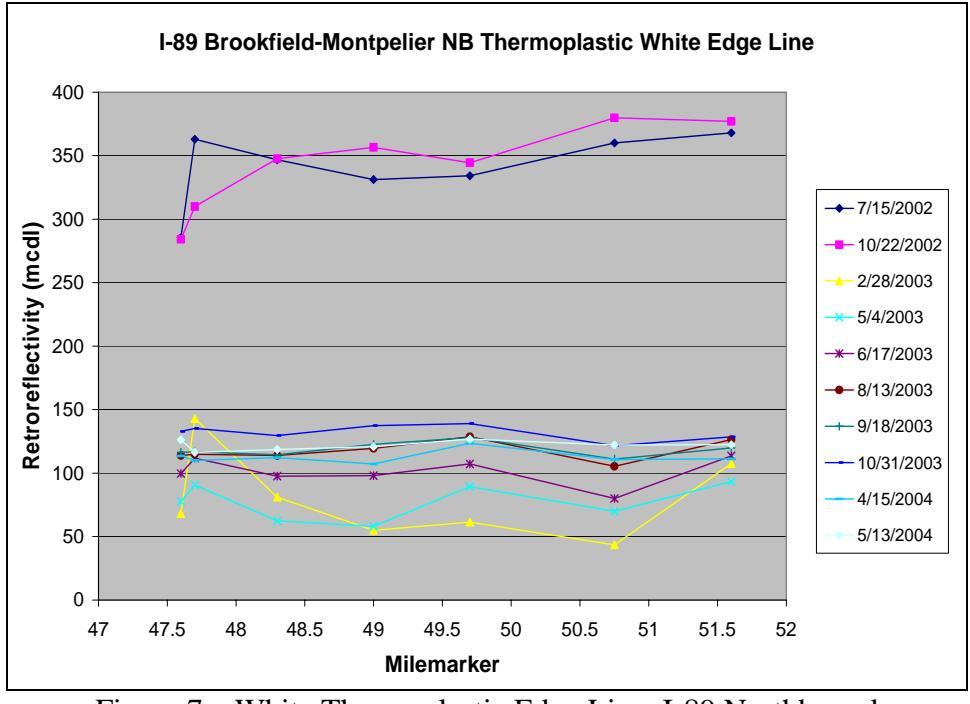
Figure 7 – White Thermoplastic Edge Line, I-89 Northbound

To further examine variability within the data sets, the average retroreflectivity result per test site was plotted in reference to mile marker location. Once again, one would expect the results to be fairly consistent for a given date across the entire project as many of the parameters, such as weather conditions, installation date and material composition, would be held constant on any single date. The data in Figure 7 displays the dissimilarity throughout the entire length of the project during a single data collection event. It is also interesting to note that the initial retroreflectivity increased on average from July to October of 2002. While the retroreflectivity recovers during the summer months, a significant loss in retroreflectivity occurs following one winter of service, over 100 mcdl on average. Additionally, all subsequent readings were found to be below the minimum recommendation from FWHA of 150 mcdl for white interstate markings. It does raise the question as to whether this minimum expectation is sustainable in snowy climates during winter months. As a final aside, it is difficult observe any patterns in reproducibility due to the dissimilarity between data collection events. This variability will resound throughout the remainder of the analysis.

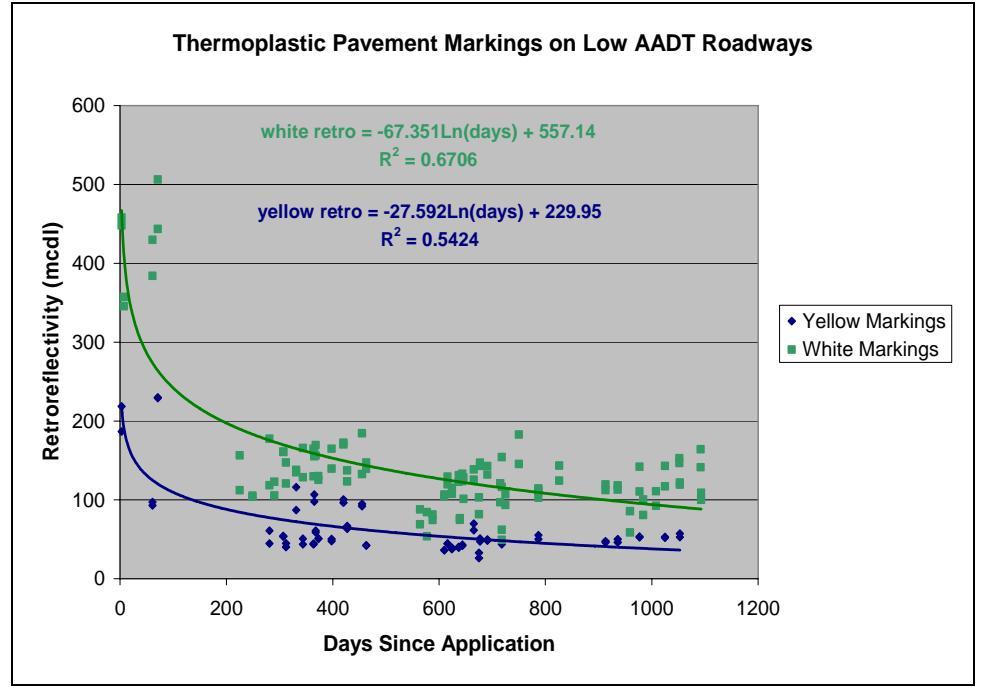
Figure 8 – Thermoplastic Pavement Markings, Low AADT

Yellow markings were found to less retroreflective with a higher variability when compared to white markings. Figure 8 exhibits the average retroreflectivity of white and yellow thermoplastic pavement markings applied in low AADT, or average annual daily traffic, (<3600) roadway sections.

While the general downward trend over time is quite visible, the amount of variably within the first 480 days following application is considerable. In particular, the reductions associated with winter maintenance occur at a similar point in time each year, but the age of the marking may vary when that event occurs. Over time the data sets appear to become more confined. However, is it important to examine the magnitude of the readings as well. Additionally, a regression analysis was performed using the trend line function in Excel in order to provide a logarithmic equation that predicts the decay of the reflectivity as a function of elapsed time. Note than an R^2 value, or coefficient of determination, was also presented below each equation. Given as a number between 0 and 1, the closer the R^2 number is to one, the closer the fit of the data to the trend line. As you can see, the R^2 value is much greater for the white markings in comparison to the yellow markings.

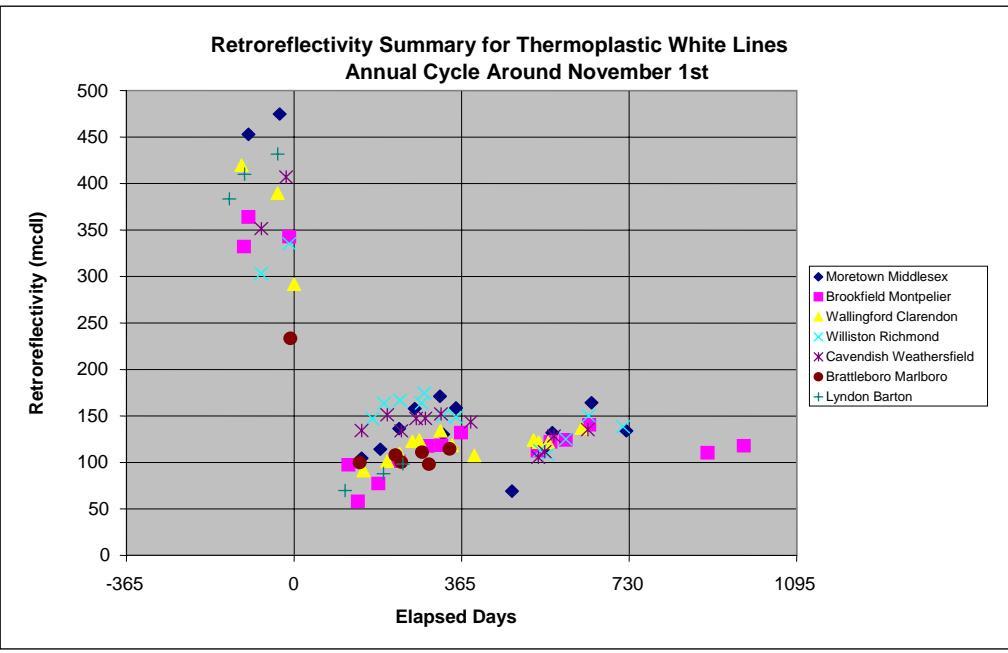
Figure 9 – White thermoplastic markings calibrated to November 1st

Since time of year will be not be a function of the dependant variable, this relationship was examined in the Figure 9 and 10 for thermoplastic and polyurea markings, respectively. Utilizing the date of a specific data collection event and first occurring November 1st following application, the number of elapsed days was calculated referenced around November 1st.

Snowfall events generally occur between November and April each year and may be assumed to be a seasonal pattern. With this in mind, the damage from snow plow events is evident for both thermoplastic and polyurea markings between November 1st and the following 150 days, roughly until April 1st. While annual damage accumulation is consistent for both markings, the subsequent response is quite different. Thermoplastic markings appear to rebound by increasing in retroreflectivity during the summer and fall months. Conversely, polyurea markings were found to plateau during the same time

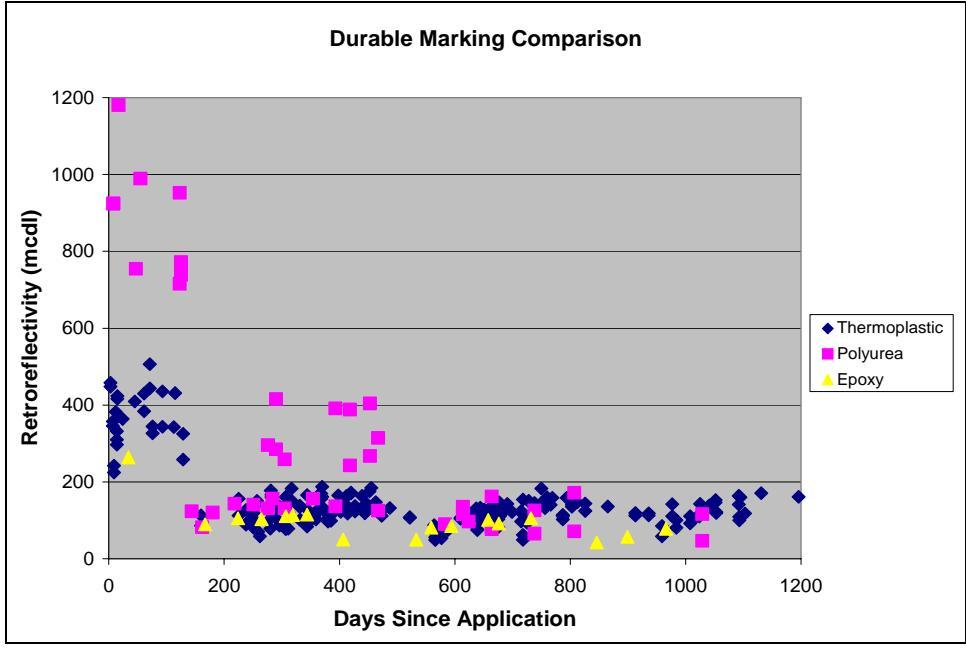
Figure 11 – Overall Comparison

Please note that due to the small sample population for the LPM pavement markings, both surface applied and recessed markings were incorporated into the graph as shown below.

As shown in Figure 11, retroreflectivity decreases in a non-linear fashion as pavement markings age. Additionally, the amount of variability in retroreflectivity for markings of the same age is quite evident. The variability decreases both in absolute value and in percentage of residual retroreflectivity. A significant loss of retroreflectivity is noted within the first 180 days following application most likely attributed to winter maintenance practices. Polyurea pavement markings display much higher luminance within the first 450 days following application. However, it was quite surprising to observe that polyurea and thermoplastic materials exhibit similar retroreflectivity following 540 days of application. As a final note, an annual cyclic pattern within thermoplastic projects is highly discernable. The decrease in early winter is followed by a recovery phase between April and June. The shape of the exposed glass bead is controlled by maintenance practices during winter months and tire abrasion during summer months.

Based upon data collection from one project, epoxy markings appear to be inferior to all other durable markings within this study. However, it is important to consider that installation was conducted on October 22, 2002 when the reported minimum and maximum ambient air conditions where 31°F and 43°F, respectively, on the low end of the specified minimum application temperature of 40°F potentially resulting in inadequate performance. A special type of bead, known as Visibead, was also dropped onto the marking material. These are much larger in diameter as compared to the <u>standard</u> <u>AASHTO Type I beads</u> and may require additional binder thickness. However, records indicate that a standard film thickness of 20 mils +/- 2 mils was utilized. Inadequate cure conditions coupled with a minimal film thickness for the larger glass beads likely resulted in reduced bond strength and loss of glass beads due to winter maintenance practices.

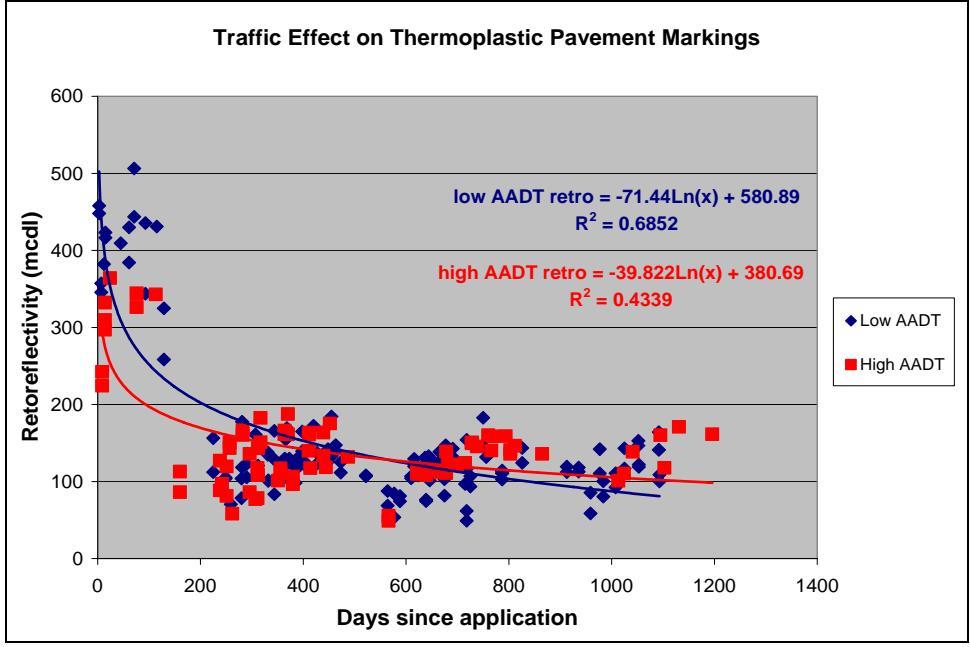
Figure 12 – Thermoplastic AADT Comparison

Although counterintuitive, Figures 12 and 13 depict higher rates of decay for rural applications over high traffic locations. In examining Figure 12, thermoplastic markings within a heavily traveled roadway decay more readily within the first 1.5 years of application. Following this period, markings applied in a low AADT area display greater decay with resultant low retroreflectivity. A plausible explanation for this condition relates back to condition of the glass bead at the surface. Wear rates on the beads are

affected by two specific events – plowing and tire abrasion. The bead surface under plow-sheared conditions does not provide retroreflectivity. As tire abrasion removes the marking material the bead is re-exposed to incipient light at low angles. This phenomenon explains the recovery on high AADT roads. The glass bead is worn at a lower rate than the marking material that holds the bead in-place.

As shown, all of the thermoplastic marking data points are clustered together regardless of traffic volume. This may be attributed to the greater application thickness of the thermoplastic markings as compared to the other durable markings. As the markings begin to wear down, additional beads are exposed. A thicker marking should allow for an increased amount of time before the marking is worn through, assuming that the resistance to wear, or hardness, is similar for all materials. However, the polyurea retroreflectivity results as shown within the graph are from both surface applied and recessed markings. Given that the application methods vary, no conclusion will be drawn regarding the overall effect traffic volume on polyurea markings.

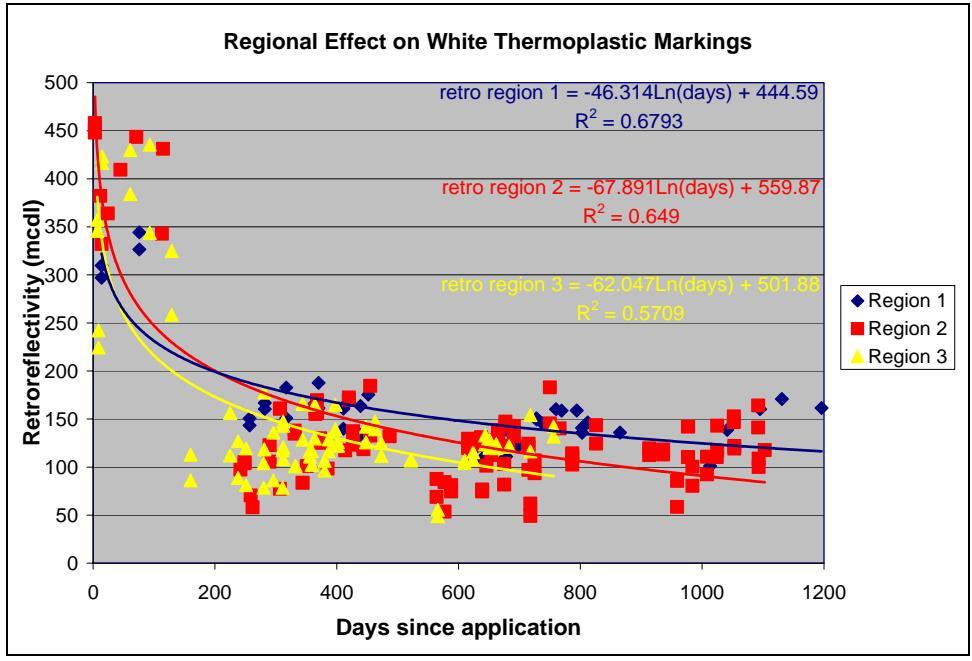
Figure 14 – Thermoplastic Regional Comparison

The geographic regional effect on retroreflectivity over time is explored in Figures 14 and 15. The state was divided into three distinct areas as follows: the Champlain Valley (Region 1), the northeast/central area (Region 2) and the southern region (Region 3). The Champlain Valley is the most heavily populated region in Vermont and lies alongside Lake Champlain which moderates the weather in nearby areas. Outside heavily populated areas, the remainder of the valley is characterized by open pastures. The northeast/central area is characterized by the Northeast highlands, Green Mountains and Western New England Upland. This area is known for an increased annual snowfall amount in comparison to both Regions 1 and 3. Southern Vermont is defined by the Taconic Range extending from Massachusetts and the Western New England Upland. While each region is unique in terms of land use and population density, other concurrent studies define Vermont as a cold climate and heavy snowfall removal. The sample population is composed as follows:

In examining Figures 14 and 15, it does appear that the location of a project within a specific region does have an effect on the overall durability and luminance of a marking. As would be expected, markings within a warmer region, as found in the Champlain Valley, appear to retain a higher level of retroreflectivity over time as was true for both the thermoplastic and polyurea markings. Then again, this area is also known for a high population density, or AADT, which typically results in a greater amount of abrasion. It may be surmised from this information that winter maintenance practices, or shearing,

cause more damage than tire abrasion. Utilizing the same logic, it was surprising to note the greatest loss of retroreflectivity within the southern region of the State as this area typically receives an annual snowfall amount of 76" as compared to the northeast and central region which obtain an annual snowfall amount of 101" and 67", respectively.

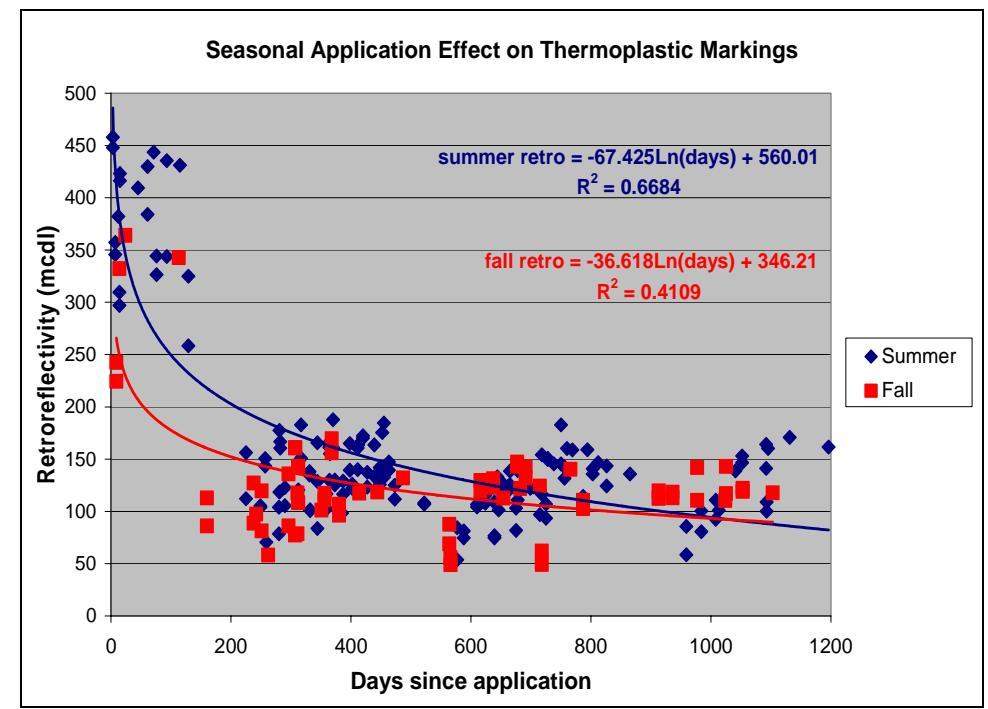
Figure 16 – Thermoplastic Seasonal Comparison

Figures 16 and 17 assess the impact of late season application on the overall durability of thermoplastic and polyurea pavement markings, respectively. The date of application for each project was examined and utilized to create two bins, summer (June through August) and fall (September through November). The sample population is composed as follows:

As shown within Figure 16 and 17, there does appear to be a correlation between seasonal placement and luminance. Within the first six months following placement, the retroreflectivity of markings applied during summer months was found to be greater as compared to markings placed during the fall. For thermoplastic markings, this trend is most evident within the first few months of application when markings applied during the summer exhibit a greater amount of reflectivity, 100 mcdl on average prior to any winter maintenance practice. After two and half years of service, the two data sets are coincident and display similar luminance. The same appears to be true for polyurea pavement markings, except the trend is less clear after one year of service. The recommended conditions for placement of the markings are dissimilar. Polyurea can be placed at a lower minimum ambient air temperature (40°F) as compared to thermoplastic (50°F). Therefore polyurea should be less susceptible to cure-related problems at lower temperatures, which may account for the greater effect of seasonal placement on thermoplastic markings during fall placement.

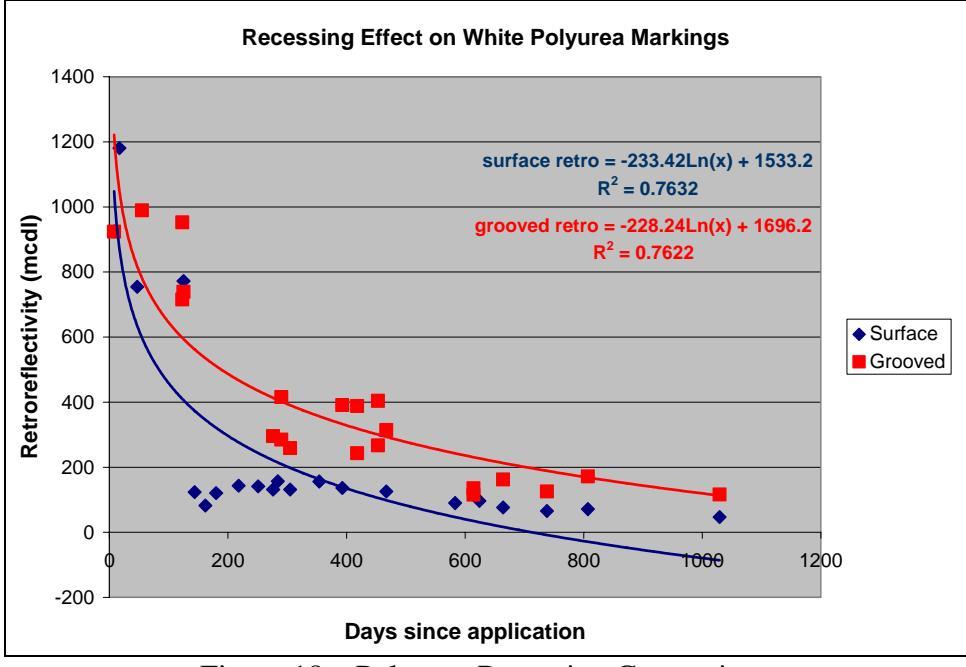
Figure 18 – Polyurea Recessing Comparison

In an effort to increase the life cycle of pavement markings, the Agency began an initiative to recess polyurea pavement markings on the Interstate. The recess entails grinding the pavement where markings are to be applied to a specified minimum depth. In theory, recessed markings should be less subject to damage from winter maintenance practices, in particular plow-sheared beads should not occur significantly. However, recessed markings do not protect markings from tire abrasion. Figure 18, provided below, contains all Polyurea 2A projects incorporated into the study. The sample population contains two recessed and two surface applied projects.

As displayed in Figure 18, recessing does appear to aid in the retention of retroreflectivity over time. Prior to the first winter season, both recessed and surface applied markings display similar retroreflectivity. However, following the initial winter season, the overall loss of retroreflectivity of surface applied markings is much more apparent than recessed markings. Additionally, regression modeling was performed on both data sets with a resulting non-linear decay trend. Although the coefficient of determination indicates that the trend line is fairly accurate, pavement markings cannot absorb light. Negative readings cannot occur, suggesting that a boundary condition exists. The model was influenced by the great loss of reflectance following the first winter season, roughly 615 mcdl for surface applied markings and 300 mcdl for recessed markings. This loss is significant and should be considered during markings, each parameter was separated into two discrete bins, prior to and following 180 days of application as displayed in Figure 19.

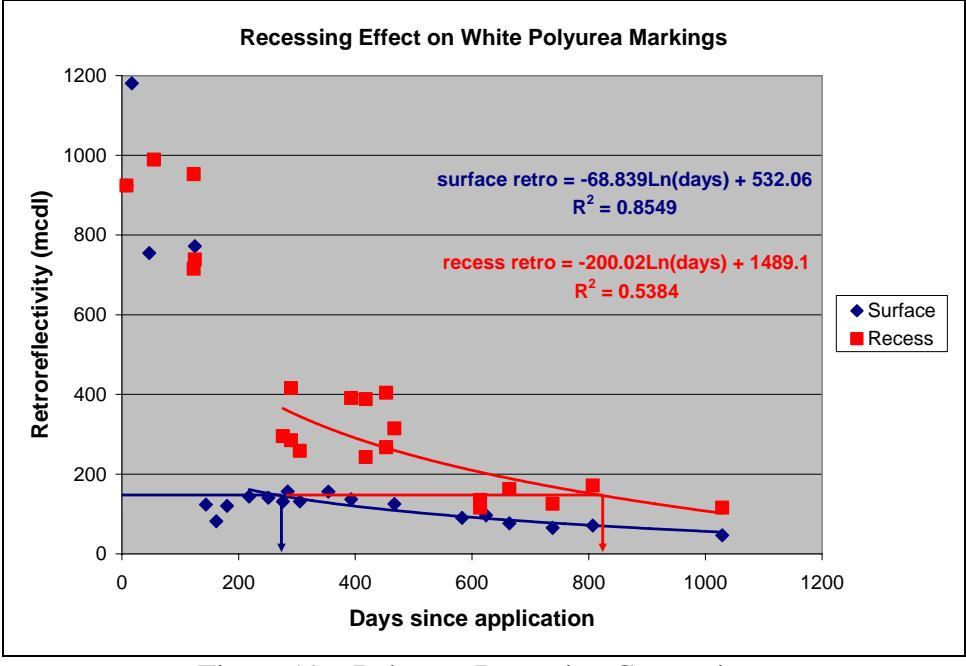
Figure 19 – Polyurea Recessing Comparison

As you can see, the new polyurea marking regression model fit from 180 days appears to be more sensible as both trend lines follow the two data sets. This further maintains the idea that pavement markings in Vermont as more susceptible to plow damage than any other variable with the exception of elapsed time. The number of elapsed days prior to meeting the FHWA recommended minimum retroreflectivity of 150 mcdl for interstates was calculated to be approximately 280 days for surface applied and 830 days for recessed markings, respectively. Seasonal rebound observed within thermoplastic markings is not evident within polyurea markings. This may be due to inherent material characteristics such as polyurea greater hardness, which means that it may not benefit as readily from tire abrasion.

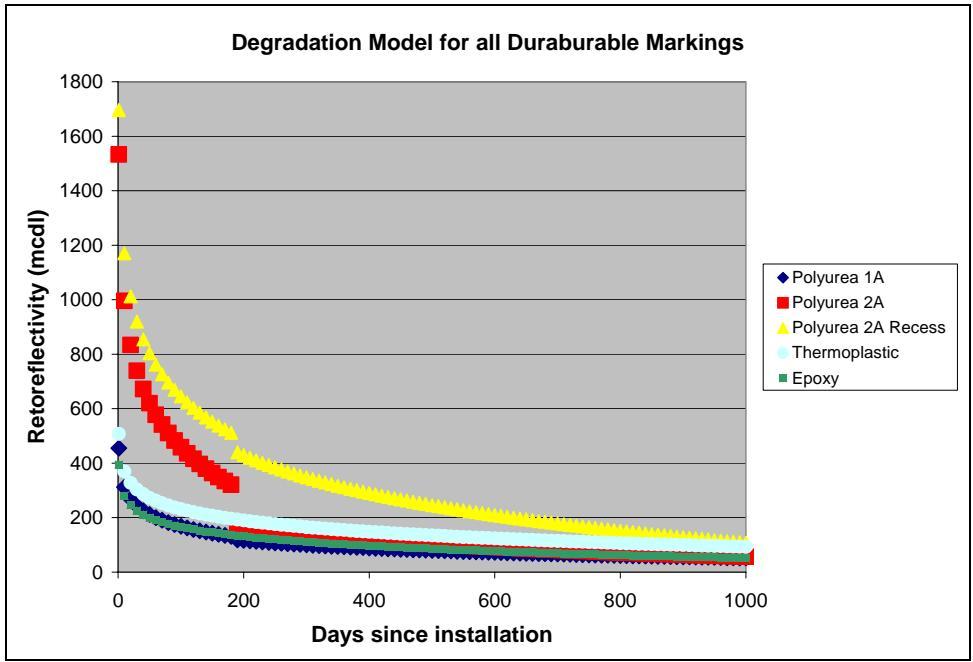
Regression modeling was performed on each type of durable marking assessed within this investigation. All models are based upon the average retroreflectivity values collected in the field for each paving project. As there was an identifiable interference with snow plow damage along with a great loss of luminance following one winter season, all polyurea markings, regardless of type and application method, were modeled in two increments, prior to and following one winter season. This appeared to provide the best fit to the data points. Conversely, while winter maintenance damage is also visible in thermoplastic and epoxy markings, the magnitude of the initial loss is much smaller allowing for one best fit non-linear trend line. Figure 20 displays each trend line along with marking type.

In addition to the decay analysis provided within the figure above, the equation of each trend line is supplied in Table 4 along with the coefficient of determination.
