RESEARCH UPDATE

Number U90-07

REPAIR OF SUBSTRUCTURE CONCRETE USING SHOTCRETE

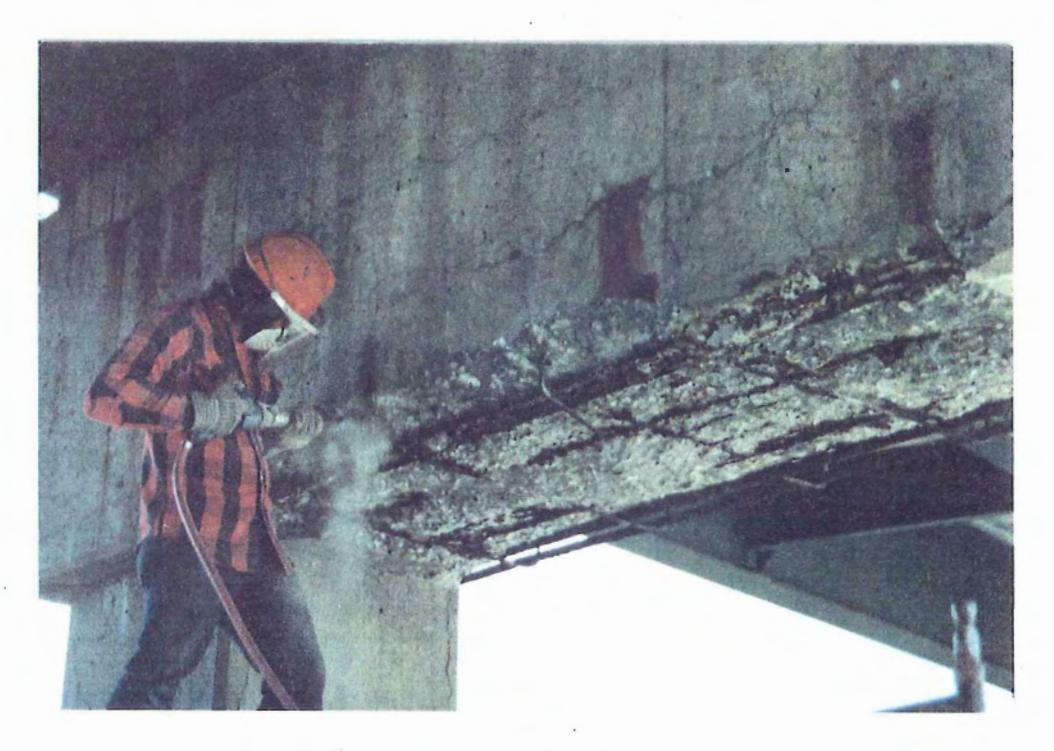
Preparation of Existing Concrete Substructure

A 4' by 12' section of the bottom of the northerly pier cap on Bridge 61S was prepared by District No. 5 maintenance forces. Preparation included the removal of unsound and delaminated concrete with a 15# chipping hammer in an area extending 4' from the easterly nose of the pier cap to the mid-point between the two columns, see Figure 1. As much of the bottom of the cap was severely delaminated, large segments up to 2 square feet in area, fell to the ground with little or no chipping effort. A saw cut was made at the mid-point to prevent Concrete was concrete removal beyond the scope of the project. chipped out 9" to 15" up each vertical face of the cap for the same 12' length as the bottom. The depth of removal was a minimum of 1" beyond the primary reinforcing steel into sound concrete. Ninety five percent of the exposed reinforcing steel was visibly corroded and the horizontal portion of the stirrups were rusted through, see Figure 2. At the completion of the removal operation the entire area was sand blasted to remove any remaining contaminants and rust from the reinforcing steel.

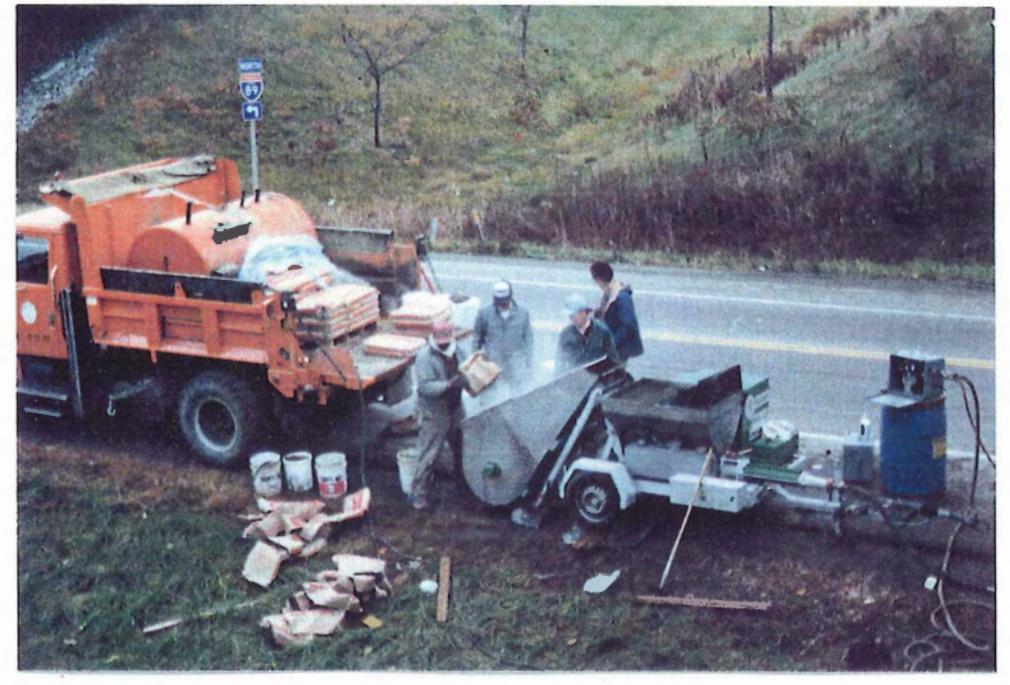
Mixing/Pumping Operation

Although the positive displacement pump was capable of discharging 7 yd. 3 /hr. the rate of application was between 1/4 yd. 3 /hr. and 1 yd. 3 /hr. The GS-Shotpatch 10 was placed in the mixing hopper, see Figure 3, along with approximately 0.7 gallons of water per 55 lb. bag. Each batch was thoroughly mixed before being dumped into the pump. When the ready-mixed mortar was applied, the mix was discharged from the truck directly into the mixing hopper and then into the pump.

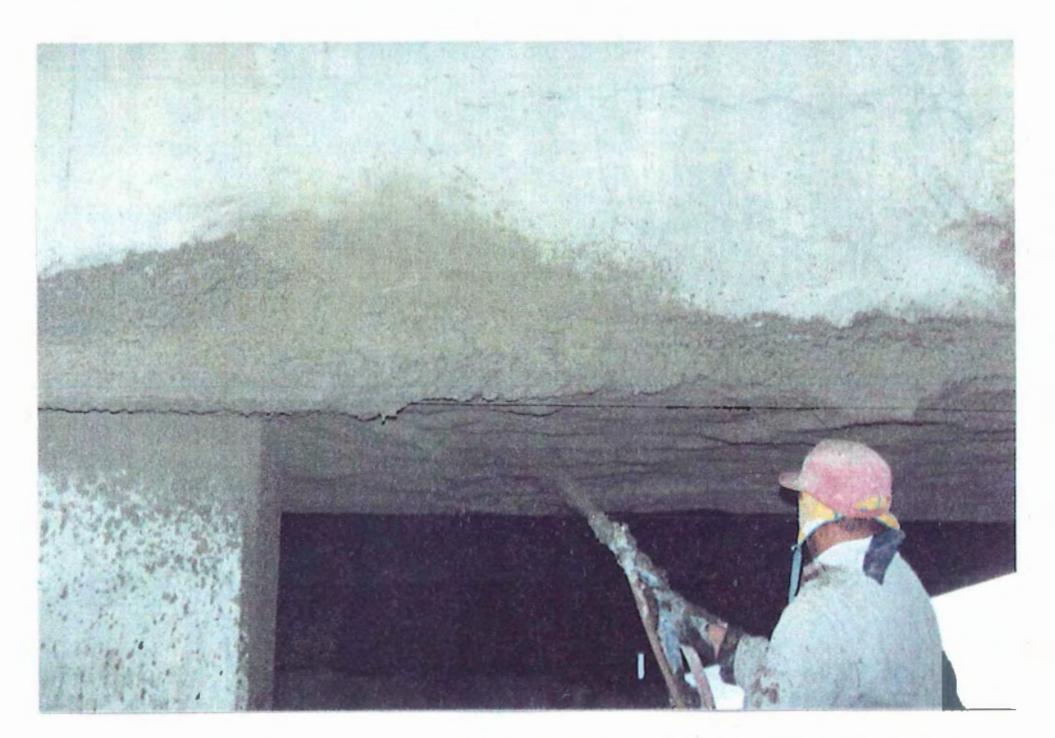
Shotcrete Application

The GS-Shotpatch 10 mortar was pneumatically applied to the pier cap on the afternoon of October 21, 1987. As temperatures were in the 40° F to 45° F range, the nozzleman had some difficulty with bond when material depths became too great, see Figure 4. When the supply of GS-Shotpatch 10 was depleted, the shotcreting operation was discontinued until the following day. The repair was completed with the ready-mixed mortar which was delivered in two - one cubic yard loads.

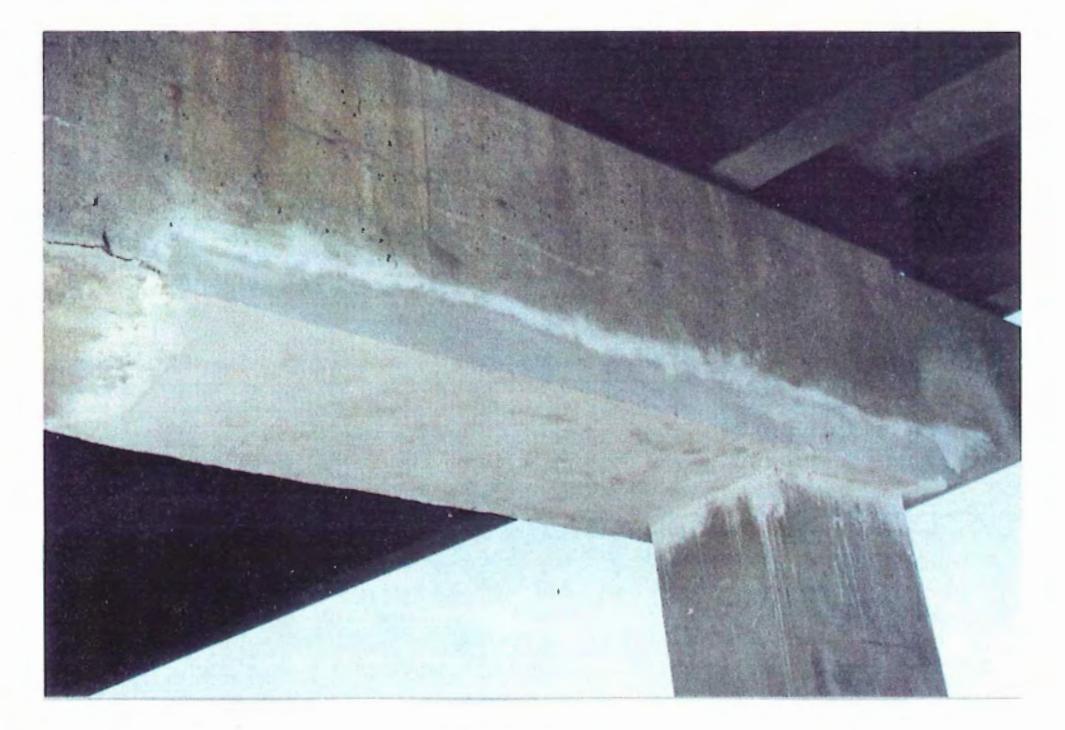
FIGURE 5

Completed Repair

Following the completion of the troweling operation, the entire surface was covered with a liquid membrane curing compound, see Figure 5, and insulating blankets to protect the shotcrete from excessive evaporation and freezing temperatures. The overnight low temperatures on the 22nd and 23rd of October were 28°F and 26°F respectively.

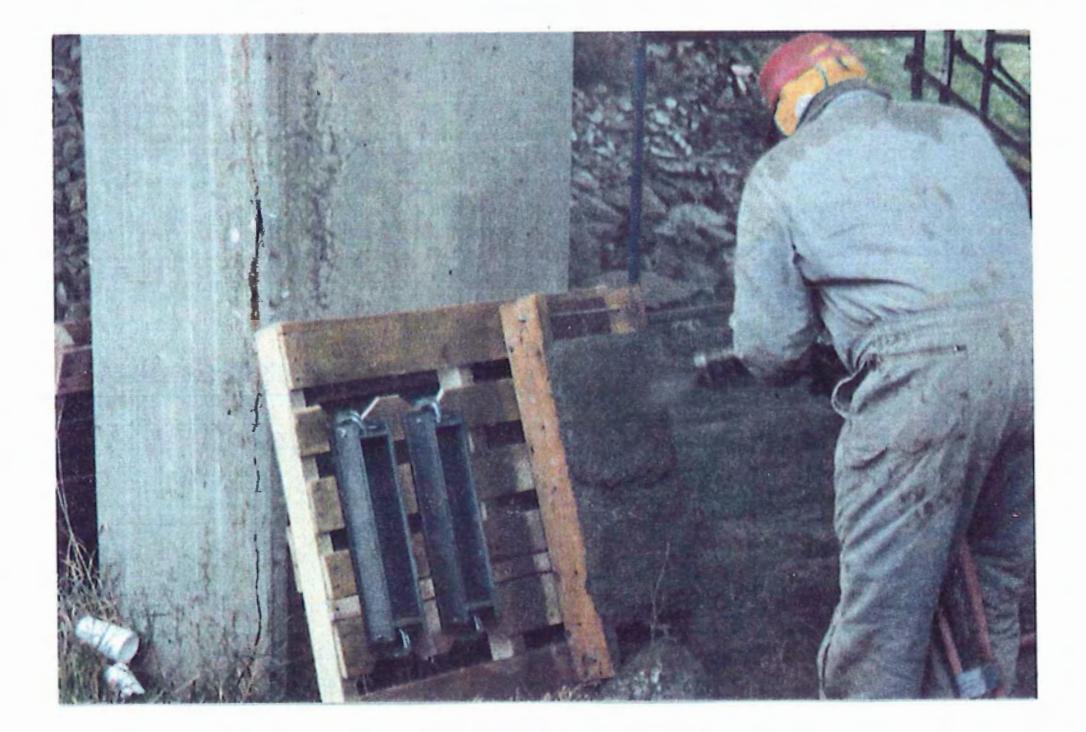
FIGURE 6

Test Specimen Fabrication

All specimens were cast in a vertical position using Gilbertson Shotcrete Specialty's GS-Shotpatch 10. Fabrication was completed with the same equipment and procedures used on the substructure repair, see Figure 6.
