RESEARCH UPDATE U96-29

ASPHALT RUBBER HOT MIX BOLTON-WATERBURY, U.S. ROUTE 2

Bolton-Waterbury RS 0284(13) U.S. Route 2

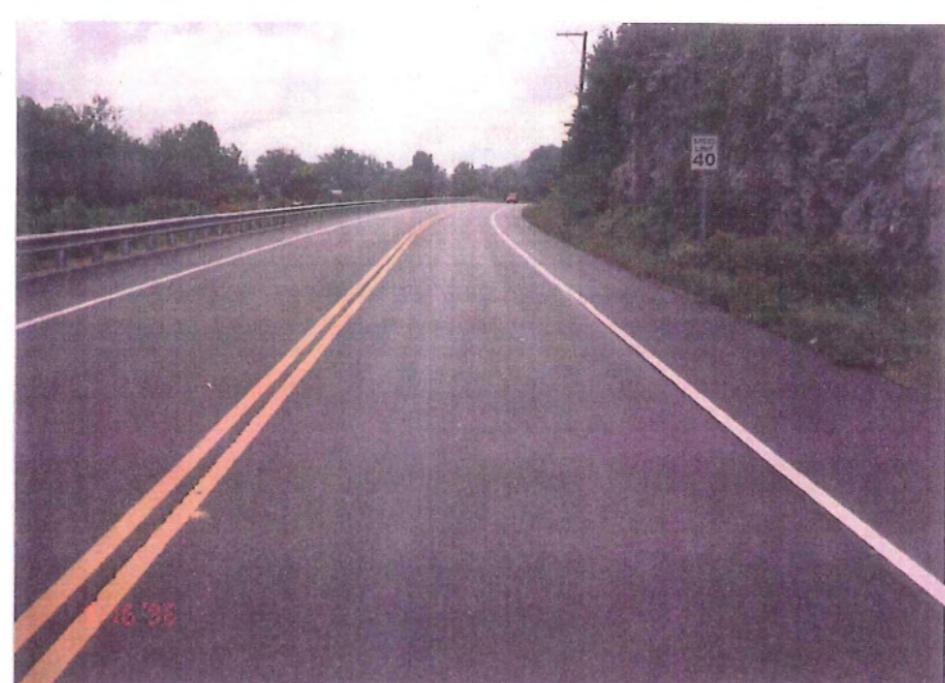
Test Site MM 3.18 90 mm AC/ 100 Recl. Base Best condition on project

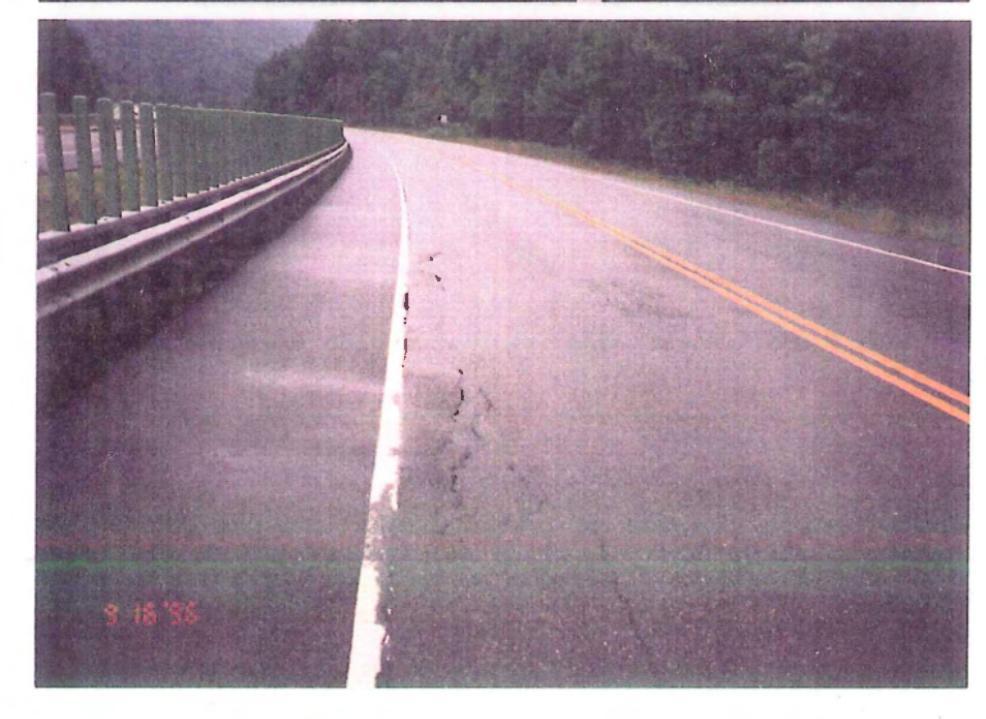
Cracking was the most prominent distress observed. Within the first year of service cracking had developed in the 40 mm standard overlay sections. Between 1995 and 1996 the rate of cracking had increased sharply in all but two of the treatments. Deep longitudinal cracks along the edge line were observed from MM 4.4 in Bolton and ran fairly regularly to the north end of the project. Transverse cracking was found in Bolton from MM 3.4 to MM 4.4. The transverse cracking was typically shoulder-to-shoulder and occurred at regular intervals. Interspersed throughout the project were patches of fine map-pattern cracking as well as incidences of joint separation at the centerline.

Test Site 4.8 65 mm ARHM/ 100 mm Recl. Base Longitudinal cracking along edge line
