MATERIALS & RESEARCH

INITIAL REPORT

U 2006-1

THERMAL-IMAGING OF APPLIED BITUMINOUS PAVEMENT STATEWIDE PROJECTS 2005 (INITIAL REPORT)

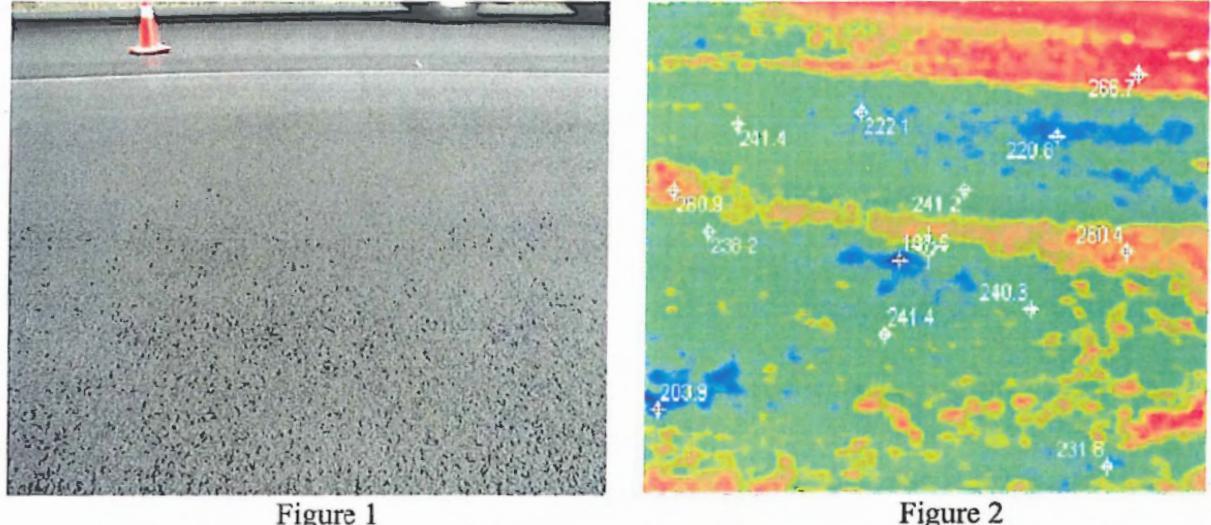
Figure 2 Thermal shot in the area of Figure 1

<u>Fairlee-Newbury</u> - Paving of this project was completed by Pike Industries Inc. The mix was produced from their batch plant in Waterford, VT. The average haul time was 1 hour. The target lay down and compaction temperature was 290 °F. Two core samples were obtained from this project for testing. The average application temperature of these samples was found to be 210 °F. This was determined by taking the target temperatures of each sample obtained by the thermal camera and averaging these values together. Figure 1 is a photographic shot of the pavement constructed in the Fairlee-Newbury project. Figure 2 shows a thermal shot with the Fluke Ti30 camera of the pavement in the vicinity of Figure 1.

434' 7" Up-station from mm 95.65

Project	Haul Time	Core ID	Core Location	Temp °F Approx Area	Lab Testing Compaction	Quality Assurance
Fairlee- Newbury	1 hour	R1	434' 7" upstation from mm 95.65	220	92.1%	93.8%
Fairlee- Newbury	1 hour	R2	507' 5" upstation from mm 95.65	200	92.3%	93.8%
Rochester -Granville	1.5 hours	· R3	1359'2" upstation from mm 2.20	193	95.2%	94.7%
Rochester -Granville	1.5 hours	R4	947'10" upstation from mm 2.20	226	94.9%	94.7%

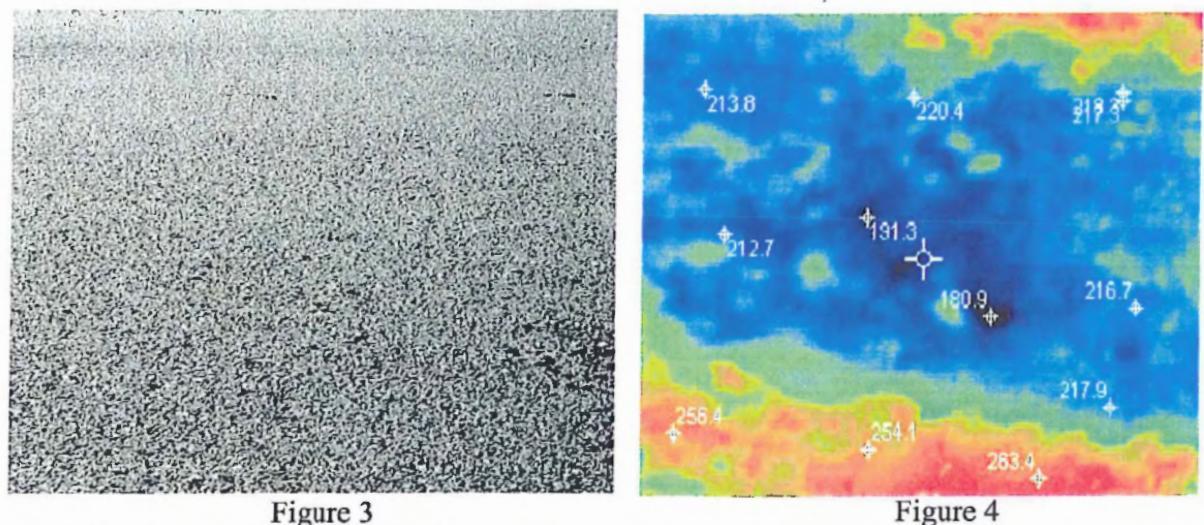
Figure 4 Thermal shot in the area of figure 3

Rochester-Granville - Paving of this project was accomplished by Pike Industries Inc. The mix was produced from their drum plant in New Haven, VT. The average transport time to the project site was 1 ½ hours. The target application and compaction temperature was 280°F. A few isolated areas of thermal segregation were identified resulting from the relocation of a paver from the lane to the shoulder. The identified segregation locations were minor and occurred at widely varying locations within the HMA mat such that a representative sample could not be obtained. Figure 3 is a photographic shot of the pavement constructed in the Rochester-Granville project. Figure 4 shows a thermal shot with the Fluke Ti30 camera of the pavement in the vicinity of Figure 3.

1359'2" Up-station from mm 2.20 in Granville
