MATERIALS & RESEARCH DIVISION

RESEARCH UPDATE

Number U91-4

DURETHANE ALL-PURPOSE BRITE FENCE

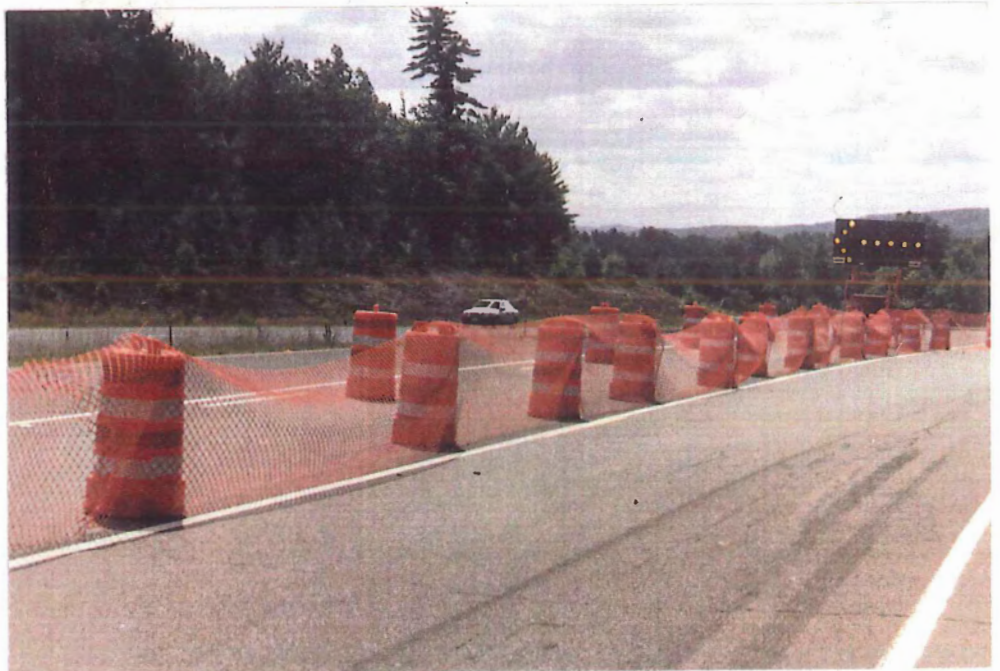
INSTALLATION: At Exit 5 the BRITE FENCE was attached to the standard drums (See Photo 1) because the contractor decided that the manufacturer supplied "Porta Posts" (See Photo 2) might become dangerous flying objects upon vehicular impact. The fence is taller than the drums and tended to sag between drums. The lead drum was struck several times which caused the fencing to intrude into the traffic lane. (See Photo 3)

PHOTO 1. Installation on Drums

**RECOMMENDATION:** Based upon the performance obtained on these two installations, DURETHANE ALL-PURPOSE BRITE FENCE is not recommended for use in the manner described in this study.

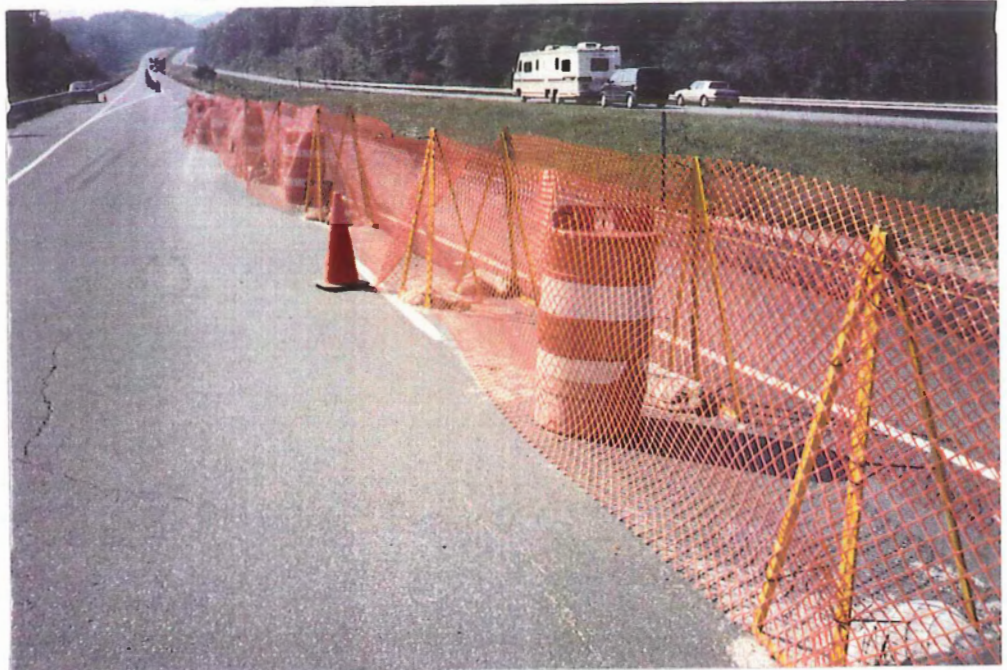
At Exit 8 a different contractor elected to use the Porta Posts to erect the fencing. When installed with the posts, the fencing material also tended to sag. The posts themselves are another element in the visual environment for the driver to identify and evaluate. (See Photo 2)

Photo 2 Installation on Porta Posts

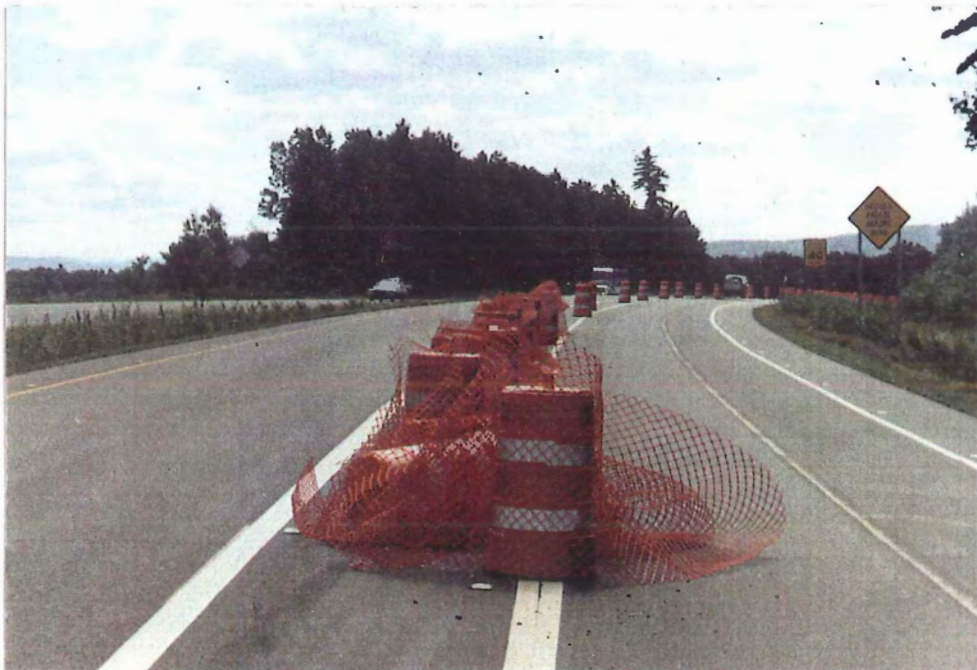
Photo 3 After Impact
