RESEARCH UPDATE

UpdateU94-16

EPOPLEX EPOXY PAVEMENT MARKING

REFERENCE WP No. 94-R-23

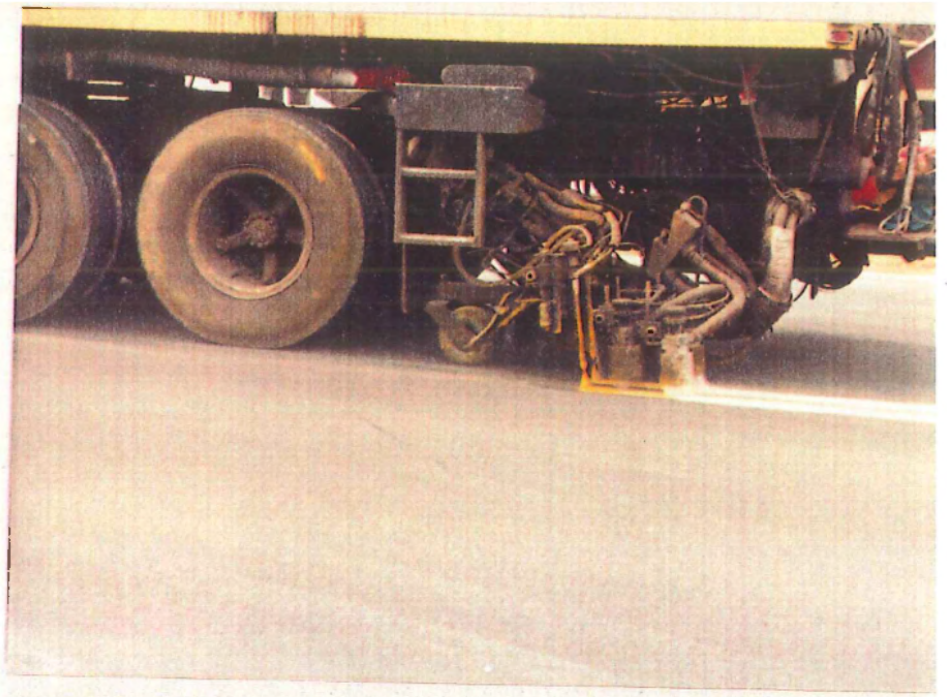
Application of the epoxy

FIELD TRIAL LOCATION AND INSTALLATION: The markings were applied on November 16, 1994. The ambient temperature was 40⁰ F, with the pavement surface temperature at 43⁰ F. Tests indicated that the average thickness of the epoxy was 23 mils. The material took approximately 20 minutes to dry, due to the cold conditions. No vehicle tracking problems were noted. The bead coverage did appear to be light on one line of the double centerline.

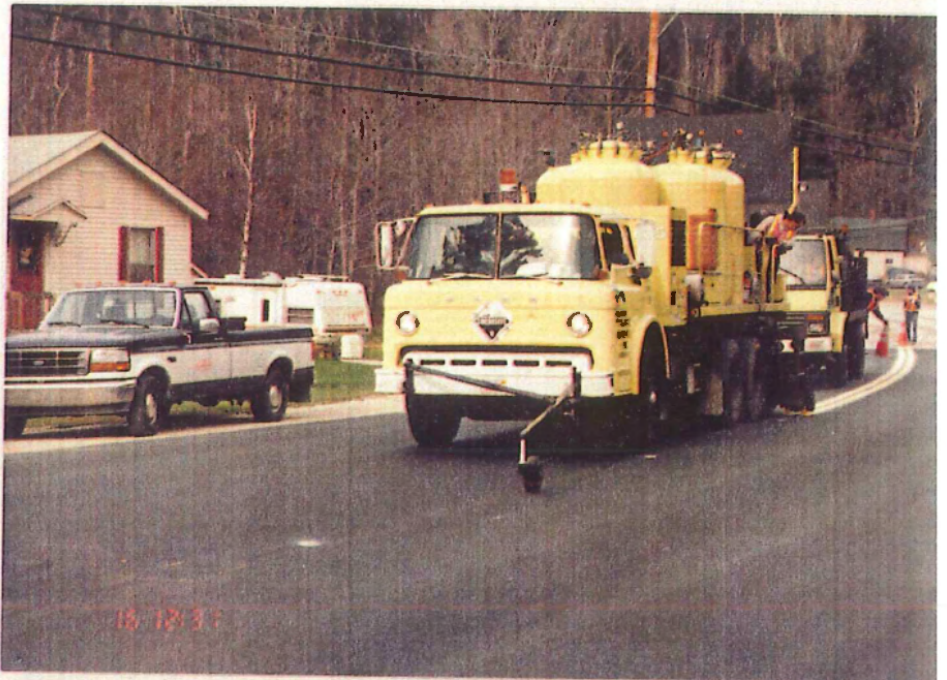
Epoxy marking equipment

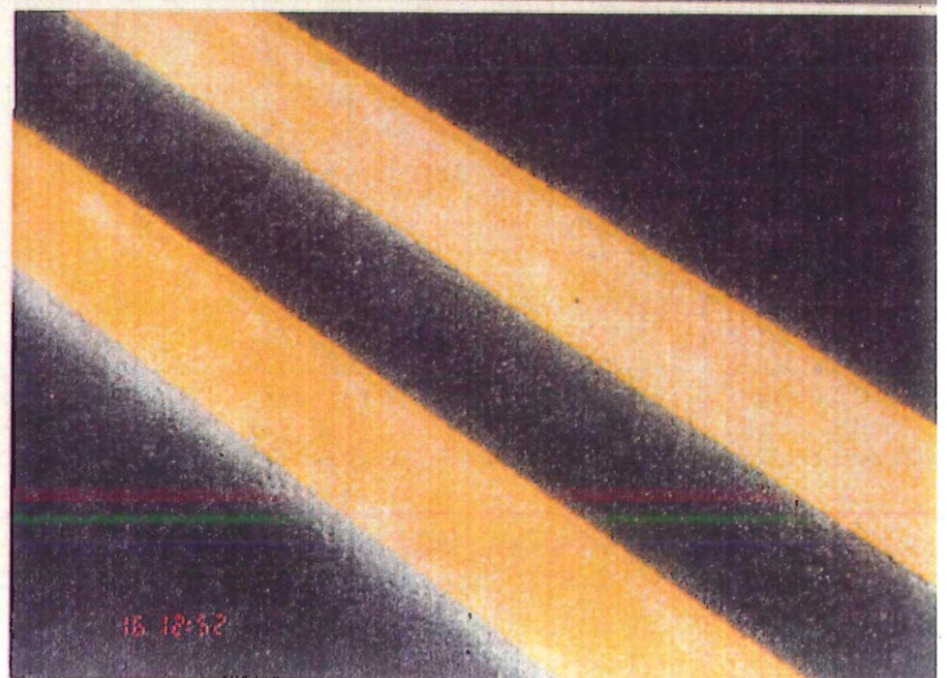
Bead Coverage

Less bead coverage on
the WB line
(Note EB line is at top
of picture)
