## RESEARCH UPDATE

U 2005-1

**RECESSED AND SURFACE-APPLIED POLYUREA PAVEMENT MARKINGS****REFERENCES:**

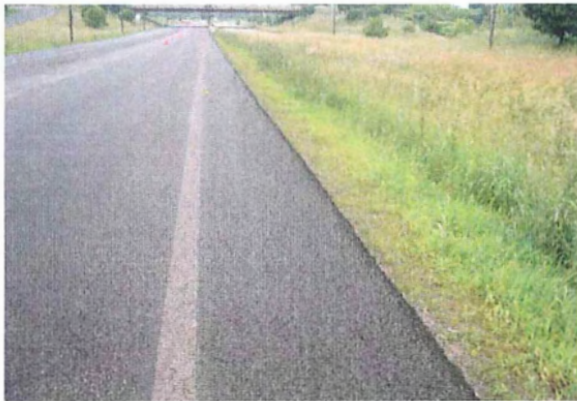
**Figure 2- Recess for Yellow Edge Line**

On June 29<sup>th</sup>, 2003, L&D Safety Markings began to prepare the roadway for both the recessed and surface applications. This involved installing a groove for all long line markings (right edge, left edge and skip lines) 40 mils in depth (+/- 10 mils) in the areas chosen for recessing (Figure 2). All recess preparation was completed in one day but further production, including application of the markings, was curtailed due to heavy rain.

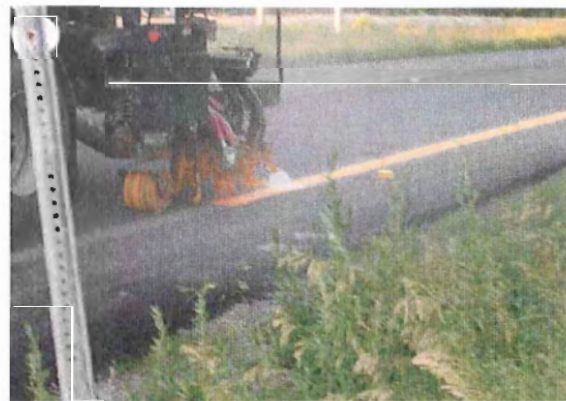
**Figure 3- Yellow Edge line being applied  
(MM 0.55 WB)**

Application of the markings commenced in the evening of June 30, 2003. All markings were applied after evening rush hour due to high traffic volumes. Weather conditions were clear with temperatures ranging from 78°F at 6PM to 64°F at midnight. Installation of the yellow edge line began at 7:40 PM as the markings were applied in the WB lane from I-89 (MM 1.443) to the US- 7 interchange (MM 0.334), a distance of approximately 1.1 miles (See Figure 3). Immediately after placing the WB yellow edge line, the EB yellow edge line from the US-7 interchange (MM 0.0) to I-89 (MM 1.492) was completed. By 8:30 PM, the entire yellow line had been applied.

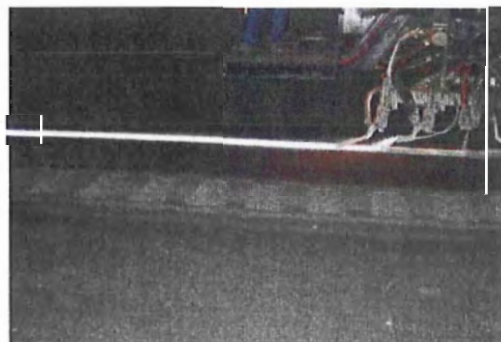
**Figure 4- White line being applied**

Following the yellow edge line application, at approximately 10:00 PM, installation of the white edge lines was begun (See Figure 4). Research and Development staff observed the placement of the EB white edge line until approximately 10:15 PM. White line retroreflectivity readings were not taken on June 30, 2003. All markings were completed before daybreak on July 1.

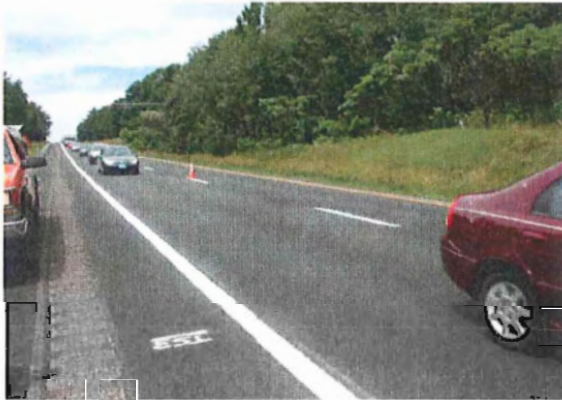
**Figure 5- Surface Markings, July 9, 2003**

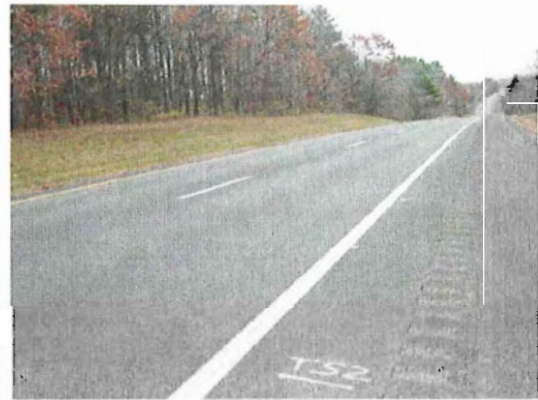
**Figure 6- Recessed Markings, Nov 6, 2003**

The second set of readings was taken on November 6<sup>th</sup> 2003, four months after the first data collection. The average remained high, however a 20 percent drop in the values (from 924 mcdl to 739mcdl) was observed on the recessed lines with a 16.5 percent drop on the surface lines (from 925 to 772 mcdl). This drop may have been due to the loss of excess beads over the four months of service. The durability rating remained at a value of 10.

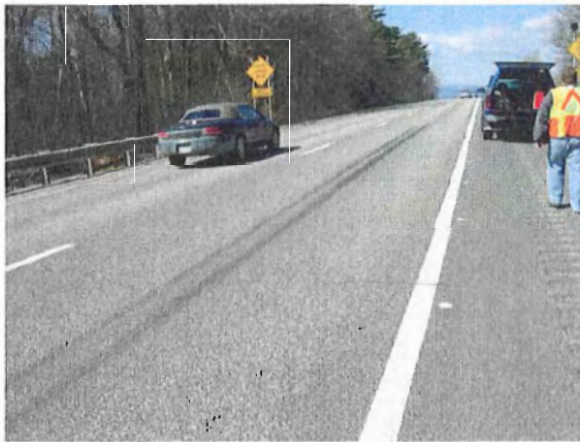
**Figure 7- Recessed Markings, May 5, 2005**

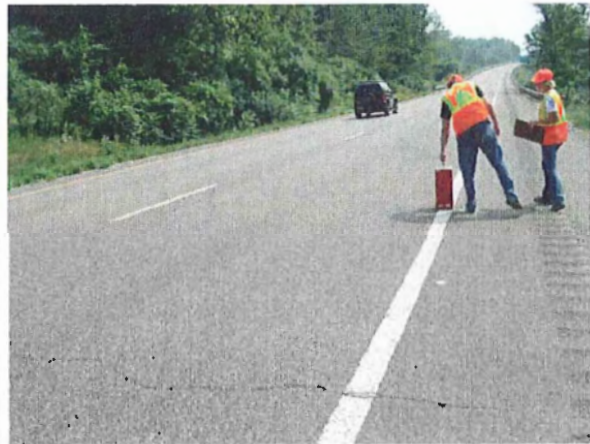
**Figure 8- Surface Markings, July 19, 2005**

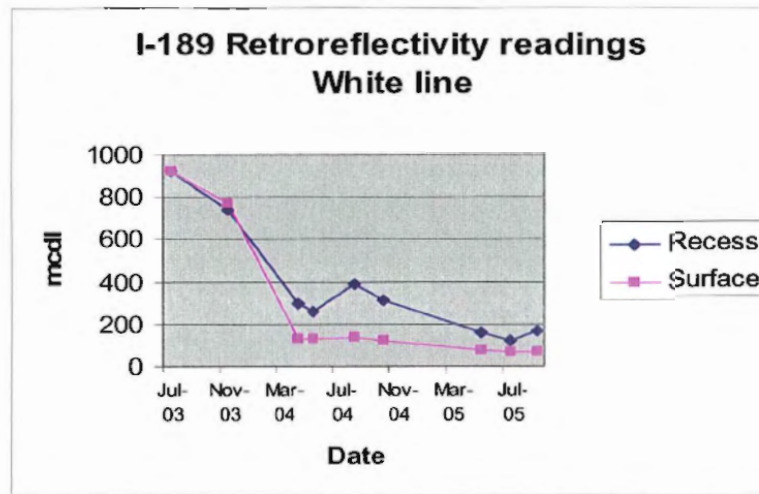
**Figure 9 – Average Reading for White Line**

The most recent readings were taken on September 21, 2005. Averages are indicated in Table 1 with a complete set of readings in Appendix A. The results show that after two winter maintenance seasons, the average readings for the recessed white lines had reached 171.5 mcdl while the surface-applied lines were 71.1 mcdl. The durability ratings had dropped to 7 for the recessed lines and 5 for the surface-applied lines. This trend is similar for most pavement marking systems tested by VTrans and is evident in the graph in Figure 9.

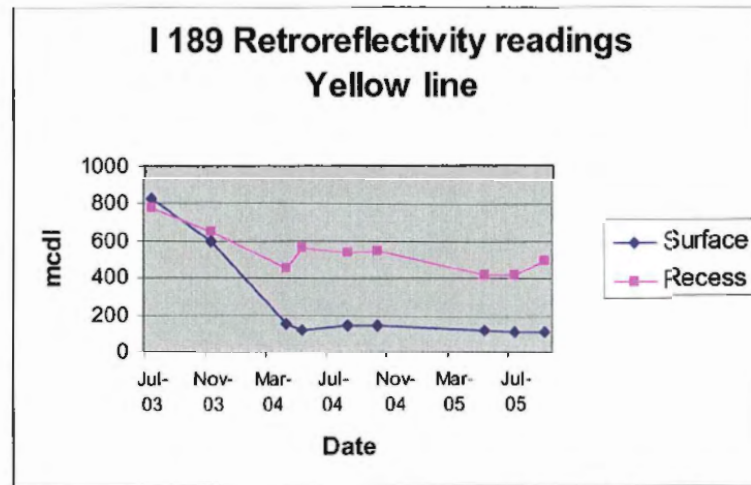
**Figure 10 – Average Reading for Yellow Edge Line**

The recessed yellow edge lines follow a somewhat different pattern than the white lines. Initial readings taken on July 9, 2003 obtained averages values of 833 mcdl for the surface applied markings and 782 mcdl for those that were recessed. Additional readings were taken in concert with the white edge with the most recent readings being obtained on September 21, 2005. At this point the average value for surface-applied readings had dropped to 110 mcdl, while the recess average remained much higher at 493 mcdl. These are shown graphically in Figure 10 as well as in Table 2 below.
