NATIONAL EXPERIMENTAL & EVALUATION PROGRAM

BRIDGE DECK PROTECTIVE SYSTEMS

WORK PLANS #4-#11 INITIAL REPORT

VERMONT DEPARTMENT OF HIGHWAYS

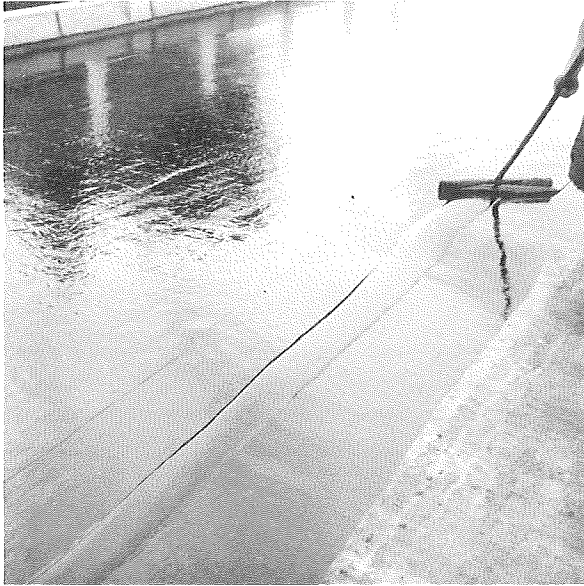
Applying the polyurethane with a squeegee. Note asphalt droppings and prime coat on concrete.

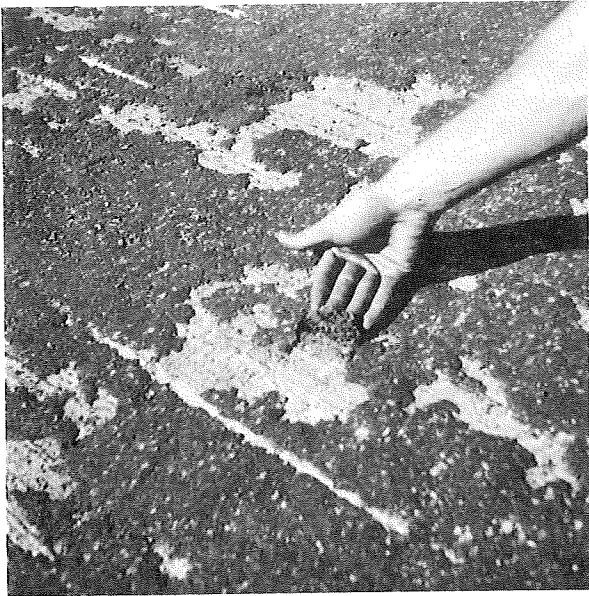
The bond between the remaining Uniroyal and the concrete allowed the membrane to be hand stripped from the deck at some locations.

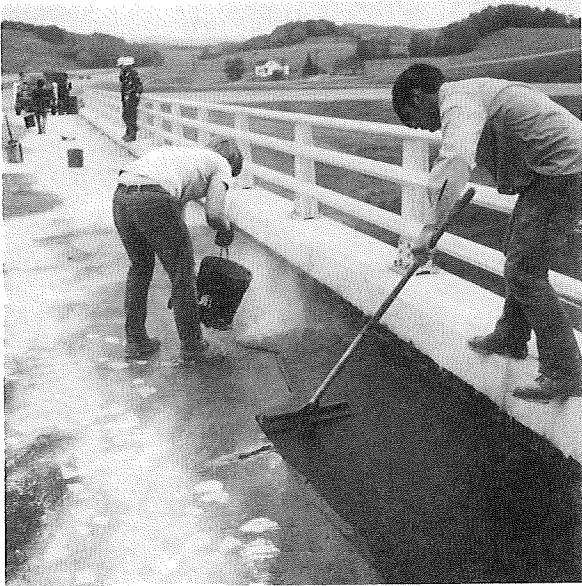
Applying second coat of liquid membrane along the curbs and over areas with holidays in the coating. Note cement dust application.

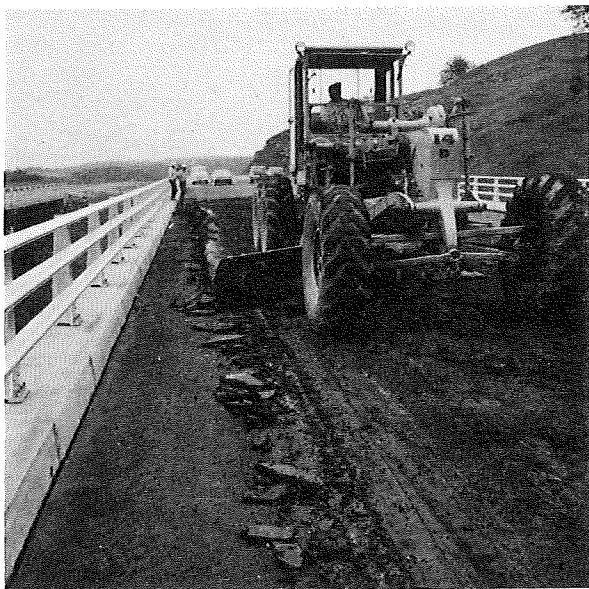
Removal of the pavement with a grader was accomplished with very little damage to the membrane.

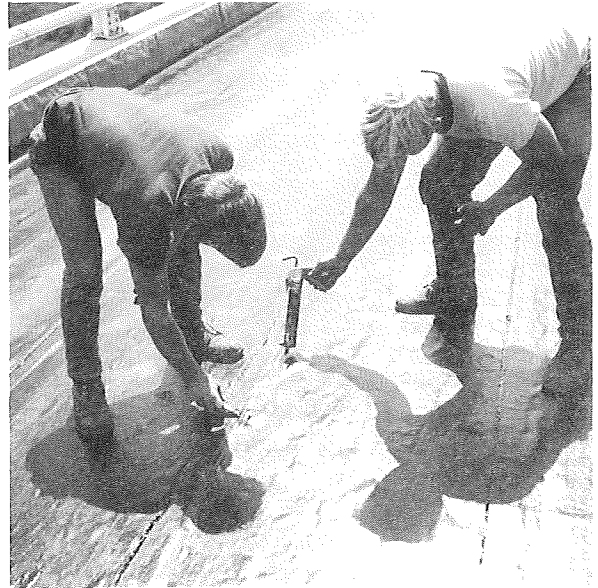
Puncturing large air bubbles and sealing the holes and overlaps with mastic.

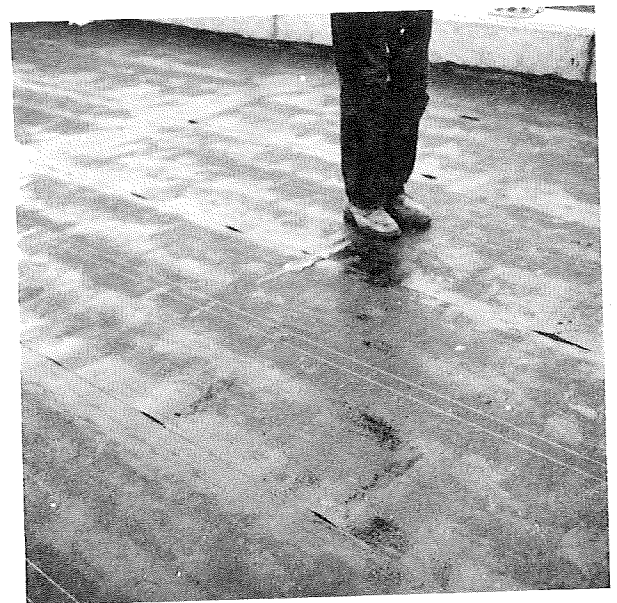
Squeezing water out from under areas of the roofing sheet which did not bond to the membrane.

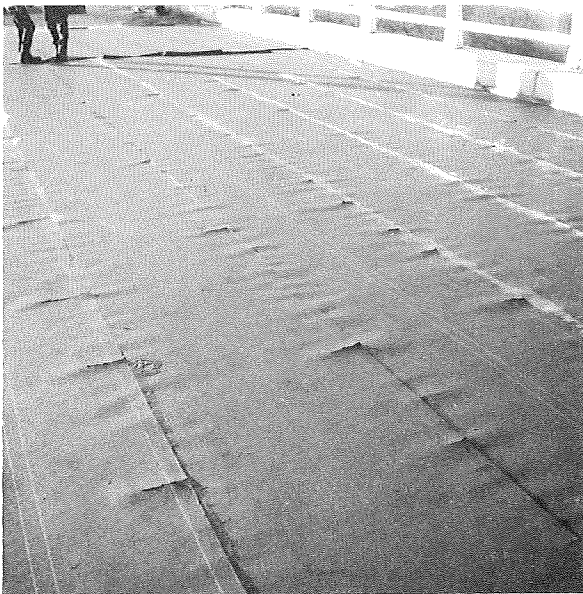
Fishmouths in the roofing sheet were cut open on the final area treated.
