INVESTIGATION OF ALKALI-SILICA-REACTIVITY IN PORTLAND CEMENT CONCRETE

PHASE II – SELECT VERMONT STRUCTURES

**Vermont Agency of
Transportation
Research, Development and
Technology Transfer Project**

DECEMBER 2008

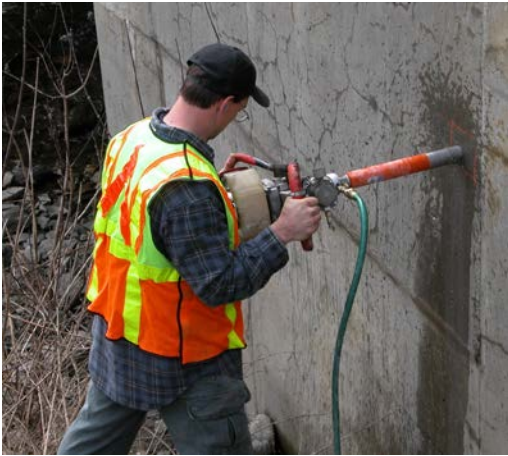
Figure 2 Coring vertical surface. Figure 3 Coring horizontal surface.
